# RECALL ABS Relay Contacts Sticking

LAND-ROVER

No: D380 Ref: Issue: 1 Date: 09/24/99

**DISCOVERY Series II (LT)**

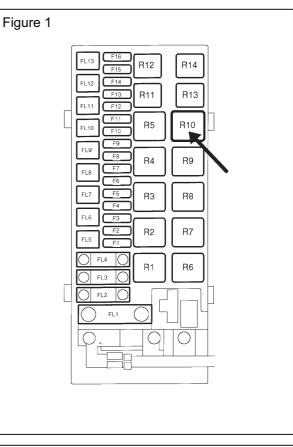
- 1. Turn off the ignition switch.
- 2. Lift the hood and remove the under-hood main fuse box cover.
- 3. Locate relay R10 (Figure 1) and remove the relay.

- 4. Bend the contacts of the removed relay to prevent it from being fitted to another vehicle.
- 5. Install new relay (YWB101300K) in position R10.
- 6. Install fuse box cover.
- 7. Turn ignition switch to the "ON" position and observe instrument warning lights.
- 8. Verify that all ABS warning lights extinguish.
