TECHNICAL INFORMATION

Front Frame Spacer Noise Correction

No: 76/13/03/NAS
Ref:
Issue: 1
Date: 05/23/03

Discovery Series II (LT)

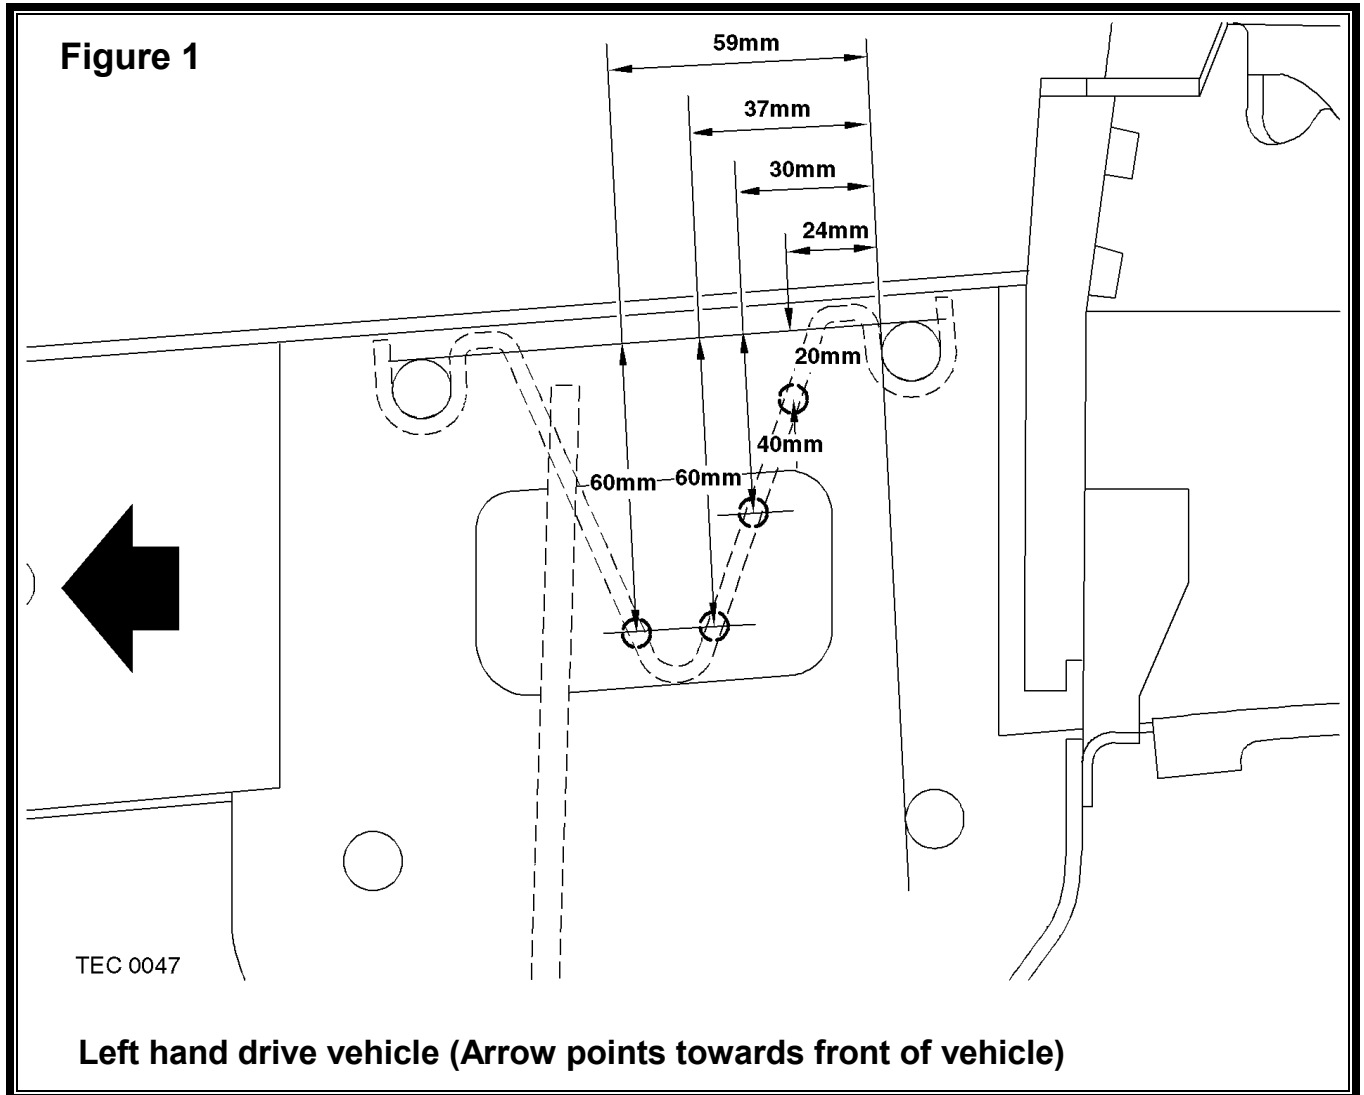
The customer may complain of a knocking or creaking noise from the front of the vehicle. The noise is frequently noticeable when making a turn. Movement of an internal spacer in the front longitudinal chassis member where the Power Assisted Steering (PAS) box is located is the cause of the noise.

NOTE: The dimensions shown on Figure 1 are approximate and are intended as a guide to the drilling position only.

7. Refer to Figure 1 for measurements to help locate the spacer.
8. Mark the "59 mm" hole position (front lower position) and center punch the 59 mm position for drilling.

9. Drill a 3 mm (0.315) diameter hole at the 59 mm position.
10. If the spacer is not exposed, drill a hole next to the first hole to establish the position of the internal spacer.
11. Mark the remaining four positions, adjusting the measurement for any variation required in step 10.
12. Punch and drill 8 mm (0.315) diameter holes at all positions including the correct 3 mm pilot hole at the 59 mm position.
