# TECHNICAL INFORMATION

No: 76/12/99/NAS  
Ref:  
Issue: 2  
Date: 05/19/99

## Fuel Door Fails to Open

**DISCOVERY Series II (LT) Up to XA223795**

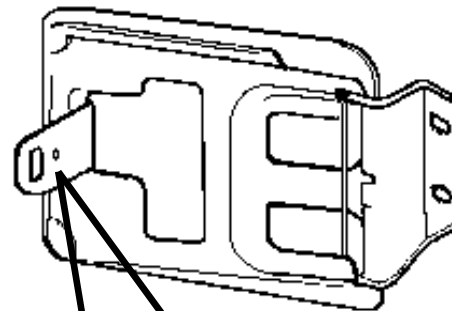
Figure 1

- The body buffers originally installed tend to stick to fuel flap back surface. This prohibits the door from opening consistently.
- The fuel door plastic latch may bind in its pivot hole, causing poor latching and unlatching.
- The actuator rod grommet can dislodge, jamming the latch and mechanism.
- Improper latch alignment can cause poor latching and unlatching.

2. Refer to Figure 1. Center a hand held 13mm (½ inch) drill bit on the plastic door latch pivot hole of the fuel door tab.
3. Carefully rotate the drill by hand to remove paint and material from a localized area **on the back** of the fuel door tab around the latch pivot hole.
4. Thoroughly clean the bare metal and surrounding area of the tab.
5. Apply a sparing amount of Dinitrol® (RTC7769/25) to exposed metal on the tab.
6. Continue with repair procedure while Dinitrol® is drying.

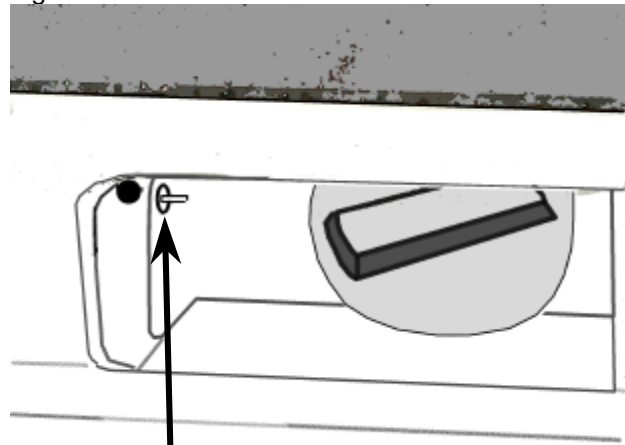
Figure 2

Actuator Rod and Grommet

2. Apply Loctite 4210 to backside of grommet shoulder.
3. Install grommet into body opening.
4. Clean off any excess adhesive and ensure that no adhesive has found its way into inside diameter of grommet where actuator rod travels.

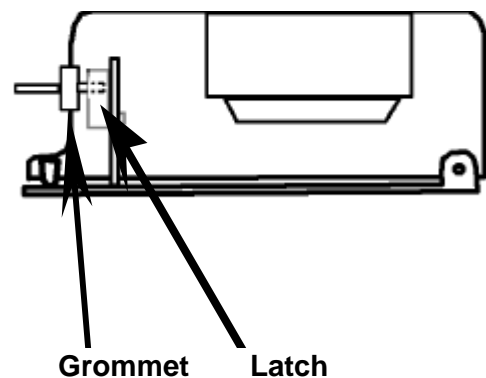
Figure 4

### *Top View of correct tab alignment*

3. Refer to Figure 4. Carefully bend filler door tab as required to align face of plastic latch parallel to the body at actuator rod.
4. Verify that there is no contact between the latch and the grommet or between the actuator rod and the filler door tab.
5. Latch and unlatch fuel door 3 times to verify correct operation.
