# TECHNICAL ALERT

TA00 8601 Ed 2

## Loose Electrical Connector at Starter Motor

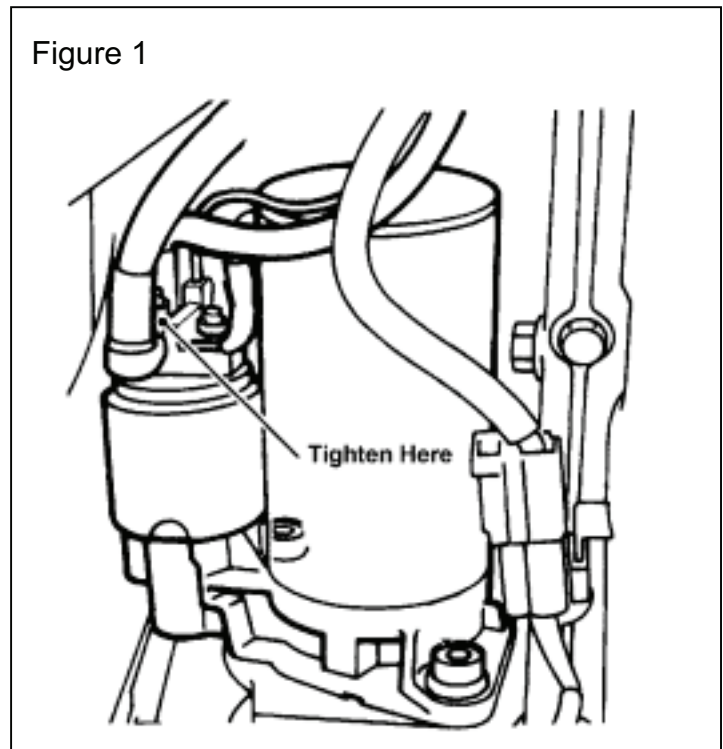
Figure 1

Field reports have indicated that the primary electrical connection on these vehicles may not be adequately torqued to provide a solid electrical connection. Testing of warranty return starters supports the suggestion of a loose connection. Returned starters frequently test "no-fault-found".

Whenever a no-start situation is encountered on 1999 and 2000 "Bosch" Range Rover or Discovery vehicles, the first check should be to tighten the main starter electrical cable connection as follows:

1. First disconnect battery ground terminal.
2. Slacken and remove the battery-lead-to-starter-solenoid-securing nut.
3. Install a star washer on the solenoid stud.
4. Install and tighten the nut to **18 Nm (13 lbf.ft.)**.
