TECHNICAL INFORMATION

No: 76/07/99/NAS Ref: Issue: 1 Date: 04/23/99

Rear End Door Rattle

DISCOVERY Series II (LT) All

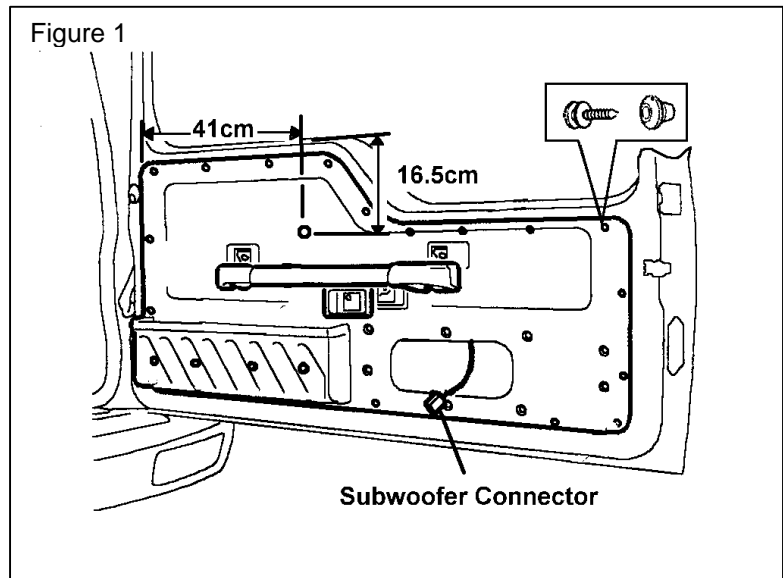
Customers may experience a rattle from the rear end door area. In cases where rear subwoofers are fitted, this rattle may be particularly noticeable when the radio has been set to a high bass level.

Two potential sources for an end door rattle have been identified. When a customer complaint is addressed on vehicles with subwoofers, verify that the trim clips are properly installed. Vehicles without subwoofers may have a wire harness making contact with body components.

1. Verify correct engagement of the 20 trim fasteners. (Dots in Figure 1)
2. Verify correct engagement of the four fasteners located inside the rear door pocket. (Figure 1)
3. Measure across and down from the inner top of the trim panel as shown in Figure 1.
4. Feel the area to determine if a fastener is in place or if a hole exists under the fabric.
5. If a fastener is present, push home the fastener.
6. If a fastener is not present, perform replacement of center clip outlined below.
