TECHNICAL INFORMATION

No: 86/08/99/NAS
Ref:
Issue: 1
Date: 10/08/99

Series II Battery Cover Latch

DISCOVERY Series II (LT)

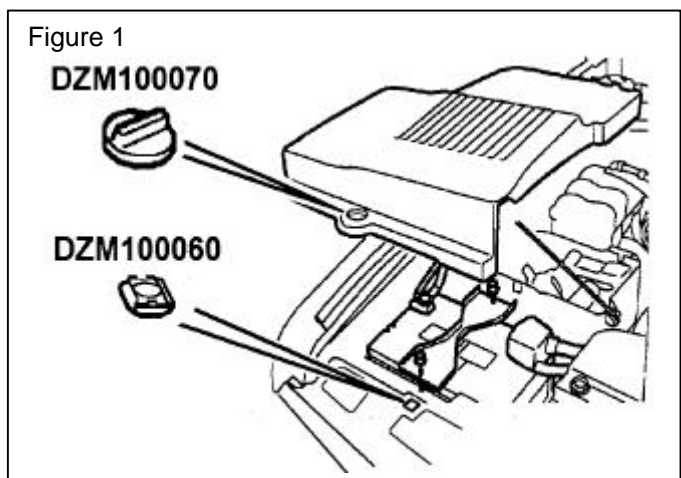
BATTERY COVER LATCH FAILS

Battery covers on some Discovery Series II vehicles may not latch. This may be due to a failed latch mechanism.

1. Remove and save plastic washer from failed latch mechanism
2. Install new latch in battery cover.
3. Secure latch with original plastic washer.
4. Remove latch receiver by pressing downwards and retrieving from below the hood platform.
5. Install new receiver as follows:
 - Place new receiver underneath hood platform
 - Align with receiver hole
 - Press upwards until receiver snaps in place
6. Close battery cover.
7. Fasten cover by rotating latch mechanism one-quarter turn.
