TECHNICAL INFORMATION

No: 86/10/04/NAS
FGN LT501
Ref:
Issue: 1
Date: 20 December 2004

SRS Warning Lamp Illumination

Discovery Series II (LT)

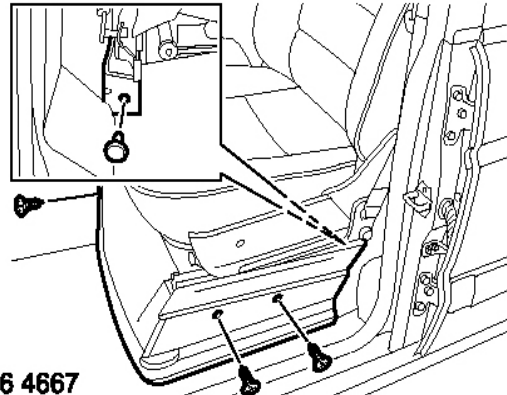
Figure 1

Left-hand front seat shown. Right-hand front seat similar.

1. Refer to GTR section 86.15.01 and disconnect the battery ground cable.
2. Open both front doors.
3. Remove screws and trim clips securing both front seat lower trim casings, and remove the lower trim casings. (Figure 1)
