## **TECHNICAL INFORMATION**

No: 86/04/99/NAS

### **Under-hood Ground Integrity**

DISCOVERY Series II (LT) ALL

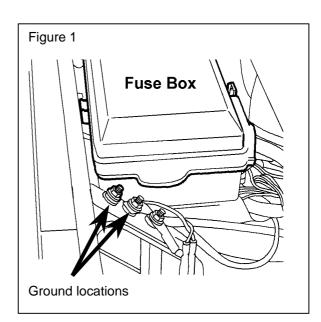
- Inspect ground points C558. C559, C560, C810, and C811. (Figure 1)
- 2. Torque retaining nuts as outlined in "Procedure to Obtain Good Ground."

- 1. Remove the fastener that holds ground wires to the vehicle.
- 2. Inspect the post and nut or bolt for corrosion.
- 3. If the mating surfaces or the post and nut are corroded, use a wire brush to clean them.
- 4. If the surface where the eyelet contacts the vehicle is a painted surface, place a star washer between the painted surface and the eyelet.
- 5. Replace the eyelet and tighten the nut or bolt to 8 to 10 Nm (65 to 90 lbf.in.).
- 6. Coat complete connection with anti-corrosion wax.
