TECHNICAL ALERT

TA02 1701

V8 Vehicles with Secondary Air Injection Discovery Series II and Range Rover 2000-2002

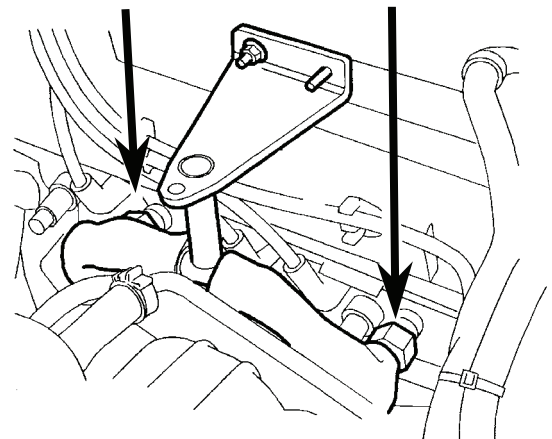
Figure 1

Investigation shows that when the components are dismantled from the engine/vehicle without damage difficulty **may** be experienced when reassembly of the removed pipe to the engine is attempted after repair. Exhaust heat from the engine has, over time, distorted the pipes very slightly. Removal from the engine permits the pipes to move/expand to release the built-up stress.

The distortion makes it very difficult to quickly re-assemble the pipes back onto the adaptors without cross threading the union nuts fittings. Patience and a little extra time are required. Refer to the RAVE WSM sections 17.25.17-18 and perform the following refined assembly process:

Finger Tighten Nuts Completely

1. Carefully align the pipe and the pipe union nuts.
2. Start the pipe nuts by hand.
(Figure 1)

3. Tighten both union nuts completely **finger tight** BEFORE any tools are used.
4. Install air manifold bracket nuts and tighten.
5. Torque the pipe union nuts to **25 Nm (18 lbf.ft.)**
