# TECHNICAL INFORMATION

No: 76/01/03/NAS  
Ref:  
Issue: 1  
Date: 01/17/03

## Water Ingress at Rear of Vehicle

Discovery Series II (LT)

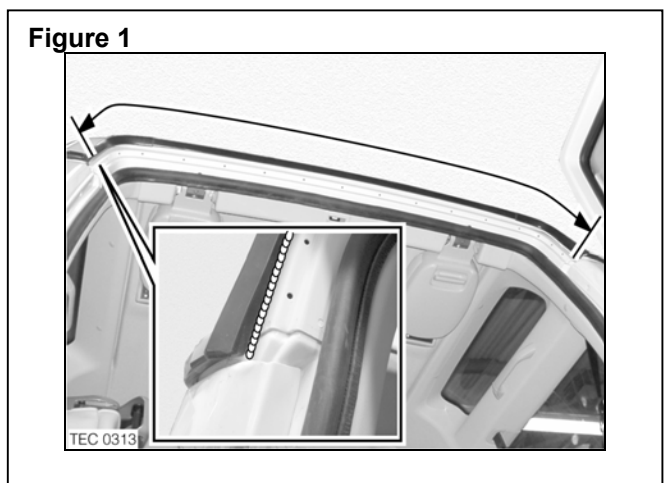
A sealing operation between the roof and the rear header outer joint may have been inadvertently omitted during production. The lack of sealant in the joint can permit water ingress.

1. Open the tail door.
2. Release 17 clips securing the tail door opening secondary seal to the body.
3. Remove the seal.
4. Clean between the roof and the rear header outer joint (Figure 1).
5. Apply a continuous bead of sealant between the roof and the rear header outer joint (Inset in Figure 1).
6. Wipe off any excess sealant.
7. Fit and secure the tail door opening secondary seal to the body.
8. Close the tail door.
