# **TECHNICAL INFORMATION**

No: 84/01/01/NAS

### Windshield Wiper Nut Improvement

Discovery Series II (LT) XA200412 to 1A299999

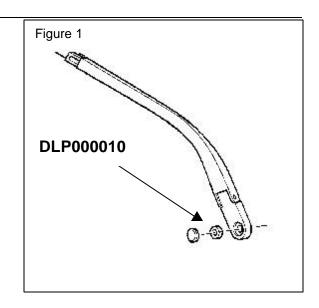
During winter operation additional loads can occur to the wiper system if a customer fails to free a wiper from ice or heavy snow prior to operation. The wiper arms may loosen on the spindle taper under these conditions and fail to sweep consistently when switched on. Torque relaxation of wiper arm securing nuts may be a factor in this condition.

- 1. Verify loss of wiper arm nut retention torque is the cause of the owner complaint.
- 2. Remove and discard the original nuts.
- 3. Inspect the wiper spindles for damage.
- 4. Install wiper arm and position correctly.
- Install and tighten the new nuts to 20Nm (14.7 lbf.ft.).
