# TECHNICAL BULLETIN

No: LTB00060  
Issue: 1  
Date: 22 Jun 2007

## Shuttle Valve Switch Related ABS/TC/HDC Warning Lamp Illumination Troubleshooting

Discovery Series II (LT)                      VIN: ALL

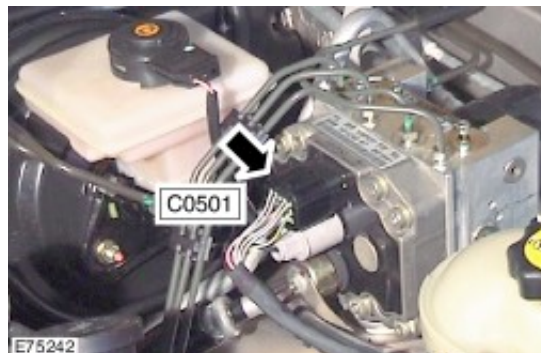
Figure 3

2. Disconnect and check the 13-pin connector at the ABS modulator (C0501). (Figure 3)
3. Disconnect the 15-pin connector C0506 at the Self Leveling and Anti-lock Braking (SLABS) ECU. (Figure 4)

4. Inspect both connectors for moisture ingress or corrosion and correct as follows:
  - If moisture or corrosion is present, dry and clean the connectors.

- Repair corroded connectors as necessary.
5. With connectors C0501 and C0506 disconnected perform the following:
  - Check for continuity between pin 6 of the 15-pin SLABS ECU connector (C0506) and pin 9 of the 13-pin ABS modulator connector (C0501) yellow/green wire.

- If there is no continuity (or intermittent continuity when the wire is flexed), repair as necessary and ensure the wire is correctly crimped and soldered.

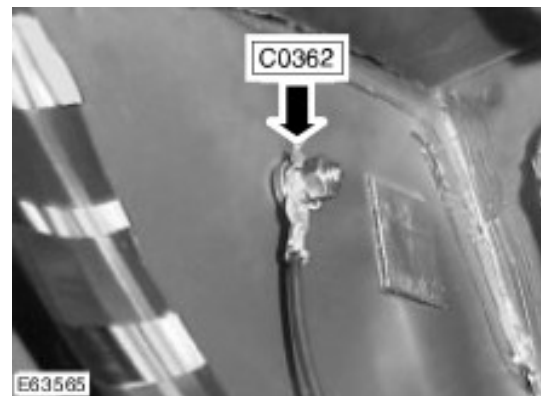
Figure 5

6. Disconnect the 18-pin SLABS ECU connector (C0504).
7. Check for continuity between pin-12 of C0504 and the ground connection located under the left-hand side of the fascia (C0362 – black wire). (Figure 5)

8. If there is no continuity (or intermittent continuity when the wire is flexed), repair as necessary and ensure the wire is correctly crimped and soldered.
