# 8920A-02A

## S E R V I C E N O T E

### HP 8920A RF Communications Test Set

#### Early Instruments Require Firmware Upgrade

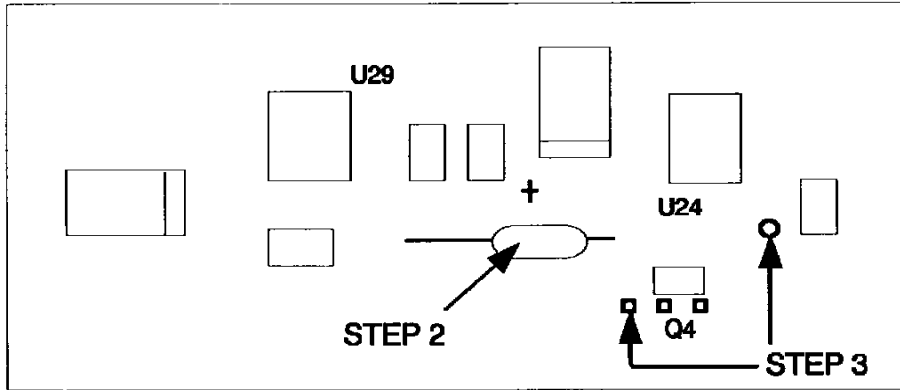
Figure - 1

Instruments with these serial prefixes have an A7 Controller assembly that is incompatible with the new A8 Memory assembly which is required to upgrade the firmware.

1. Remove the A7 Controller (DCU) assembly from the instrument. Locate the area of the board shown in Figure 1.
2. Remove the diode in this location and install a 2.87 Kohm resistor.
3. Install a 1 Kohm resistor on the backside (circuit) of the board between these 2 feedthrough holes. Scrape the solder resist off the pads on both sides of the board on the feedthrough hole to the left of the surface mount resistor. Clear the solder out of the feedthrough hole to the left of Q4. It's a tight fit, but the leads will go through the holes.

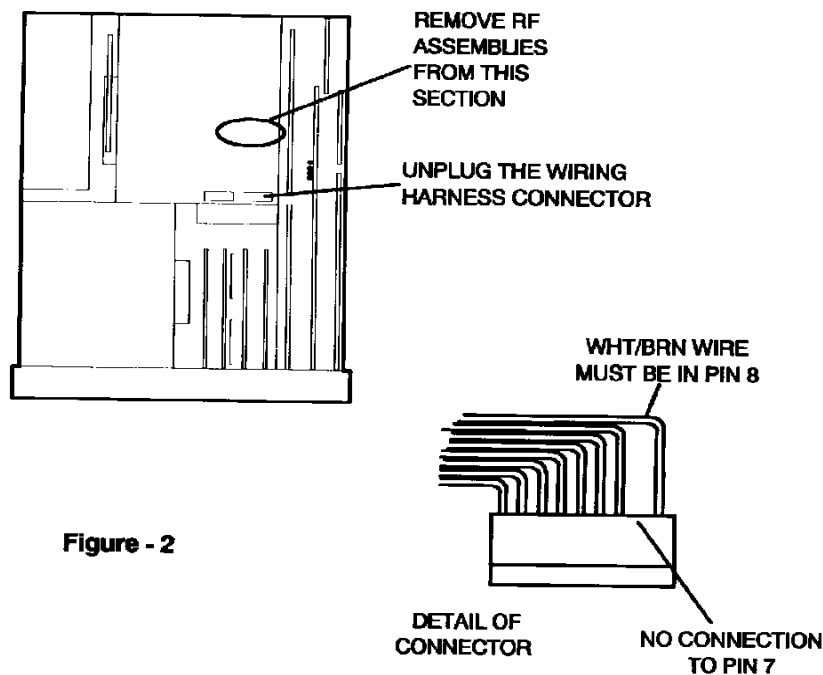
Figure - 2

Instruments in this serial prefix range have an error in the main Power Supply wiring harness. This error prevents the processor from identifying whether the power supply is powered in AC or DC mode which prevents detection of a low battery condition.

1. Remove all the RF assemblies from the instrument.
2. Unplug the wiring harness connector shown in Figure 2.
3. The WHT/BRN wire should connect to pin 8 of this connector. See Figure 2. If the WHT/BRN wire is connected to pin 7, it must be moved to pin 8. There should be no wire connected to pin 7.
4. To move the wire insert a small sharp pointed tool into the cutout on the side of the connector body next to the pin to be moved. This should allow the wire to be removed from the connector body. Then insert the wire into the pin 8 position of the connector body.
