Tektronix 49x/275x/279x-Series Spectrum Analyzer Service Notes

John Miles, KE5FX
jmiles@pop.net

April 29, 2011

Errata and helpful notes on calibration/service procedures

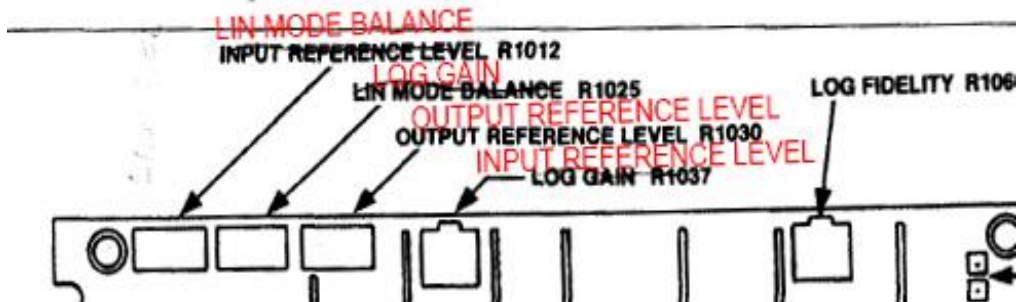
The catch is that at least two different layouts were used for the controls in figure 5-13. At some point, probably around the time Tek redesigned the board using surface-mount components in the late 1980s-early 1990s, the trimmer functions were reordered *while their physical locations were left alone*. In earlier logamp assemblies, the order is as specified (left-to-right on the component side):

INPUT REFERENCE LEVEL R1012
LIN MODE BALANCE R1025
OUTPUT REFERENCE LEVEL R1030
LOG GAIN R1037
LOG FIDELITY R1060

In later assemblies, the correct control order is:

LIN MODE BALANCE R1025
LOG GAIN R1037
OUTPUT REFERENCE LEVEL R1030
INPUT REFERENCE LEVEL R1012
LOG FIDELITY R1060

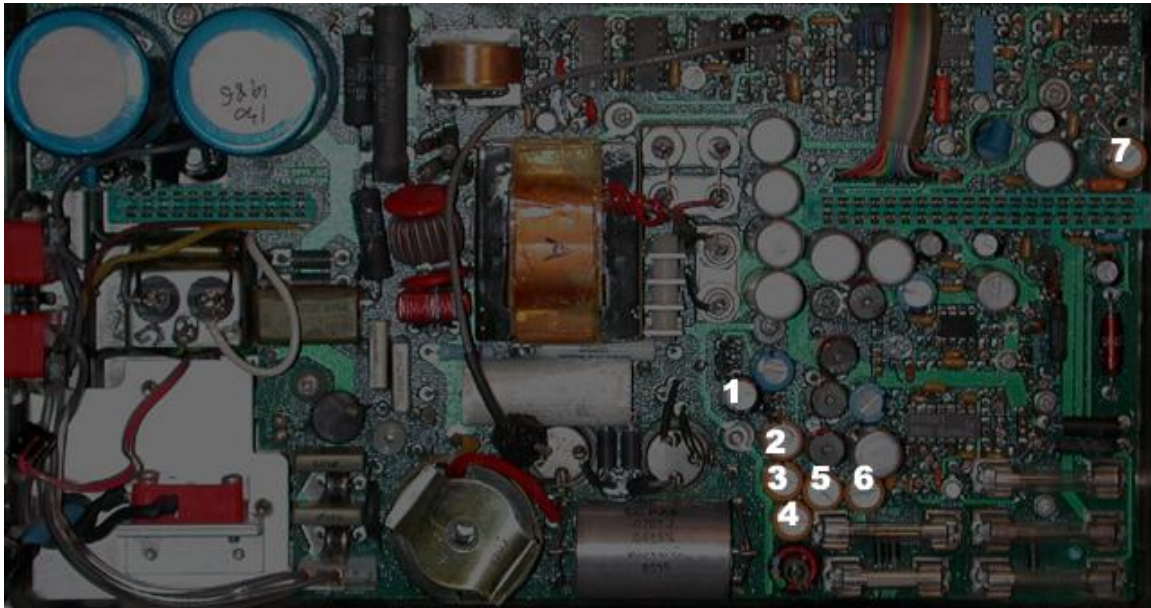
Regulation tolerances for the low-voltage supply buses are specified in service volume 1, and are not usually a problem. However, the +100V and +300V supplies are frequently below their specified values. If any 66-kHz ripple or sagging is observed, all of the miniature 2.2 uF/200V axial-lead electrolytic capacitors in the power supply should be replaced. These are inexpensive high-failure-rate parts, so they should be replaced in any event if the power supply is otherwise disassembled for service.

I recommend checking the ESR on any replacement high-voltage electrolytics as well. Several "new" capacitors in this voltage range have proven defective when obtained from surplus sources.

High ESR in the filter capacitors on the lower-voltage rails (+17V, +5V) has been reported as a cause of excessive power-supply temperature, so when servicing the power supply, you should check ESR on *all* electrolytics as a matter of habit. Check heat-sink fasteners for tightness, and renew the heat-sink compound while you're at it. Avoid losing track of the mica washers and aluminum spacers that may fall out when you remove the PCB.

Use 105 degree C-rated electrolytics where possible, e.g., 3.3 uF 350V 105C, [Digi-Key](#) part # 493-2046-ND. These can replace all of the smaller high-voltage capacitors in the power supply (6x 2.2uF/200V, 1x 1uF/350V).

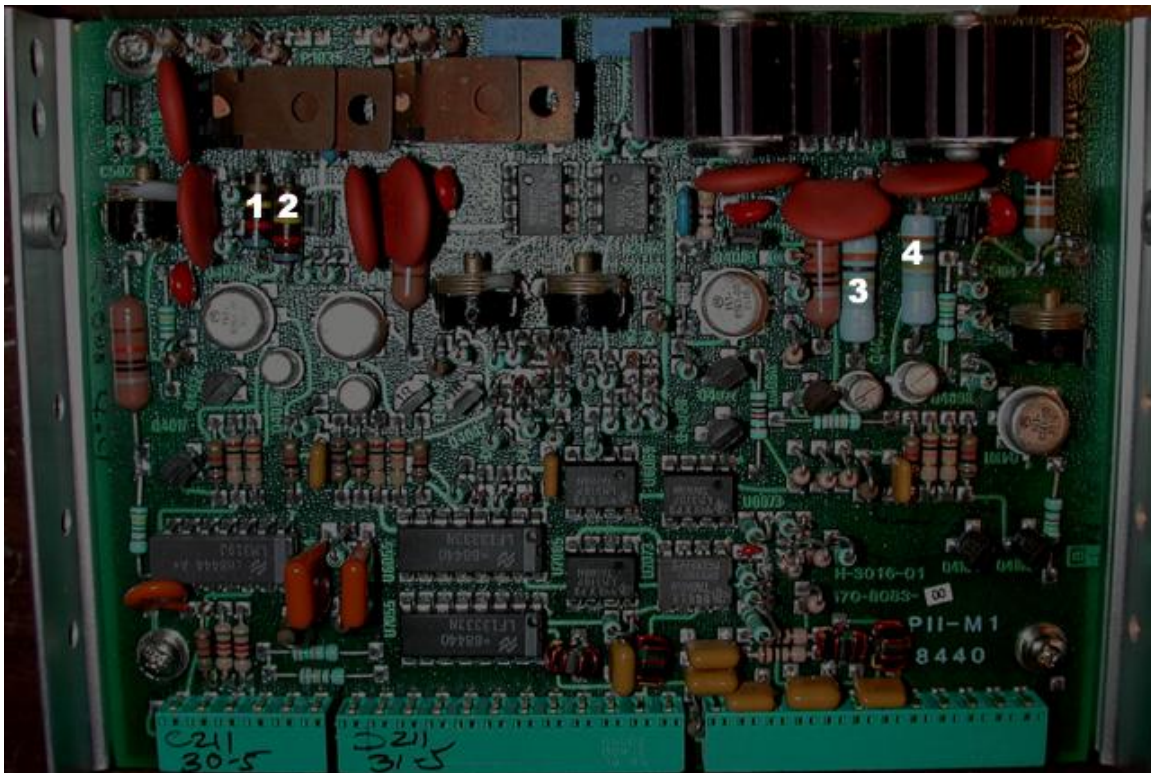
This particular board already had 300K metal film resistors (3,4) in place, so they were left alone. The 620K, 5% carbon-composition resistors (1,2) were measured at 580K and 980K, respectively.

When servicing instruments with the pre-1988 deflection amplifiers, it's a good idea to replace the 620K and 300K carbon-composition resistors in the negative-feedback paths. Many of these resistors have drifted upward over time, and/or become noisy. Typical replacement parts would be [Digi-Key](#) P620KBBCT-ND (two each) and BC300KW-2CT-ND (two each). Calibrate the deflection amplifier and digital storage subassemblies after replacing these resistors.

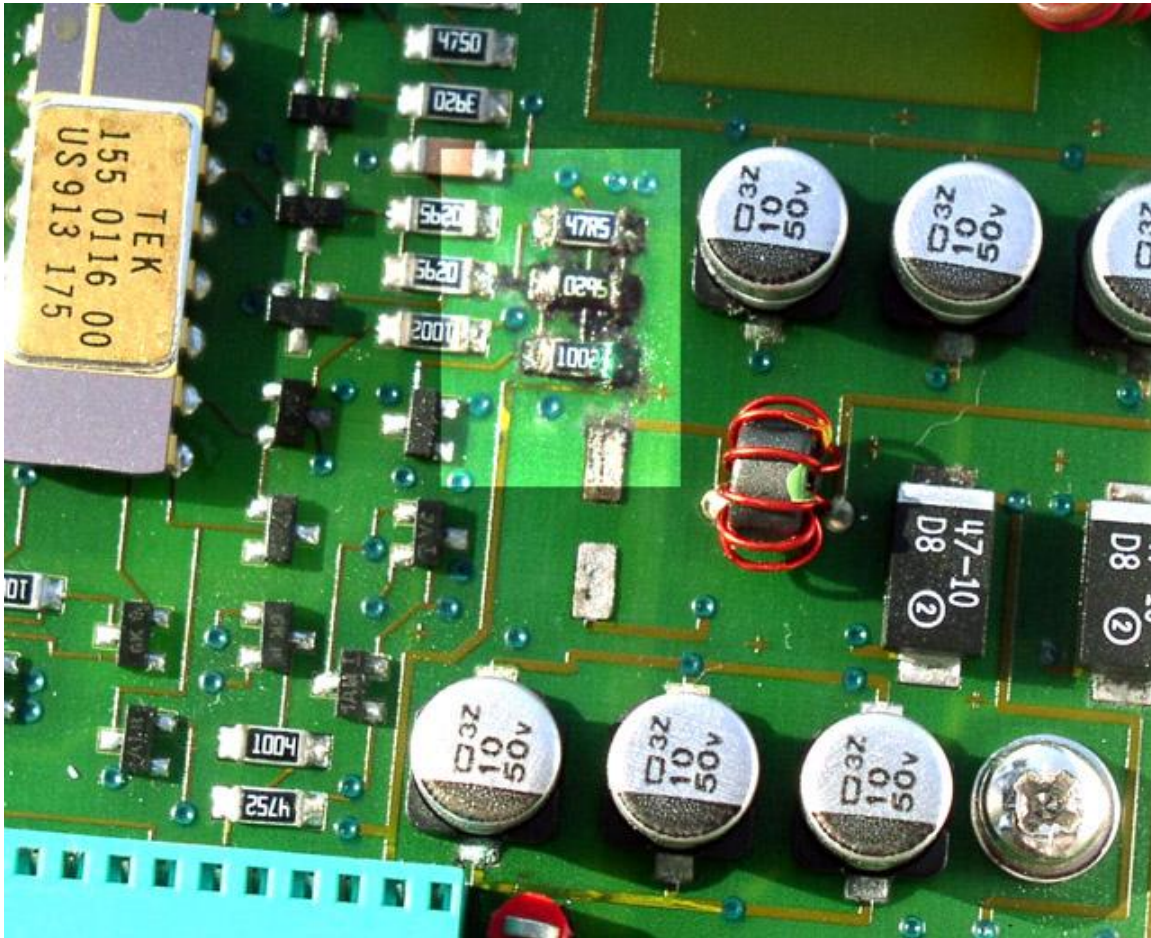
Amplitude instability in the newer units (e.g, later-production 494APs, as well as 495Ps with serial numbers after B030000) is becoming all too common, thanks to Tek's eagerness to adopt surface-mount technology at a time when component quality wasn't yet up to par with traditional through-hole tech. If you own one of these early-1990s vintage analyzers, chances are good that your logamp board (in particular) already looks like this:

The black "crud" in the highlighted area doesn't originate from the resistors or from the soldering or assembly process. Rather, it's caused by outgassing of corrosive vapors from one or more of the 10 uF/50V electrolytics nearby. Any corroded traces should be cleaned or bridged as soon as you spot the problem, and *all* of the aluminum-can electrolytics should be replaced.

50-volt capacitors aren't needed in most cases -- 35V is fine for supply buses up to +/-15 volt -- and their exact type (tantalum or aluminum) isn't important either. Just get those old caps off the board! Keep in mind that affected traces can be several inches away from the nearest capacitor. A careful inspection of the entire PCB is necessary when this failure occurs.

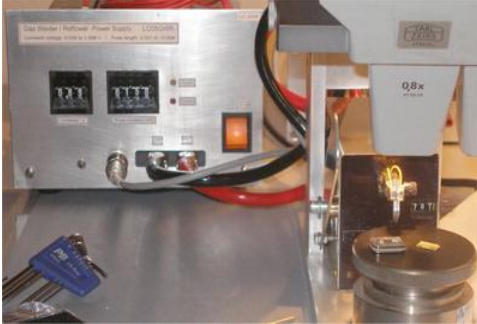
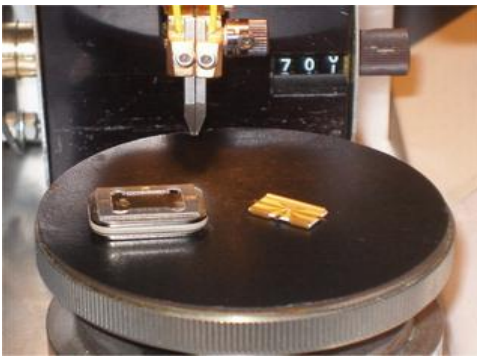
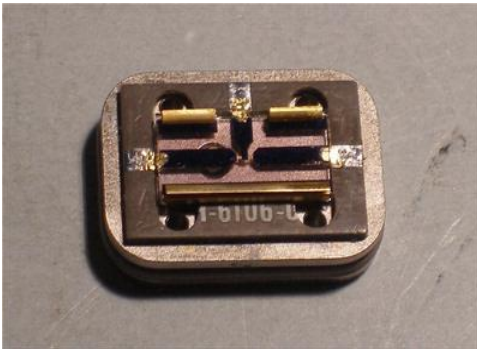
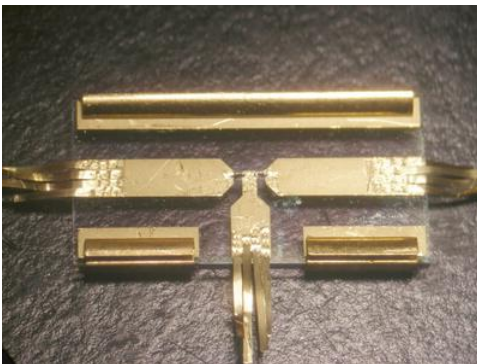
Photos courtesy Luis Cupido, CT1DMK, of the [chip-hybrids](#) group, showing the diode carrier from the 21 GHz first mixer with its substrate removed, undergoing diode replacement.

The mixer diodes themselves are almost too small to see, even in the magnified view at bottom. Actual width of the entire substrate is approximately 15 mm.

It's been reported by Luis Cupido, CT1DMK that the beam-lead diodes can be replaced with either BAT30 low-barrier parts from Infineon or MSKN709 medium-barrier diodes from Metelics. Low-barrier Metelics parts should also be usable, as may similar diodes from MA/COM. Luis has found that the better-known HCSC9101 diodes need more LO power than the analyzer has available.

Although the mixer and its diode carrier are easy to work with on the bench, replacing the diodes on the carrier is another matter. Gap-welding capabilities are required for the gold ribbon-to-substrate attachment, while gap reflowing is used to attach the ribbons to the diode holder (although the latter operation may be performed with a small soldering iron). It may be difficult to preserve the original gold ribbons during disassembly; be prepared to replace them with new ribbon stock.

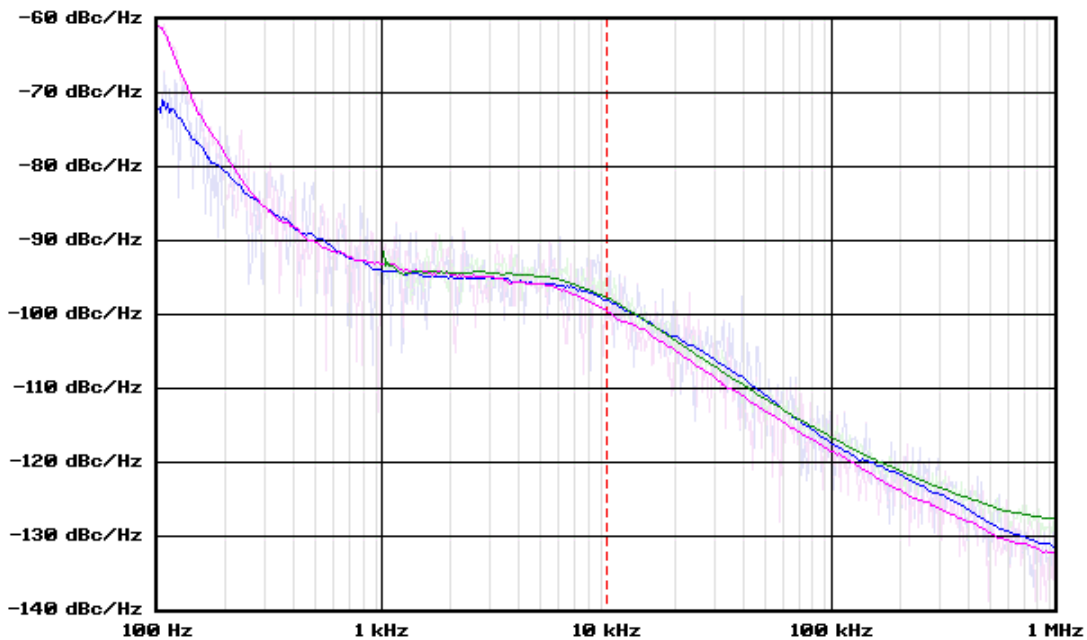
The traces below were acquired with PN.EXE from the GPIB Toolkit, measuring the output of a Wenzel crystal oscillator whose phase noise is substantially lower than the analyzers' own. Typical examples of the 494AP, 494P, and 492P spectrum analyzers were compared. Minimum RF attenuation was set to 0 dB in all three cases, and 20 dB of carrier clipping was used.

The 494P appears noisier close to the carrier, but this is actually a consequence of its broader 30-Hz RBW specification compared to the 494AP's 10-Hz minimum bandwidth. The 30-Hz filter skirt, and not the LO phase noise, is responsible for the observed performance at offsets below about 300 Hz.

At offsets of 10 kHz and beyond, all 49x/275x analyzers should generally perform within +/- 5 dB of these traces. All three analyzers meet Tektronix's rather-loose PN specifications easily.
