# SuperStar 4900B Troubleshooting

### Transmit Section Repair Memorandum - 12/2000

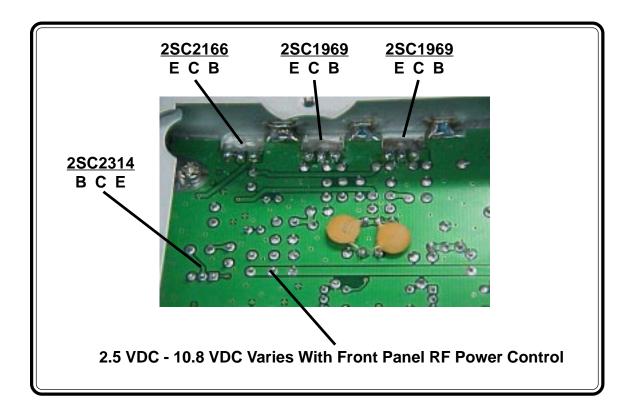
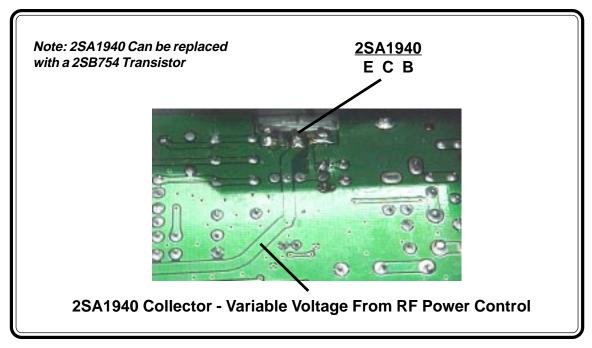
<sup>\*</sup> See the pictorial diagrams for component location and pin out information.
