SVT-CL Customer Service Bulletin: CSB0003

November 6, 1997 Customer Service Bulletin

Units Affected:

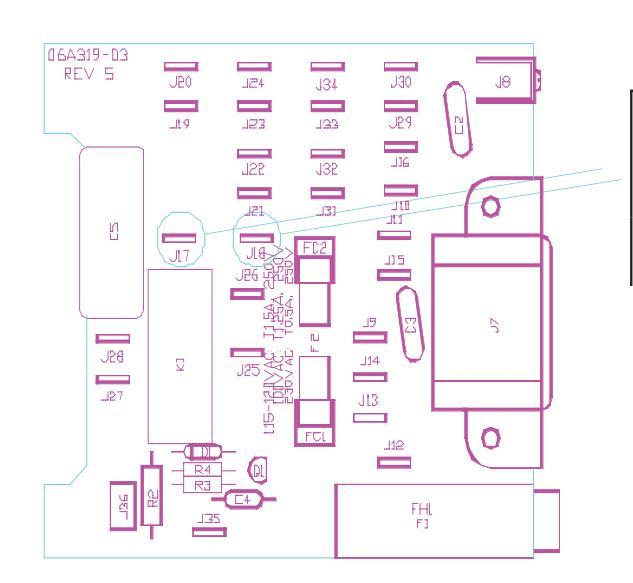
07-319-xx AC Termination board as viewed from inside lower chassis

AC mains fuse for filament transformer would fail prematurely during normal operation when tuming unit on as a result of a design change to use IEC approved fuse beginning with 1/1/97 production. Replacement with larger value fuse would solve false tripping problem but would not always provide adequate protection against damage during severe fault condition.

- 1. Disconnect the AC power from the unit.
- 2. Remove lower chassis assembly from cabinet and view from bottom.
- 3. On the 07-319-xx AC termination PC board, remove blue and gray leads from tabs J17 and J18.
- 4. Add one 97-123-23 ICL assembly in series with the blue transformer lead and tab J17, and one in series with the gray lead and J18 by attaching the female Fast-on connector of ICL to the tab on the printed circuit board and the male Fast-on to transformer lead.
- 5. Secure the assembly with a cable tie to other AC wires so that no leads are touching other parts.
- 6. Replace the fuse (F2) with a T1.25A (SLME part number 23-512-05).
- 7. Remove any fuse label so that "100VAC T1.25A" is visible on the printed circuit board.
- 8. Reassemble and check out unit for proper operation.

Add one 97-123-23 ICL assembly in series with J17 and the blue transformer lead and one in series with J18 and the gray transformer lead.
