SERVICE MANUAL

nx520p

TYPE:YS1002

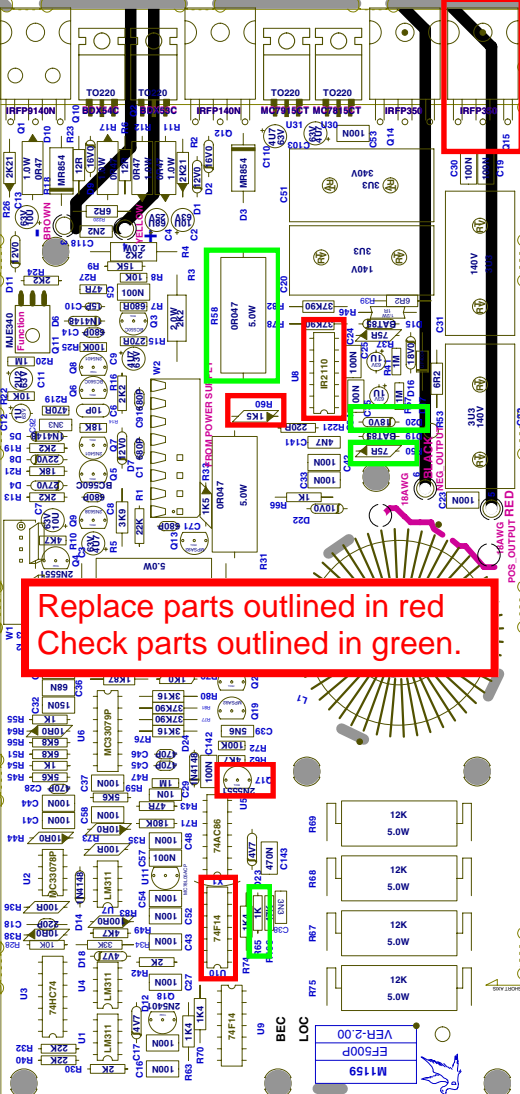
We have experienced some failures with the short pilot runs of 520P and EF500P due to an incorrectly mounted resistor on the power board. There are only about a dozen of each of these in each of our market territories. These failures at first sight will seem somewhat intimidating due to the blackening soot which is produced when the resistor arcs out to the printed high voltage rails under the resistor designated R60. The damage looks far worse than it really is and is generally repairable by anyone with basic electronics and soldering skills.

Replace parts outlined in red
Check parts outlined in green.

The process for repair of units suffering from an R60 arc over is as follows.

- A) Remove the remains of R60 and clean the soot from the board. Please remember this is a double-sided circuit board with thru plated component holes. Do not use excess force to remove the component leads from their solder holes. They will come out easy enough when you have enough heat on the joint.
- B) Replace the following components : 1) Q15 , IRFP350 2) Q17 , 2N5551 3) U10 , 74HC14N 4) U8 , IR2110 And finally, R60 , 1K5 , which should be installed about ¼" above the board so as not to arc out to the high voltage traces again.
- C) Measure the following parts; just to be sure we don't have any stragglers. 1) R58, .47ohms 2) R50 , 75R 3) R65 , 1K and 4) D20 , 18 volt zener.
- D) Yorkville Part #'s (Q15 = 6914) (Q17 = 5107) (U10 = 6603) (U8 = 6887) (R60 = 2034)
