SERVICE ACTION Market Program BCU for Battery Drain

No: H220 Ref: Issue: 1 Date: 08/15/00

Discovery Series II (LT)

QUIESCENT BATTERY DRAW RESULTS IN DEAD BATTERY

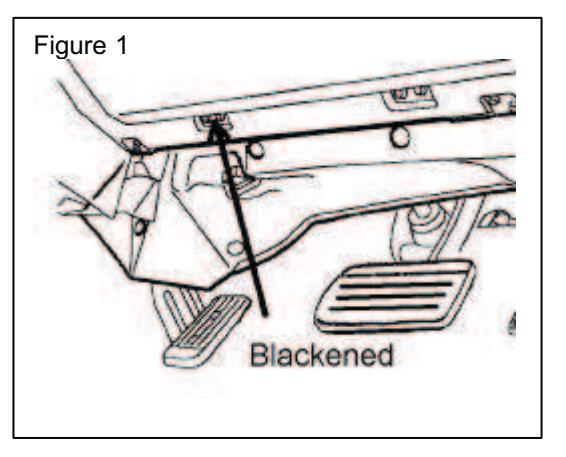
- NOTE: Some vehicles have been inspected for battery drain configuration problems at the Port of Entry. These vehicles have been marked. No market program is required if the appropriate mark is present.
- Inspect the passenger compartment fuse block cover fasteners for a blackened screw head on one of the LH fastener positions. (Figure 1)
- 2. If the screw has been blackened, apply the Service Campaign label.
- 3. If the screw is *not* colored black, perform the market program.
