Official Journal of The Collins Collectors Association

Second Quarter 2002

## Repair of the 70E-8 PTO used in my Collins 32V3

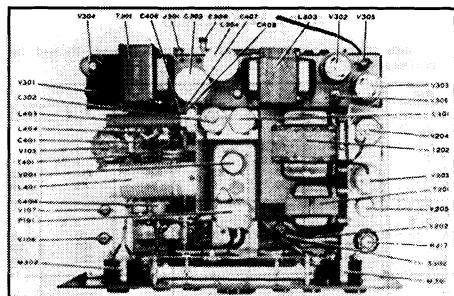
Inside the Collins 32V3 transmitter
