THINGS TO LEARN, PROJECTS TO BUILD, AND GEAR TO USE

## The Collins 30L-1 Amplifier Revisited

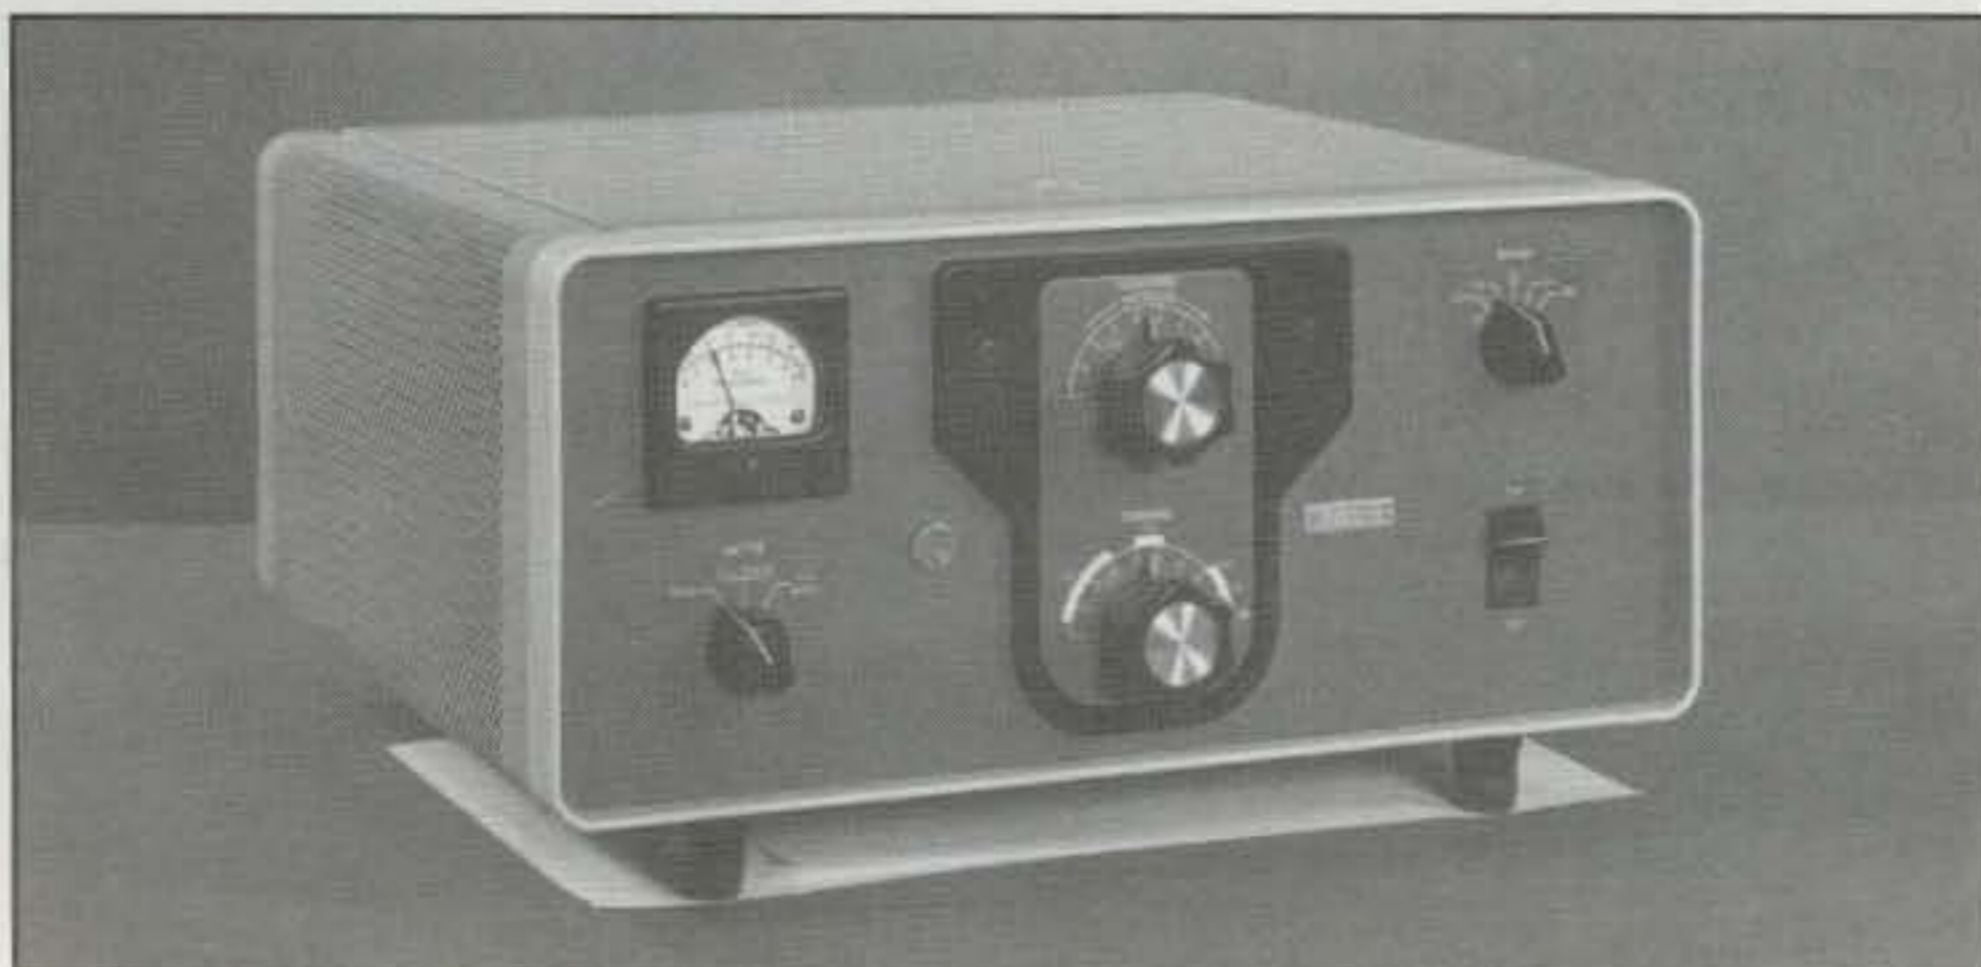
The Collins 30L-1 linear amplifier introduced in the early 1960s.
