ANATOMY OF THE COMET CHA-250BXII

Despite the mixed reviews⁽¹⁾, about 4 or 5 months ago I decided to purchase a Comet CHA-250BXII antenna. These are sold as a “broadband HF vertical that does not require radials”. Some people think they’re the greatest thing since sliced bread; others rate them as a glorified dummy load. Interestingly, there don’t seem to be too many people with an intermediate view; they either love it or hate it.

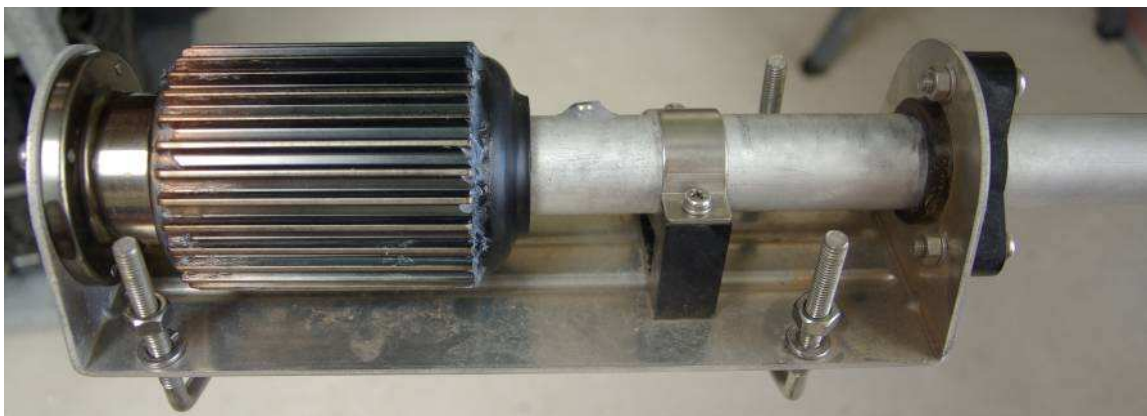
Image 1 – Antenna Base Assembly

The following pictures are actually in reverse order because they were taken after I had dismantled the unit. This first image is of the antenna base assembly. This was taken after I had put everything back together. You can see the silicone I applied to the joints to help seal out moisture (which turned out to be the cause of the fault).

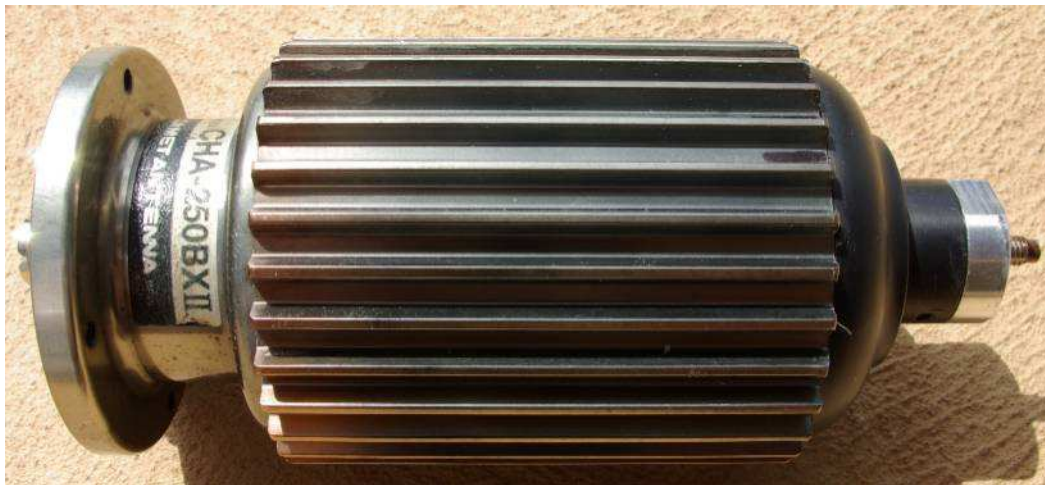
Image 2 – The mysterious “Black Canister”.

Image 2 shows the matching unit (a.k.a. black canister, dummy load) removed from the antenna base.

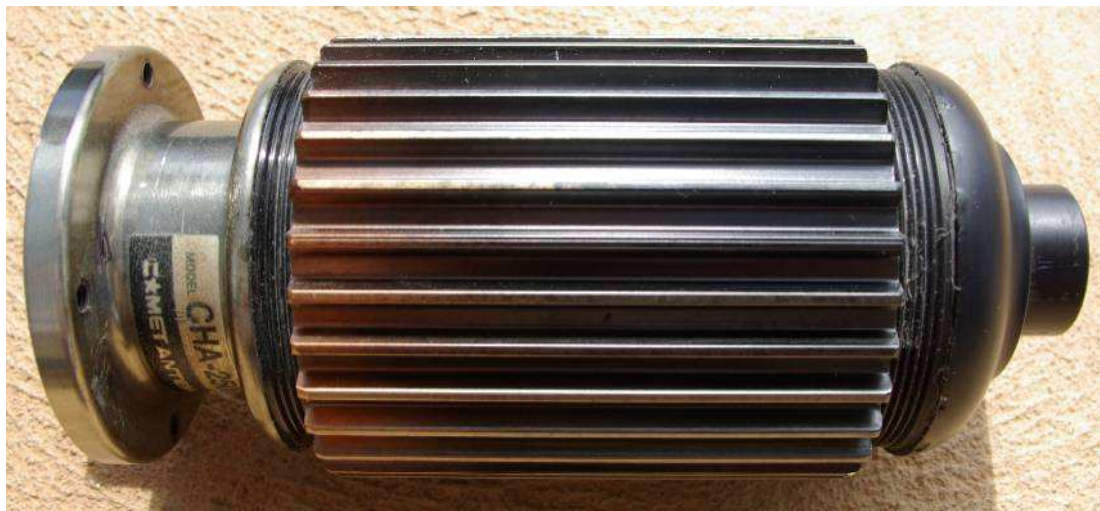
Image 3 – Showing how the top and bottom sections are screwed in.

Image 3 shows how the top and bottom sections are screwed into the central section (bit with the fins). Before the top can be removed, you must first remove a small grub screw that locks the top aluminium piece in place. You can then start to unscrew the central spigot at the top. Note that this has a wire soldered into the centre of it. Don't even bother trying to undo this joint with your average soldering iron; it requires too much heat. As you undo this spigot you will be twisting the attached wire. This doesn't matter since there's plenty of it inside. Once the screw has been undone to the end of the thread, hold the end spigot with a pair of pliers and heat with a gas blowtorch to melt the solder and pull the spigot off the wire.

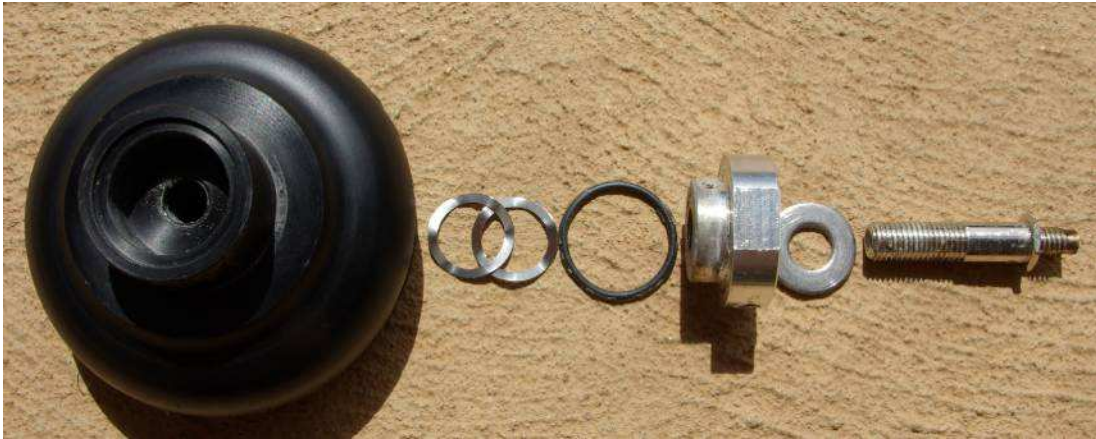
Image 4 – Top section parts.

Image 4 shows the parts in the top section assemble. Once the spigot, washers, etc. have been removed the black plastic cap can, in theory, be unscrewed. In practice, the torque required to break the glue on the threads is colossal. What I did next (after trying various things involving hammers and screwdrivers) was to carefully saw into the plastic cap (with a hacksaw) right next to the fins. Bear in mind that, at this stage, I didn't know the cap was screwed in; I assumed it was just glued in. I had to cut to a depth of 10-12mm before the cap came off. This left the part with the threads still in the top of the central section. Using a hacksaw blade I made two cuts through this piece 180° apart. After this a light tap with a hammer was enough to break the glue and the two pieces came out. With hindsight you

could perhaps drill some holes in the cap so that a specially fabricated lever can be attached to it with screws. You *might* then be able to apply sufficient torque to unscrew it in one piece, but I still think it unlikely. At this point I was left with the plastic cap in three pieces; the top cap plus the threaded section in two halves. These were put back together with superglue and some small self-tapping screws (the cap in images 3 and 4 is after I put it back together).

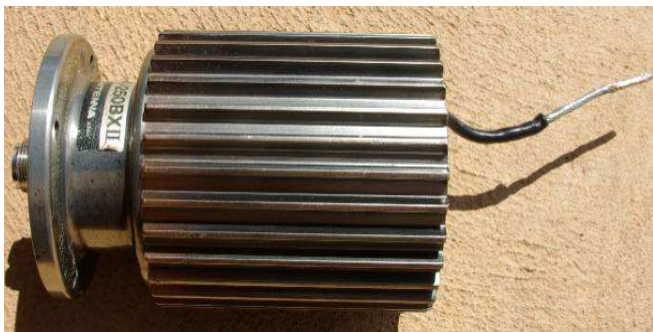
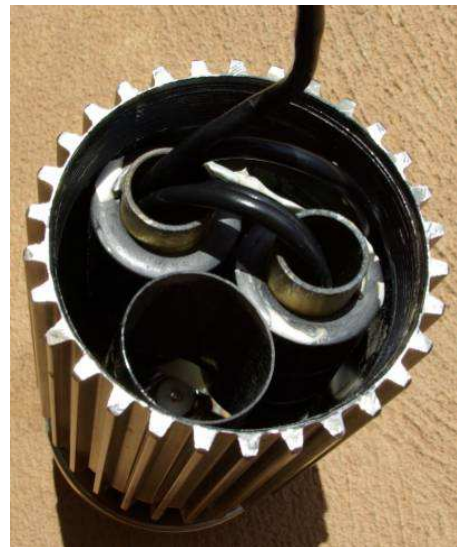
Images 5 and 6 show the matching unit with the top cap removed. There are two wires going to the SO-239 socket in the base. In my case, the ground wire to the socket was already broken due to corrosion. After much poking and prodding with a screwdriver I managed to break off the second wire at the centre pin of the coax socket. The central assembly was then pulled out of the canister.

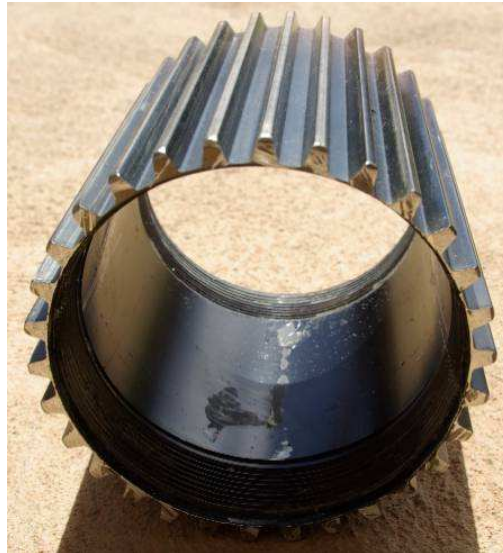
Image 7 – Threaded aluminium sleeve.

Next I used two of the mounting holes in the base to attach the canister to a piece of 4mm thick steel strip which was in turn held in a vice. A vehicle oil-filter removal tool was then used to unscrew the central section from the base. Even with this arrangement, I still had to heat the joint between the two sections with a gas blowtorch to soften the glue before I could undo it (hence the need to break wires and remove the insides first). This is the cause of the discolouration visible on the lower part of the fins in images 2 and 3. Image 7 shows the aluminium sleeve after removal from the base.

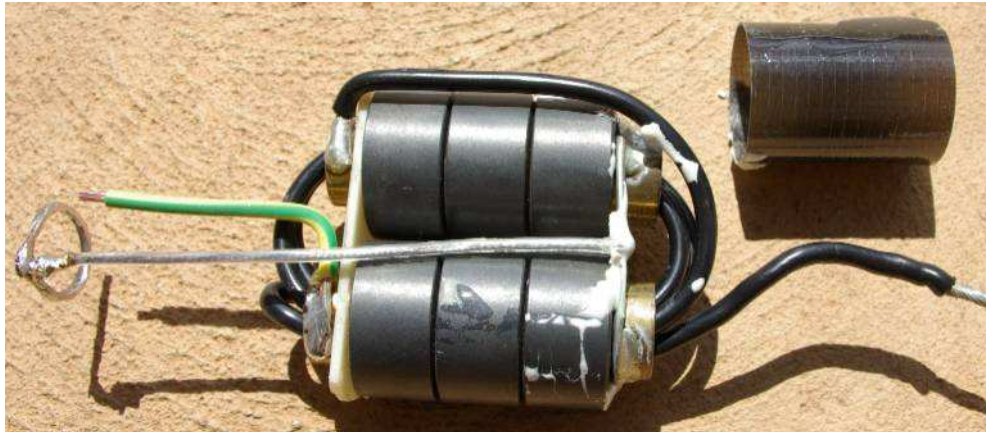
Image 8 – Matching unit side 'A'

Images 8 to 12 show the matching unit assembly. The small fibreglass cylinder in image 8 is used as packing to make sure the parts can't move around. The matching unit appears to be a balun with a ratio of about 12:1. The ring at the end of the wire with clear insulation goes under the nut on the SO-239 socket while the green/yellow wire goes to the centre pin. The black wire on the right goes to the antenna element.

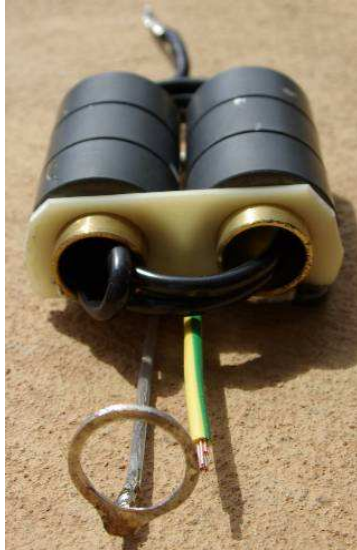
Image 10

The brass tubes through the toroids for the first “turn”. The two tubes are joined at the top and this point is connected to ground. The bottom end of one tube is connected to the coax centre while the bottom of the other end connects to the start of the coil that goes through the tubes. The end of the last turn goes through one of the tubes then loops back to the top (left hand tube in image 10).

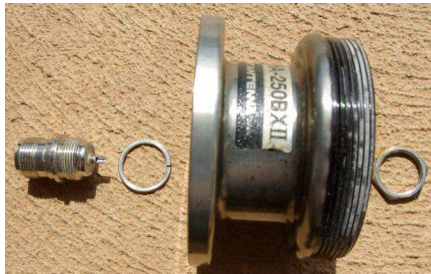
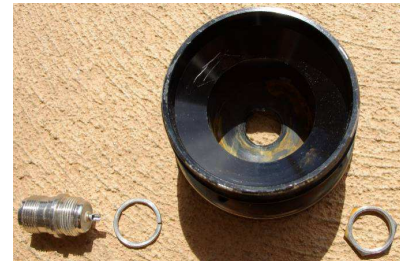
Images 13, 14 and 15 show the parts in the bottom section assembly. Note that the base section is threaded to take the SO-239 socket. Image 16 shows the matching unit refitted to the base section prior to reassembly.

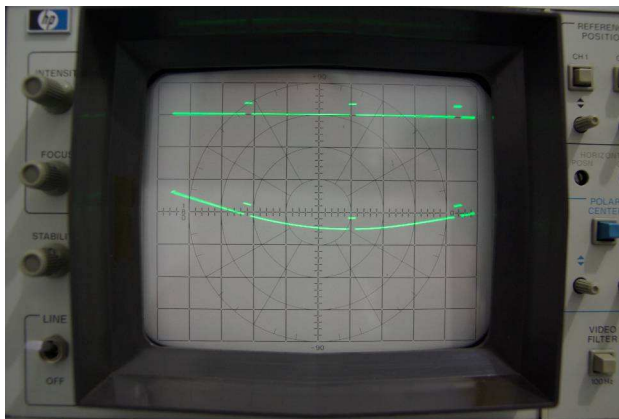
Image 18 – Test results

Image 18 shows the loss over the range 3 – 30 MHz. The upper trace is the 0 db line. The markers are at 10 MHz intervals. The vertical scale is 2.5 db per division. This is not an entirely accurate test because the output impedance of the matching unit is nowhere near 50Ω .

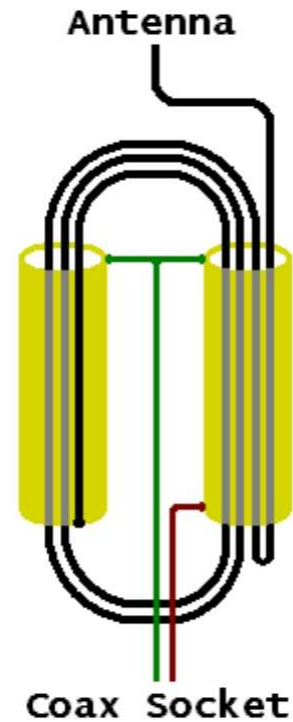
The sketch above gives a clearer view of how the matching unit is wired up. I will try to answer any questions you may have regarding the construction of this device. Please send them to [cha250 at vk5zdb.com](mailto:cha250@vk5zdb.com) (replace ' at ' with @).
