Technical Service Bulletin No. 21

Created by: Lab.gruppen AB Service Department

Reference no: C...X models

C20:8X, C10:8X, C10:4X & C5:4X

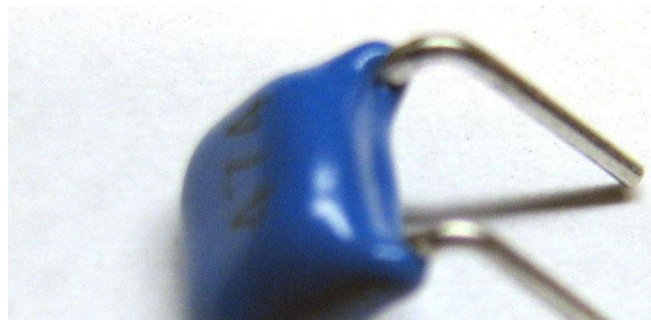
7.	Form capacitors legs according to picture.		
----	--	--	--

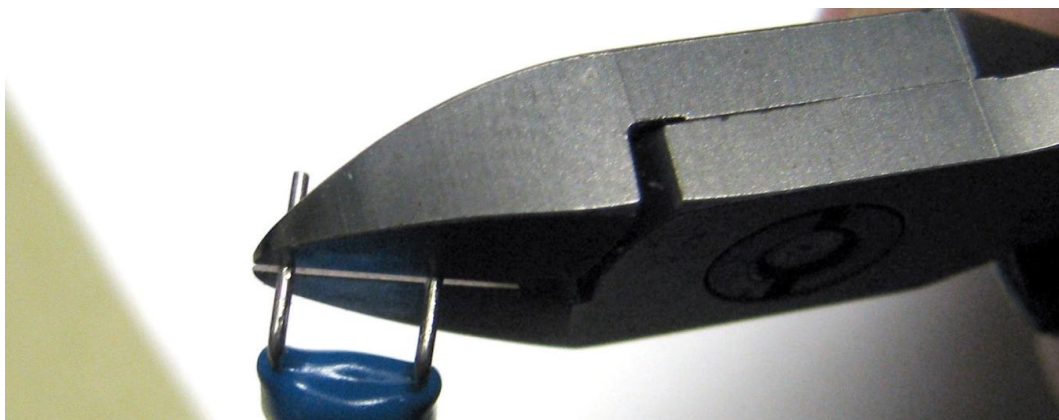
8.	Cut of legs according to picture.		
----	-----------------------------------	--	--
