TECHNICAL BULLETIN

MODEL/DERIVATIVE:
Discovery II

Bulletin N°: 0046
CDS. ref: L8750bu
Issue: 1
Date: 16.01.02

PROBLEM:
RADIO SECURING CLIPS - BREAKING WHEN RADIO IS REMOVED

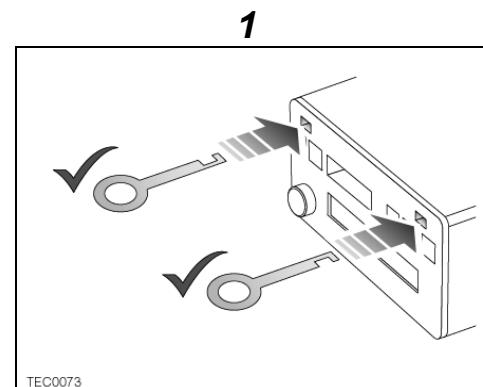
Correct fitment of radio removal keys illustrated

1. Insert radio removal keys, horizontally (shown in illustration 1), into the slots located at the top of the radio. Refer to tool information for part number detail.
2. Push the radio removal keys forwards horizontally, until a click is heard. This indicates that the radio removal keys are locked in position on the radio securing clips.
NOTE: If no force is felt between a radio removal key and the radio securing clip, then remove the key, and re-insert correctly.
3. Using the radio removal keys pull unit horizontally rearwards and remove from fascia.
NOTE: Only pull on the radio removal keys. Do not pull on the radio.
4. Remove the radio removal keys by pushing the radio securing clip down and pulling the radio removal keys out.
