TECHNICAL BULLETIN

MODEL/DERIVATIVE:
Discovery Series II

Bulletin N°: 0062
CDS. ref: L8620bu
Issue: 1
Date: 24.01.01

SCUFF MARKS ON OCCASIONAL REAR SEAT SQUAB (THIRD ROW)

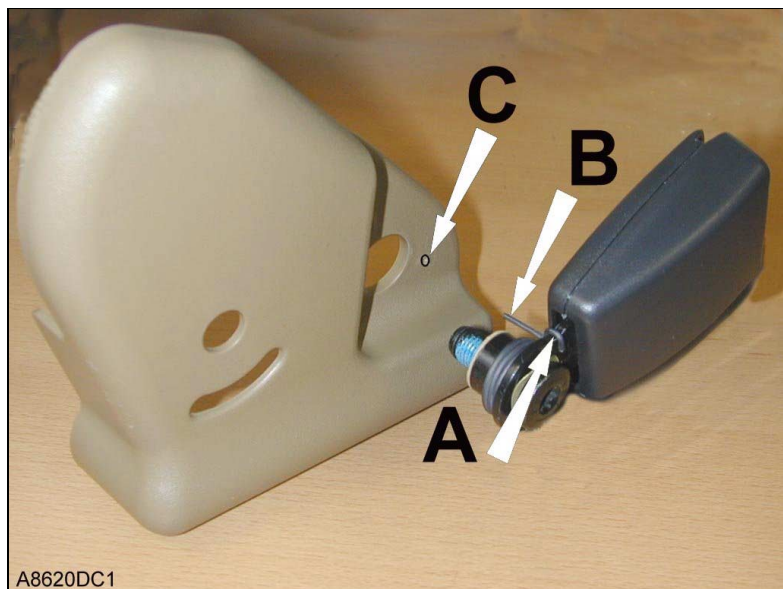
1. Pull off the squab release lever.
2. Remove the seat belt anchorage Torx bolt and remove buckle.
3. Remove the screw securing the hinge cover and remove cover.
4. Replace hinge cover with new cover from kit and secure with screw.
5. Obtain the appropriate return spring from the kit, (left hand illustrated) and engage with the seat belt buckle as shown at 'A'.

6. Refit seat belt buckle, locating the free end of the spring 'B', into hole 'C' in the hinge cover.
7. Apply lubricant such as STC4224 (Tefoil with PTFE spray) to the seat belt buckle pivot and anti-rattle washer.

Replace the inner squab hinge cover on both seats with modified covers incorporating a spring which automatically lowers the seat belt buckle. The new parts are now available in vehicle sets, refer to *PARTS INFORMATION*.

8. Tighten the seat belt buckle Torx bolt to 32Nm.
 9. Confirm that the seat belt buckle returns freely to the lower position when released.
 10. Refit squab release lever.
 11. Repeat for other seat.
-
