TECHNICAL BULLETIN

MODEL/DERIVATIVE:
Discovery Series II

Bulletin N°: 0061
CDS. ref: L8633bu
Issue: 1
Date: 10.01.2001

PROBLEM:
DAMAGE TO TAILDOOR PAINT FILM IN AREA OF UPPER HINGE

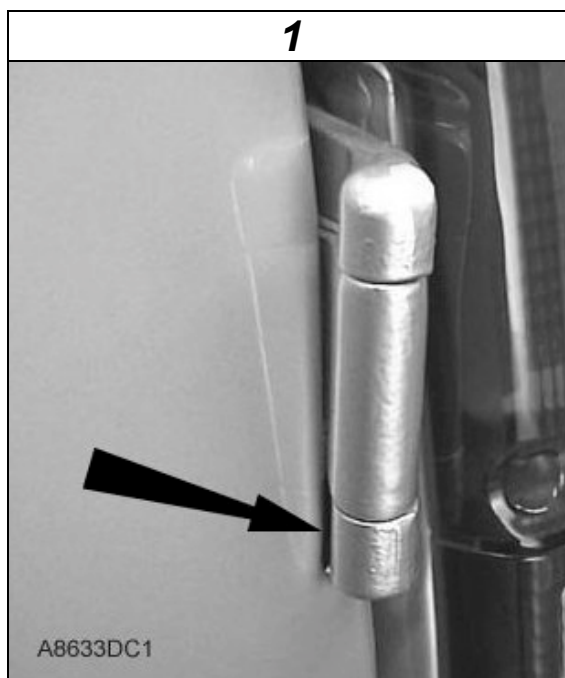
CAUSE:
A foul condition between the taildoor upper hinge lower scroll and the taildoor skin.

1. With the door closed, examine the lower scroll of the upper hinge. The precise area of concern is arrowed in illustration 1.
2. If there is contact between the lower scroll and door skin, this will immediately be apparent as paint will have been rubbed from the hinge scroll where indicated. If no paint has been rubbed off, there is no contact.
3. Where contact has occurred, fully open the taildoor.
4. Obtain a suitable wedge. This should be produced from nylon, hardwood or similar, approximately 15mm wide and 6mm thick, with one end tapered to a chisel point.
5. Working from the taildoor inner face, insert the wedge into the gap between door skin and hinge as shown in illustration 2.

6. Drive the wedge into the gap with several blows from a rubber mallet to ease the door skin away from the hinge.

Do not lever or prise the wedge from side to side as this could cause panel damage. If used as described the wedge will safely achieve the desired result.
