TECHNICAL BULLETIN

MODEL/DERIVATIVE:
Discovery Series II

Bulletin N°: 0072
CDS. ref: L8671bu
Issue: 1
Date: 04.07.01

GLOVE BOX WILL NOT STAY CLOSED

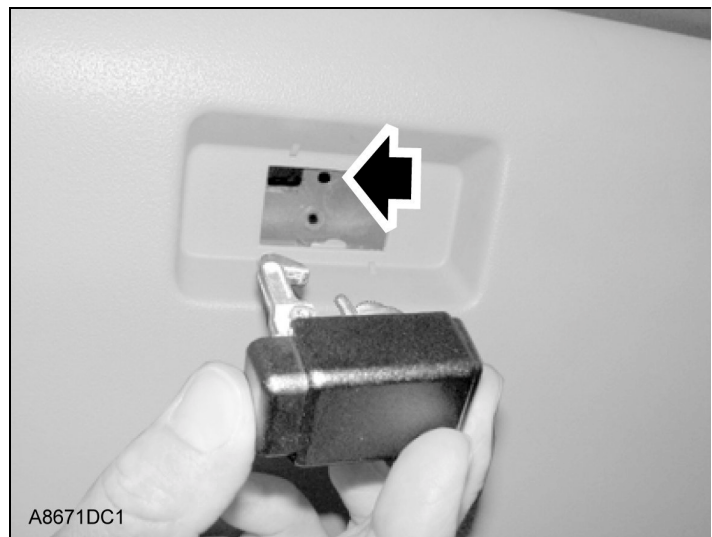
Oversize location hole for latch assembly alignment pin allowing latch to rotate, resulting in misalignment of the latch to the striker.

1. With the glove box open, using a short screwdriver, remove the single countersunk screw securing the latch assembly to the glove box.
2. Identify the hole in the glove box for the latch location pin, (arrowed in illustration).
3. Apply 'Loctite Super Glue Gel' or 'Loctite Super Attack' to the location hole.

4. Refit the latch assembly ensuring that it is aligned squarely with the moulded recess in the glove box. Tighten the securing screw to a torque of 1Nm.
5. Confirm that latch assembly is square to the glove box and operates freely, with the latching pawl returning fully to its rest position.
6. Allow a minimum of 5 minutes for adhesive to cure before testing the glove box for satisfactory operation.
