ABS MODULATOR ELECTRICAL FAULT REPAIR 11/2009

Introduction:

The Land Rover Discovery Series II uses the same ABS MODULATOR as the H1 Hummer. The company that manufactures it is **WABCO** (**Meritor WABCO**). If you have been experiencing an intermittent fault causing your ABS, HDC, and TC lights aka *Three Amigos*, your problem may be a result of a bad electrical connection.

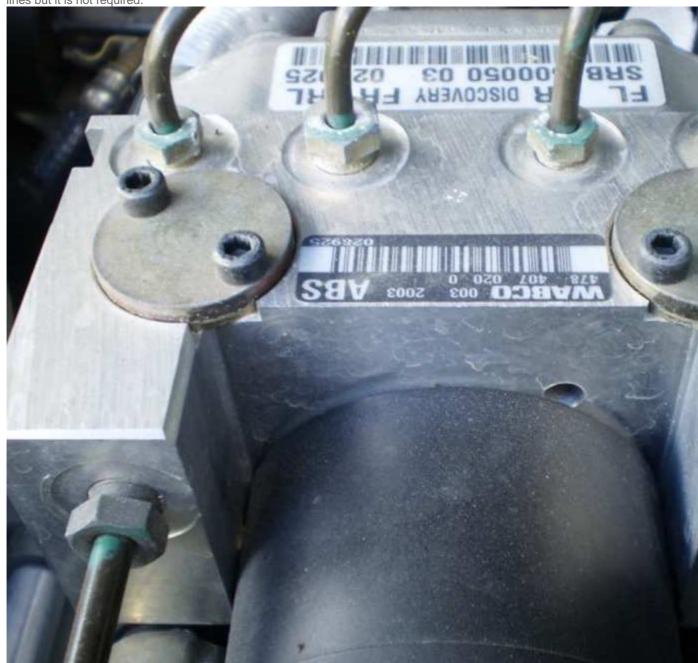
Spray Liquid Wrench on the 6 brake line nuts (4 on top and 2 on the side).
 Also spray the four hex screws on the cover plates. Removing the bolts and plate will help remove the brake lines but it is not required.

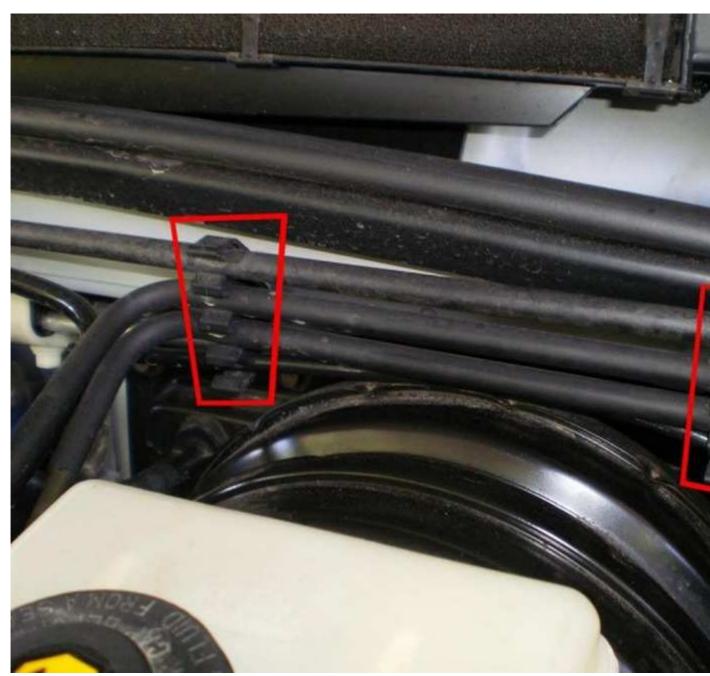
3A. While the Liquid Wrench is soaking the nuts and screws, remove the air intake arm and release the brake pipes from the clips on the bulkhead.

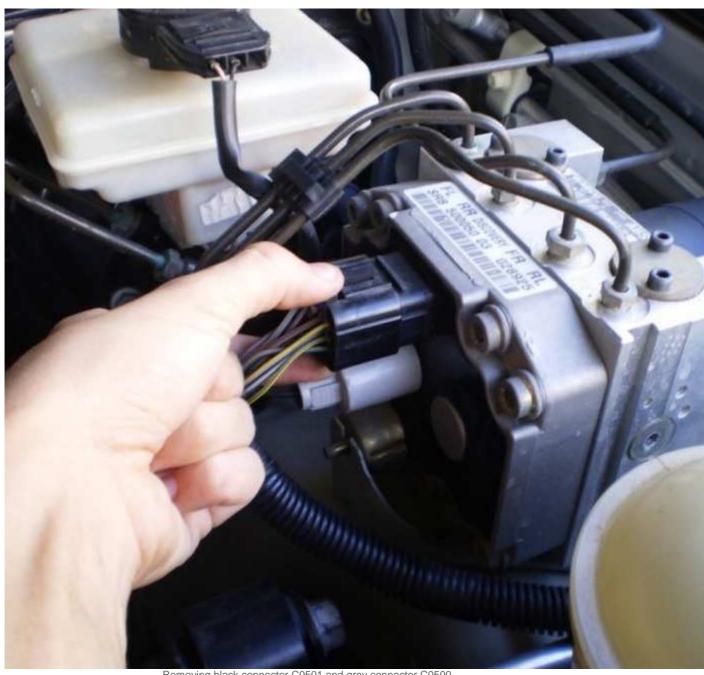
3B. Remove the 3 electrical connectors form the modulator. Two on the front and one on the side.

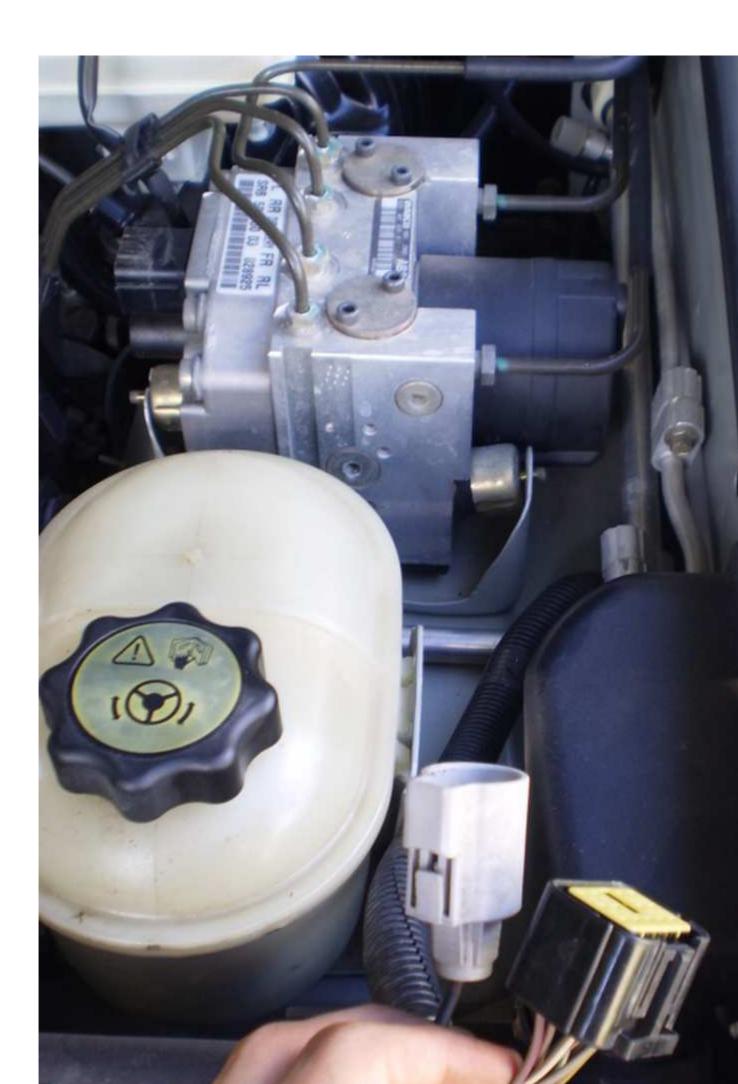
Side connector C0507

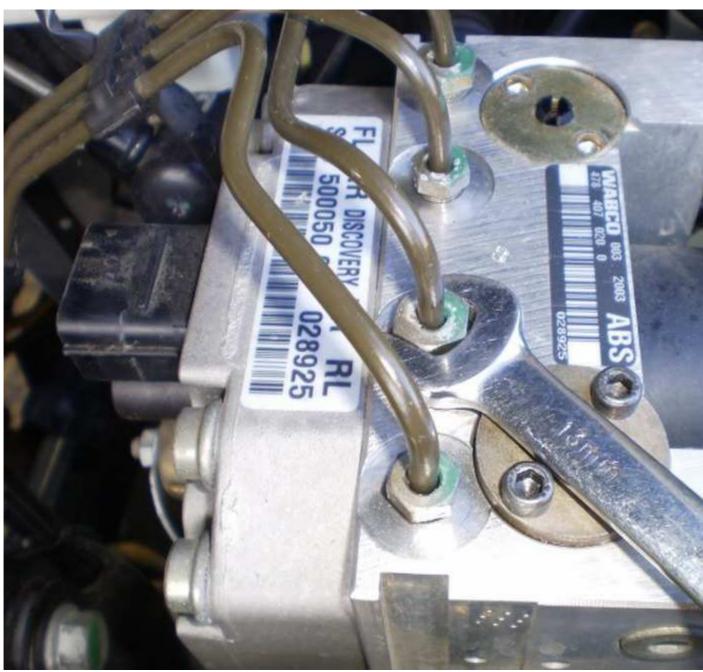
5. Brake loose the two bigger flare nuts using a 13mm wrench.

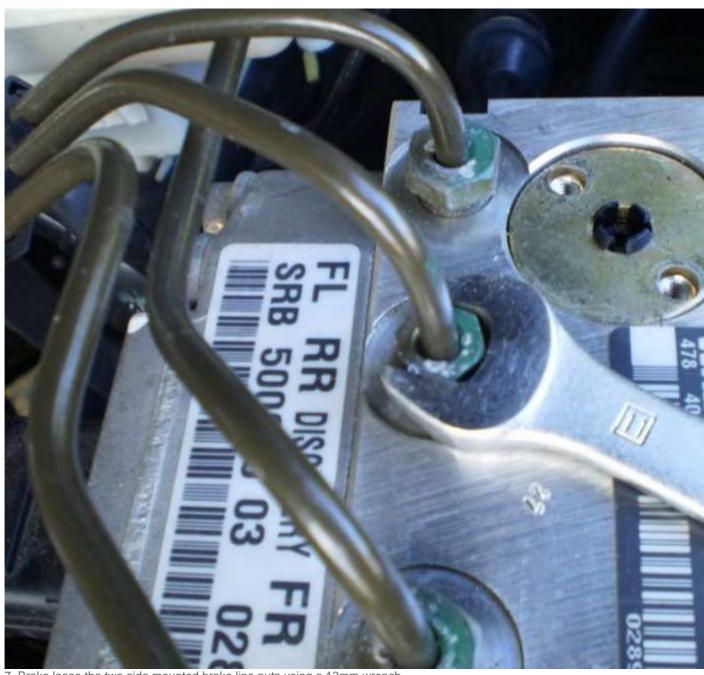
6. Brake loose the two smaller flare nuts using a 11mm wrench.

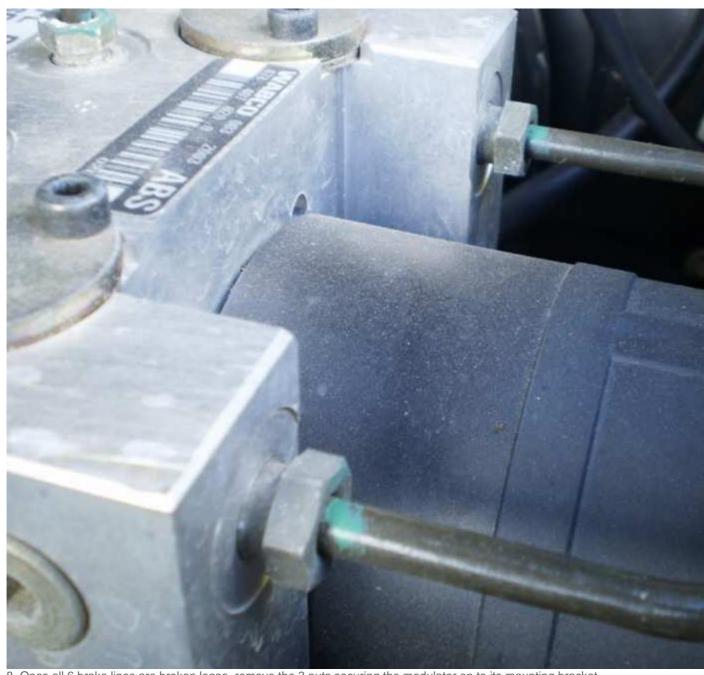
7. Brake loose the two side mounted brake line nuts using a 13mm wrench.

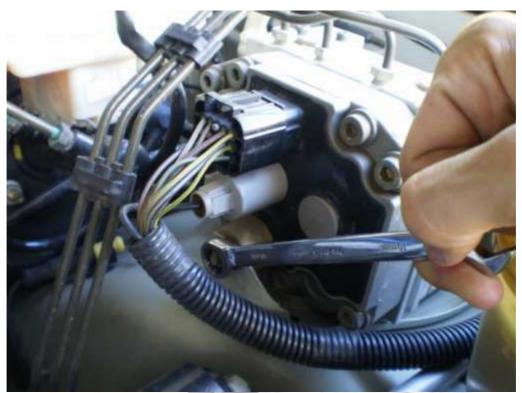
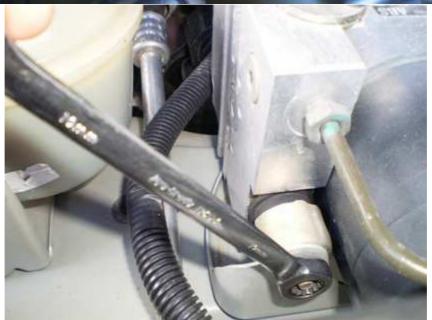
8. Once all 6 brake lines are broken loose, remove the 3 nuts securing the modulator on to its mounting bracket using a 10mm wrench.

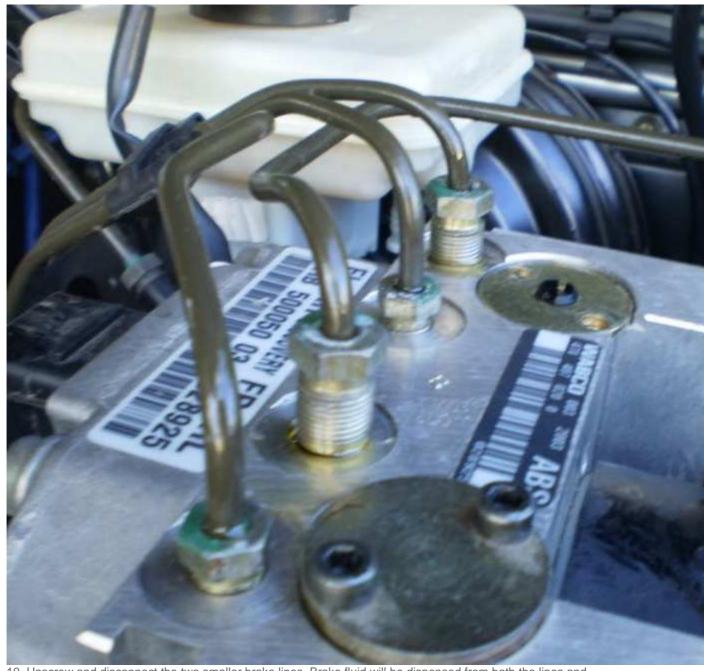
9. Unscrew and disconnect the two bigger brake lines. Brake fluid will be dispensed from both the lines and pump side. Have a shop towel nearby.

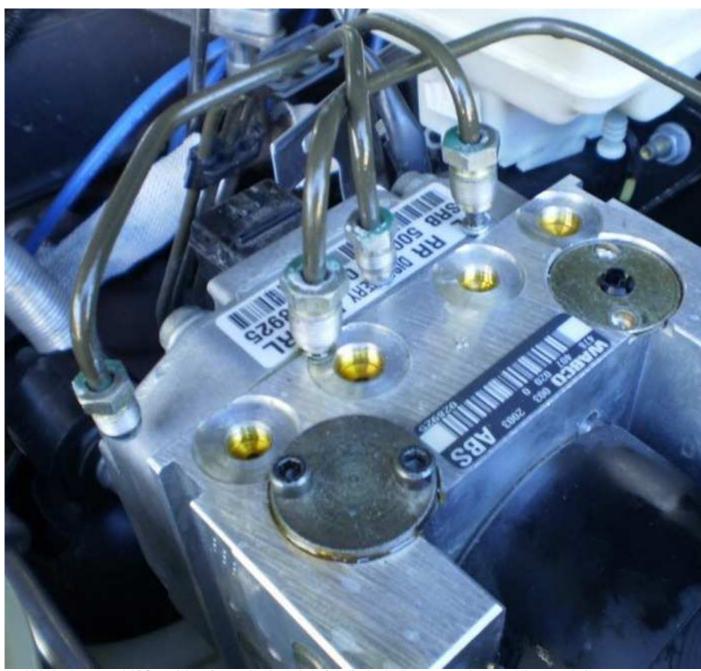
10. Unscrew and disconnect the two smaller brake lines. Brake fluid will be dispensed from both the lines and pump side. Have a second shop towel nearby.

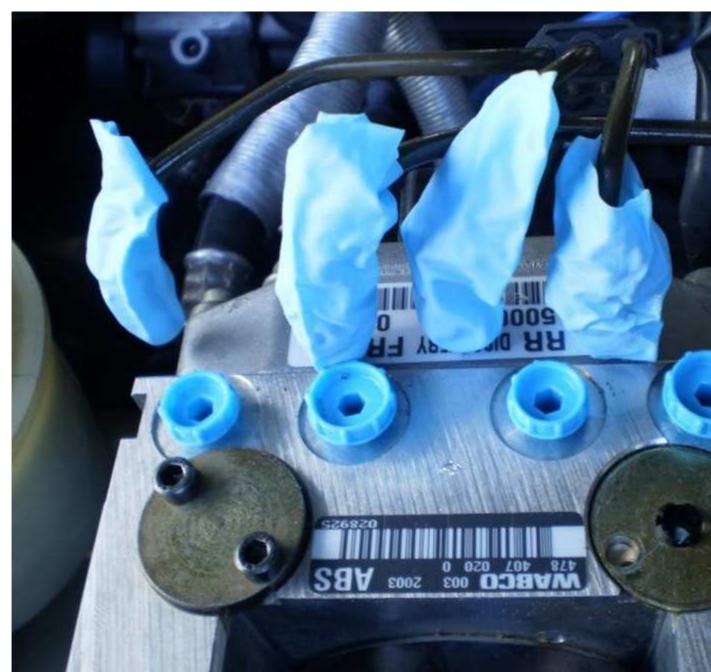
Luckily I had a second ABS modulator/pump that had plugs for all 6 brake line ports so I plugged them up. I also cut the fingers off a disposable rubber glove to keep the lines from dust contamination. It also helped catch some brake fluid. I recommend using a syringe or turkey baster to suck out the residual brake fluid from the modulator if you do not have brake plugs.

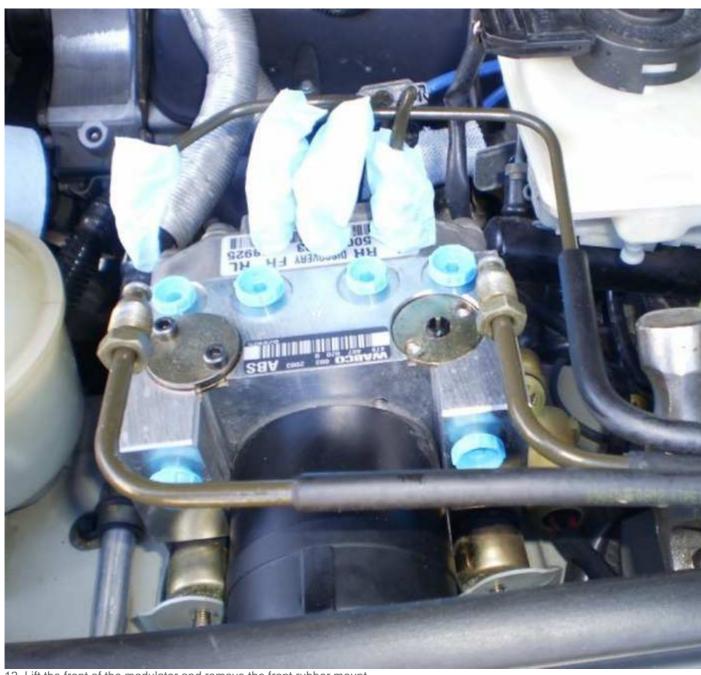
Because of the slight incline on my drive way, it was necessary for me to elevate the two side brake lines coming from the master cylinder to prevent brake fluid from continuing to pour out. I used a hammer at first and wedged it between the inside of the quarter panel.

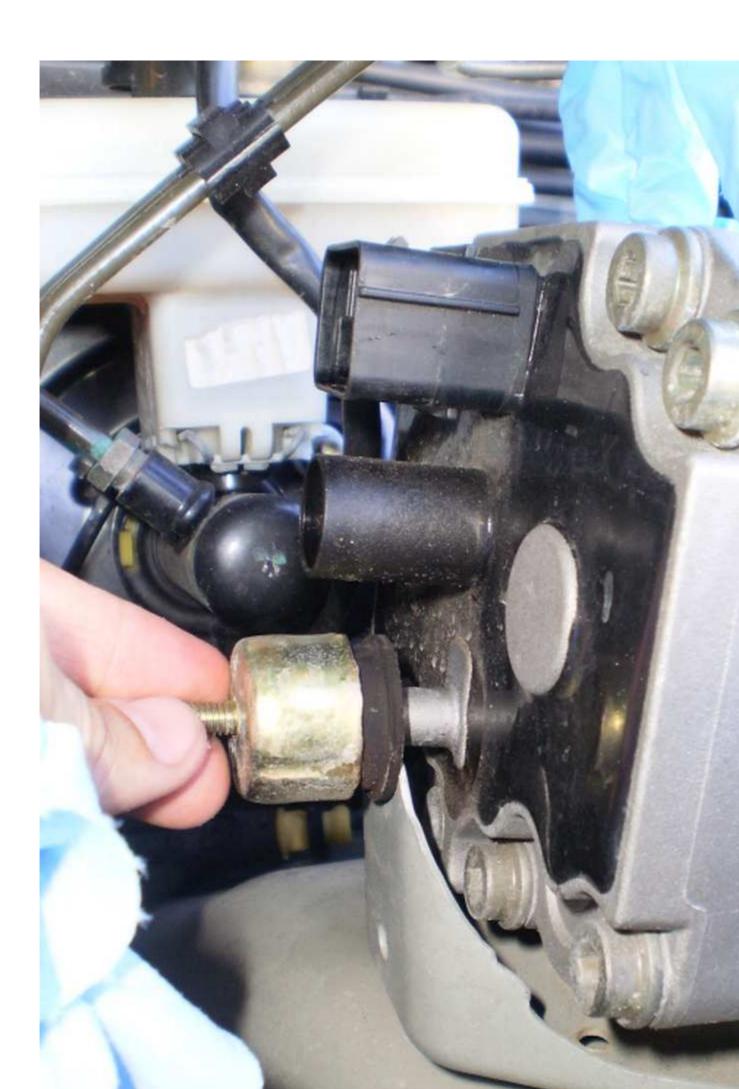
12. Lift the front of the modulator and remove the front rubber mount.

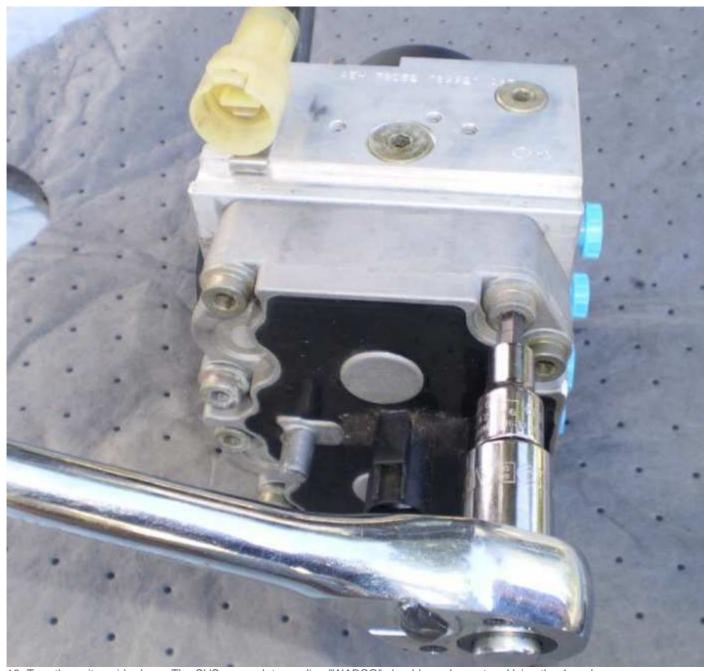
15. Clean off the modulator. Using a 6mm hex tool, remove 8 bolts on the modulator.

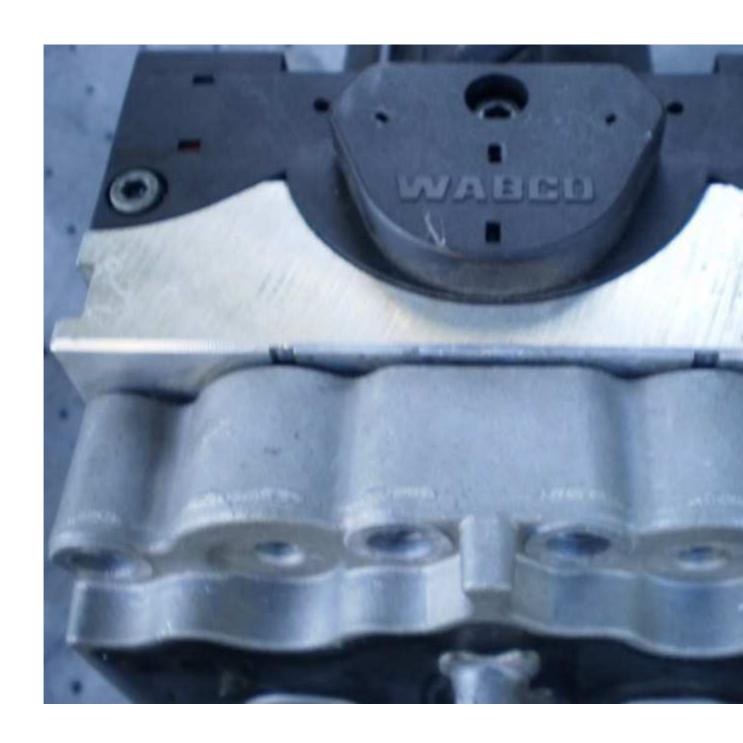
16. Turn the unit upside down. The SVS cover plate reading "WABCO" should now be on top. Using the 4mm hex bit, remove the 3 hex screws.

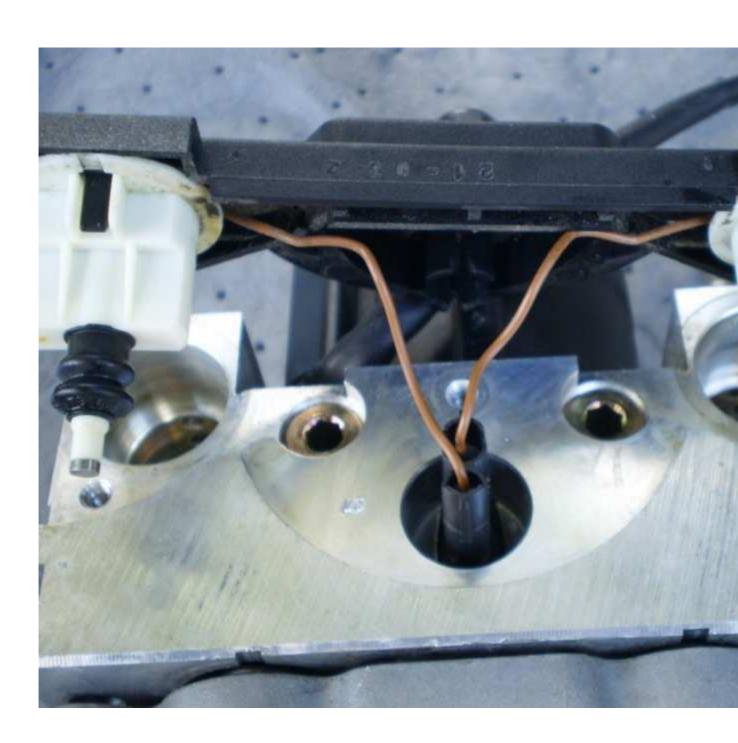
17. Carefully remove the SVS cover plate and disconnect the SVS plug. The plug should dislocate from the cover plate with minimal effort or hold it in place as you pry the cover out. If you find that a pin is lodged in the plug upon removal, and it did not remain in the SVS circuit board then you may have found your intermittent fault.

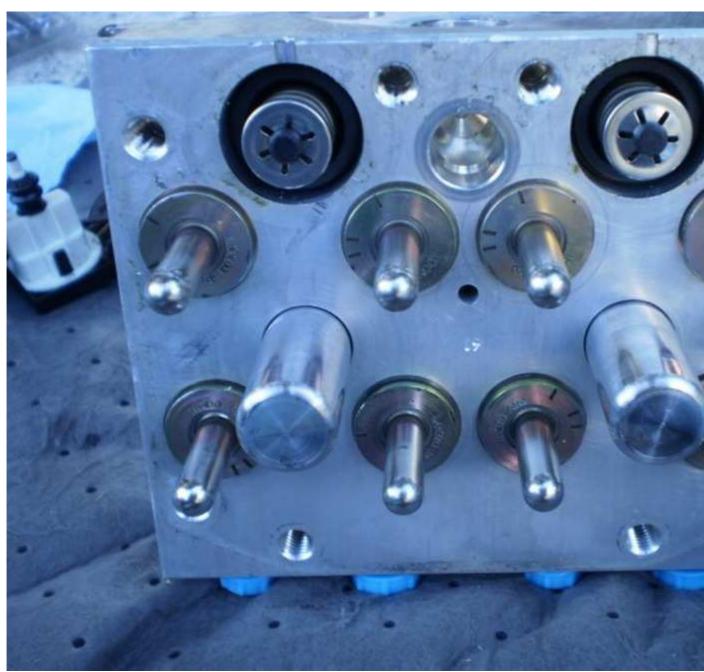
Pump side of the unit. Unit is upside down. Notice the brake line plugs at bottom.

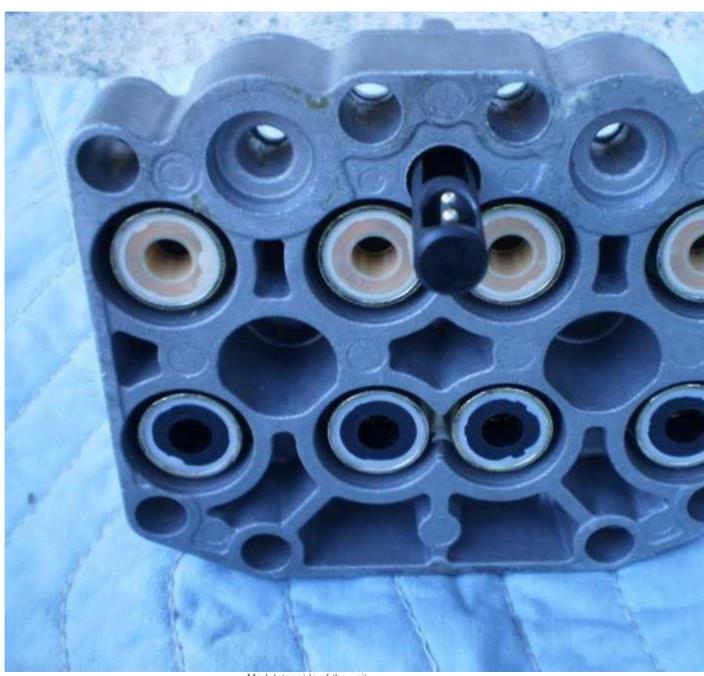
Modulator side of the unit

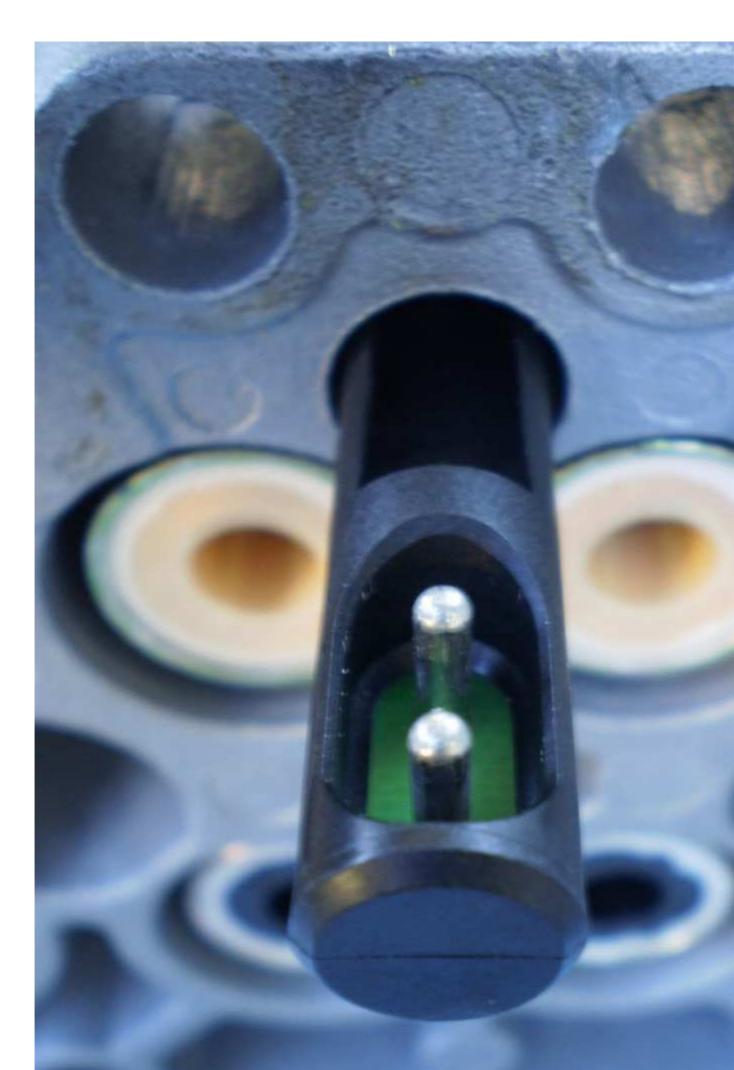
If doing option A, the base of these pins need to be re-soldered. Underside of circuit board is what needs to be shaved off.

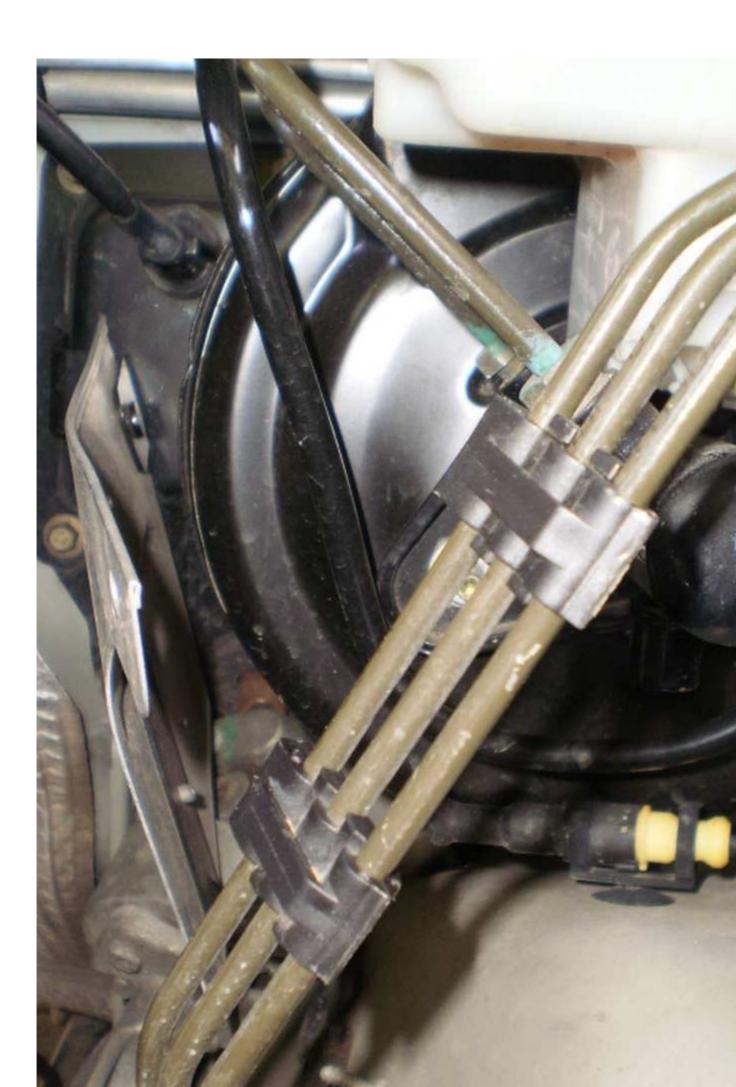
22. Remove two clips from the brake lines.

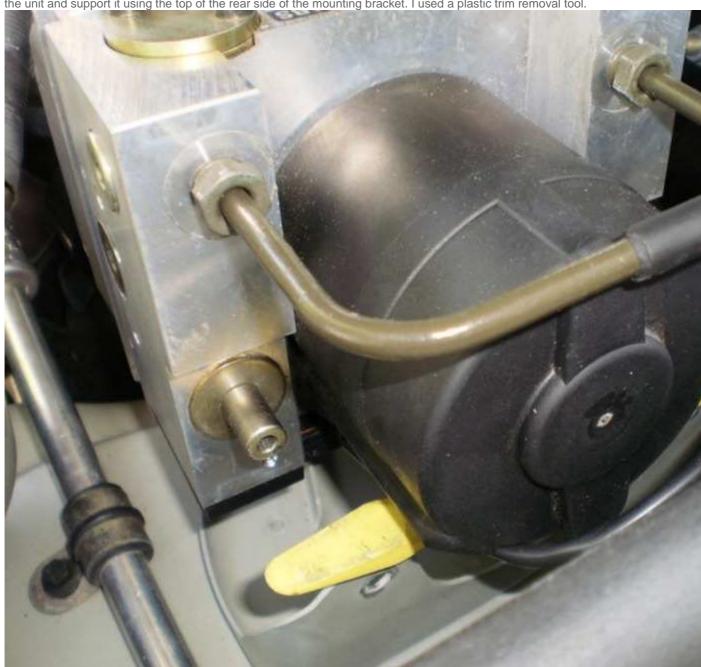
25. In order to have room underneath the ABS unit to access the SVS cover plate screws, raise the pump side of the unit and support it using the top of the rear side of the mounting bracket. I used a plastic trim removal tool.

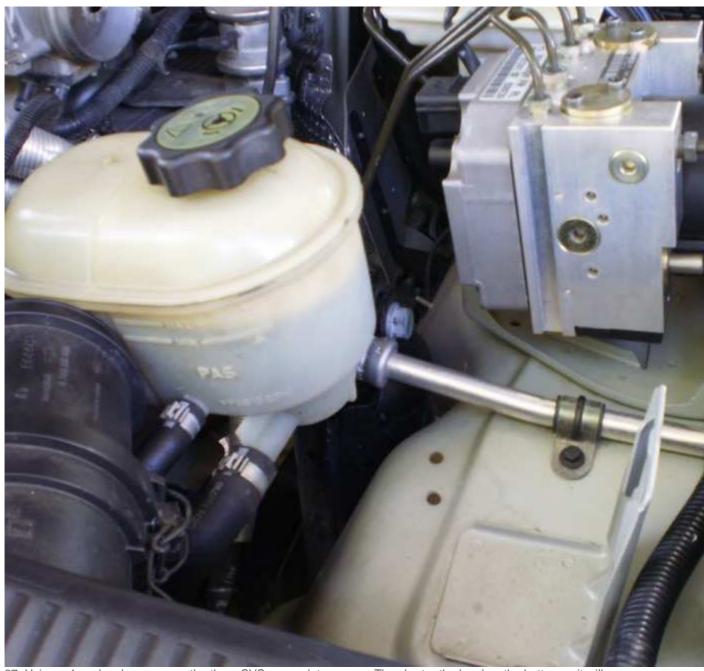
26. Reposition the PAS Fluid reservoir.

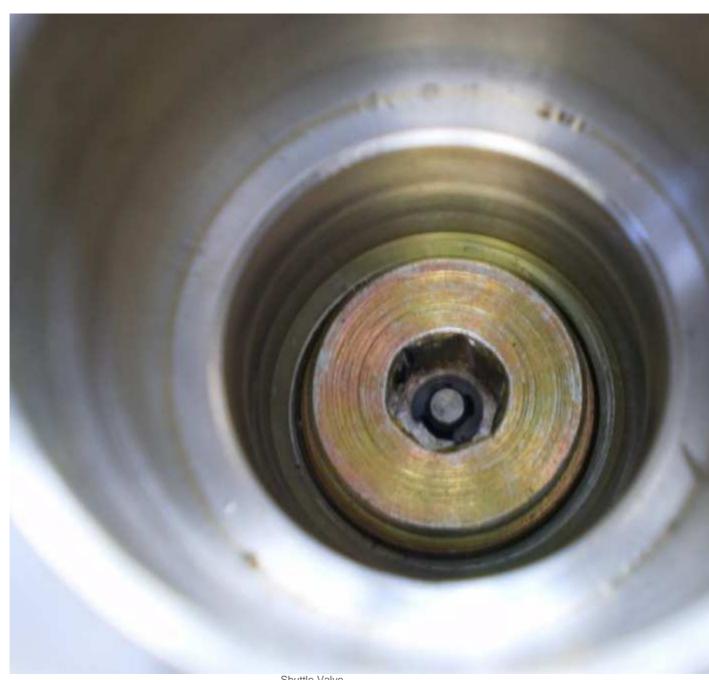
The rubber boot is what prevents brake fluid from seeping out of the shuttle valves getting inside and messing up the switch. If the shuttle valves are leaking you can replace the seals with this Shuttle Valve seal KIT from Falconworks in Arizona

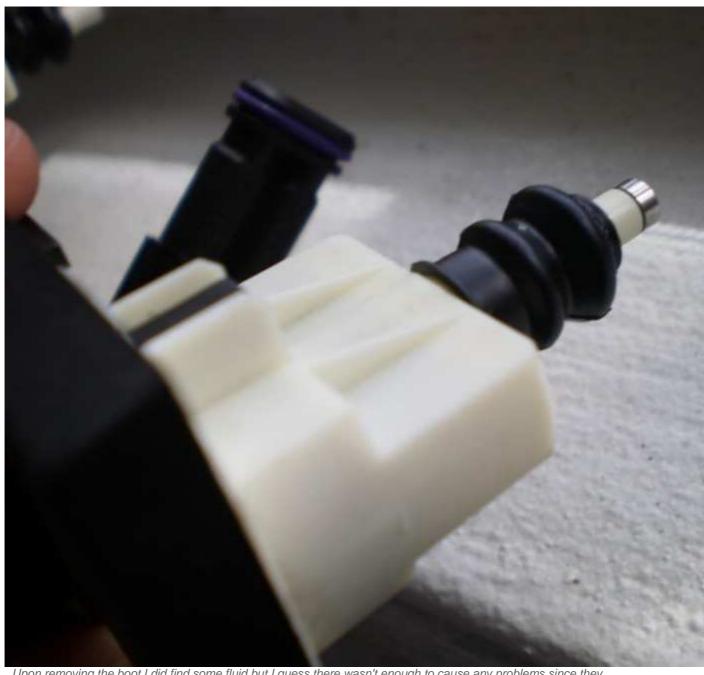
Upon removing the boot I did find some fluid but I guess there wasn't enough to cause any problems since they tested withing normal range.

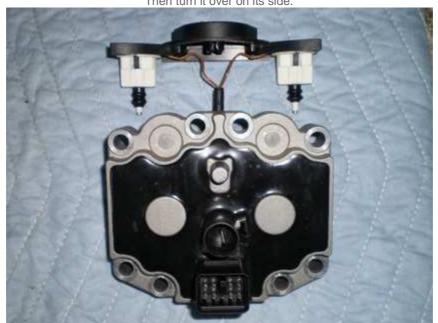
Get your handy DMM and check ohms between pin 9 (red) and 6 (black) All you need to do is have a helper push the switches while you get the readings.

Component	Resistance, ohms
Shuttle valve switches, both open (brakes off)	2977 - 3067
Shuttle valve switches, both closed (brakes on)	1007 - 1037
Shuttle valve switches, one open, one closed	1992 - 2052

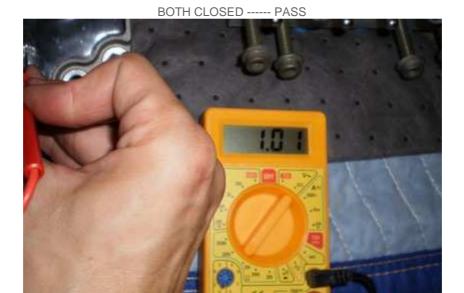
ONE CLOSED ----- PASS

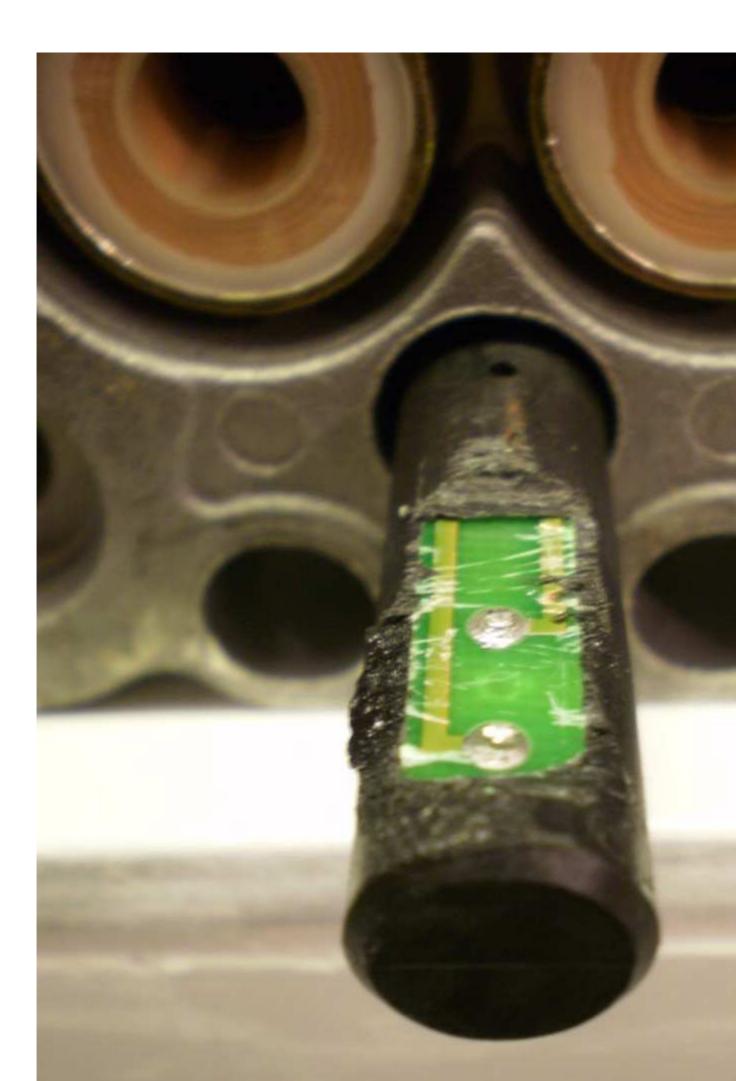
33. Now there are many different ways you can remove the VERY HARD plastic on the underside of the SVS plug circuit board. You can use a small torch and heat up a razor blade or an X-ACTO blade. You can bite it off but that didn't work. I used an X-ACTO blade from an art class I had in college.

My surgery worked SO well that I even cut into the circuit board lines which made this whole repair worthless.

FAIL....

The new challenge I had was that I completely destroyed the circuit board and even straight wiring it (Option C) would not work.

So why does it not work? Well if you remember the SVS ohm test procedure, you place the DMM prongs onto pins 9 and 6 on the modulator to test ohms on the SVS various positions. The SLABS ECU detections the ohms using ONE wire which is the YG wire on connector C0501- pin 9. Pin 9 continues to meet the SVS harness via that circuit board encased in hard plastic then through the SVS plug. Pin 6 is grounded internally within the modulator so there is no wire going to that pin via connector C0501- pin 6.

So since I severed the connections on the SVS circuit board, I created a permanent open scenario resulting in a permanent SVS Electrical Fault. The fix? Option B.

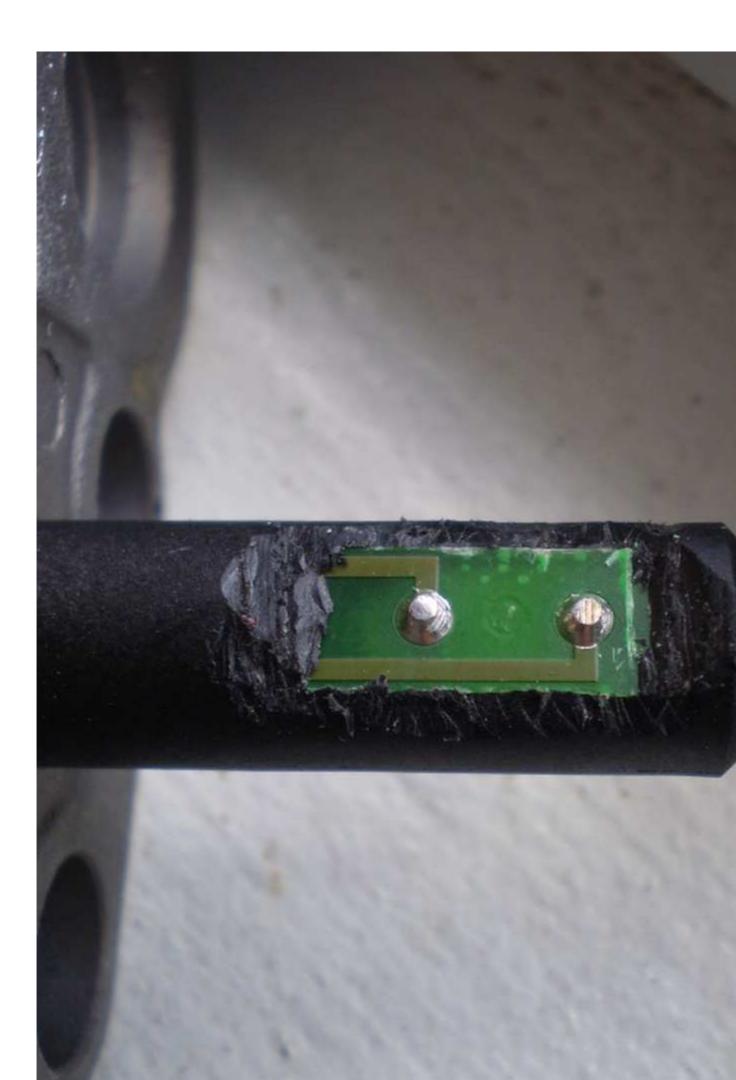
34. Luckily I had that spare modulator and I continued on with the repair. Except this time I used a very sharp serrated steak knife. WHAT A DIFFERENCE!!! I basically shaved it of little by little.

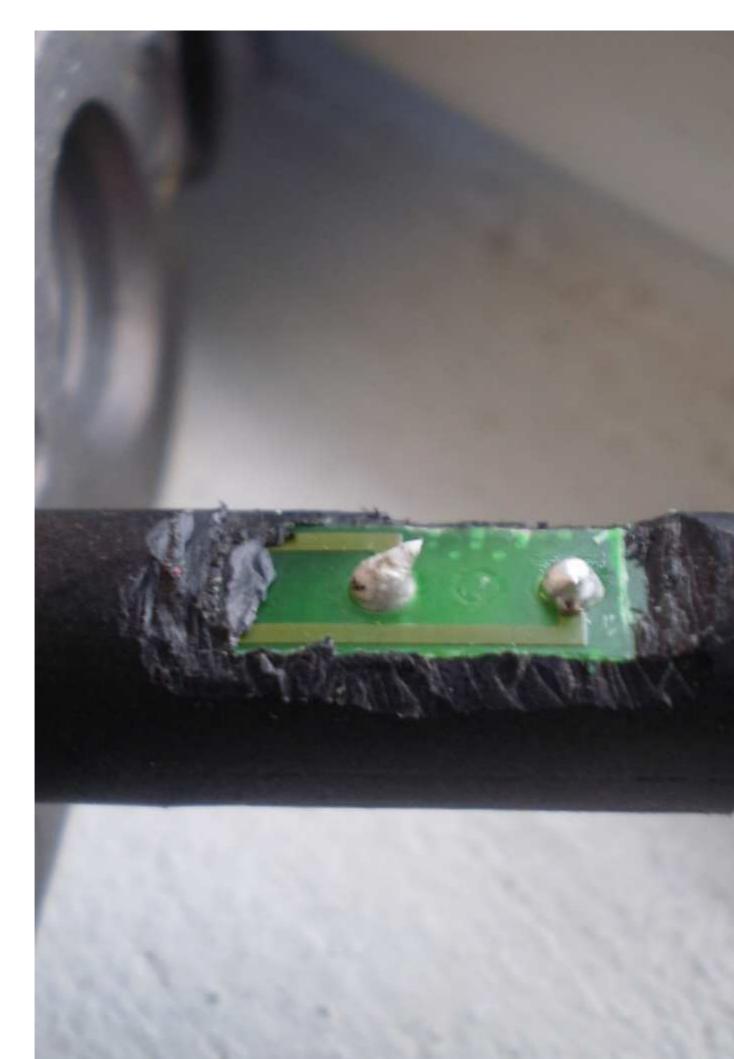
35. Upon inspection of my circuit board and that of the spare's, I found it very hard to tell if the joints were bad. Both pins remained on the circuit board when I removed the SVS plug but I could tell they weren't 100% solid. I re-soldered the pins on the spare unit. Be careful as the pins may fall out. One did fall out but I was able to reinsert it with pliers and re-soldered it. I re-tested the SVS on all three positions and passed.

I was concerned that the fallen pin would not be soldered strong enough but surprisingly it held very well and it passed the ohm tests after about 10 tries plugging and unplugging the SVS plug just to make sure.

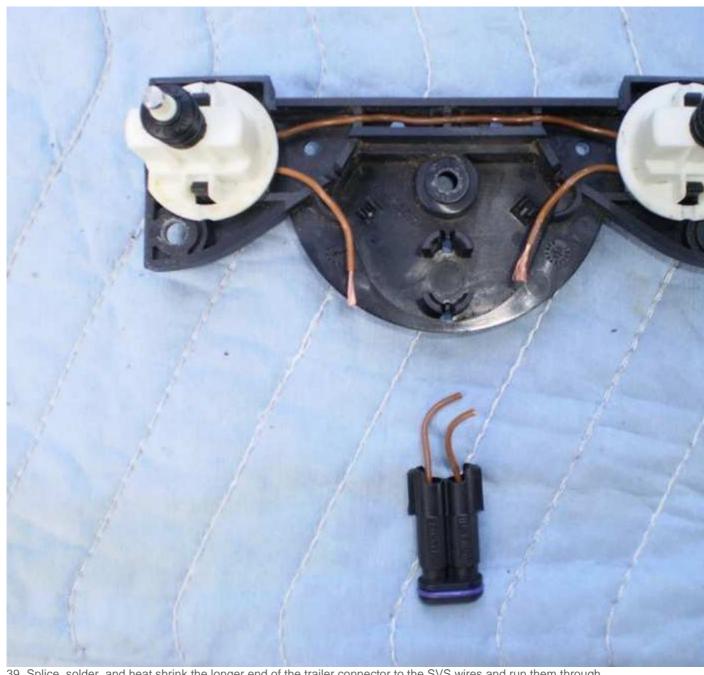
38. Remove your SVS any method you desire, Option A, or Option B without removing the modulator side (see steps # 25 through # 29) Cut SVS plug.

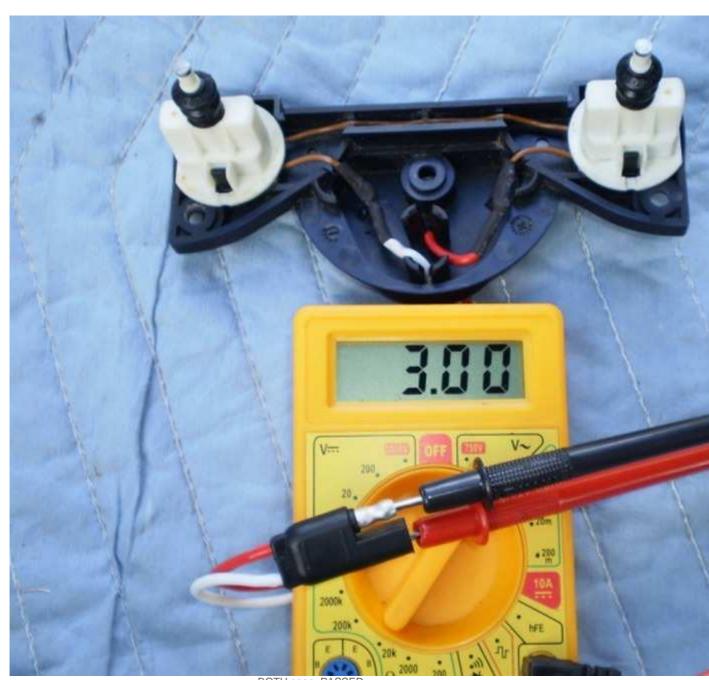
40. Now to test the connections.

BOTH open, PASSED.

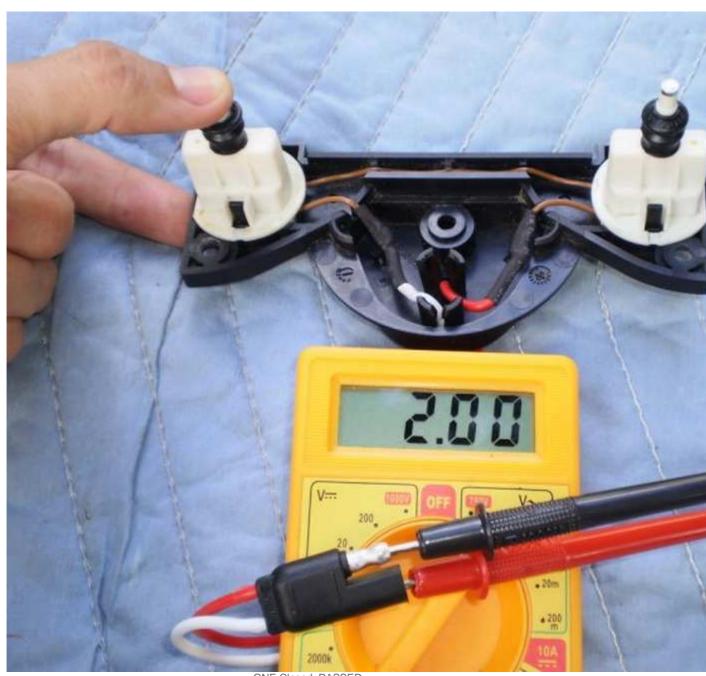
ONE Closed, PASSED.

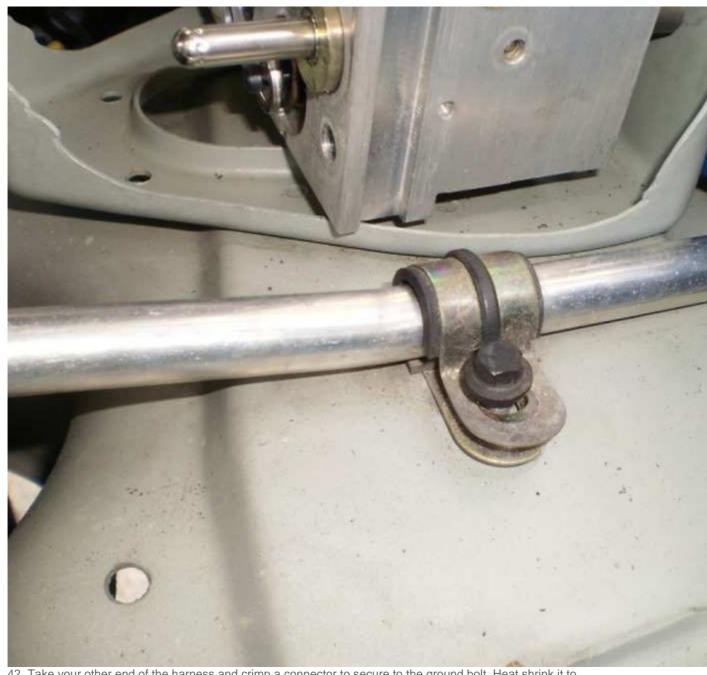
42. Take your other end of the harness and crimp a connector to secure to the ground bolt. Heat shrink it to provide better protection and it also just looks better.

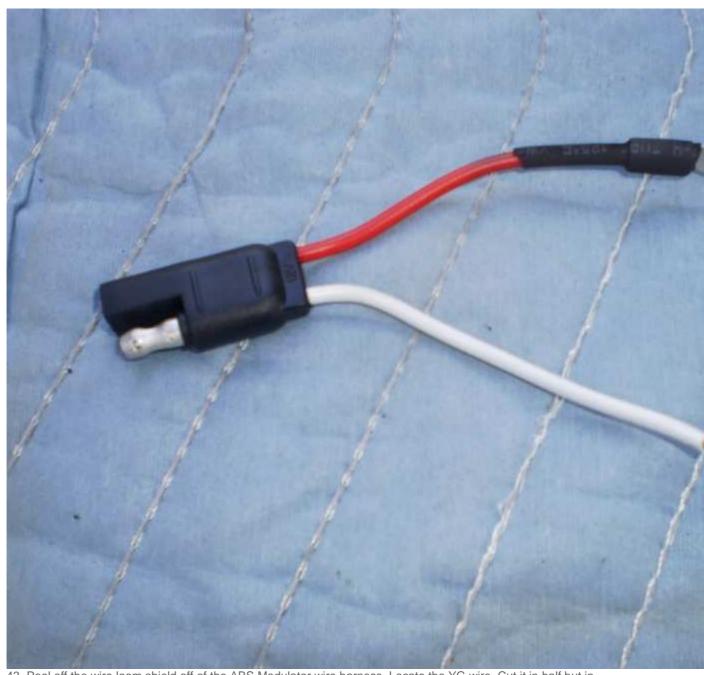
43. Peel off the wire loom shield off of the ABS Modulator wire harness. Locate the YG wire. Cut it in half but in such a way to leave enough length for your harness.

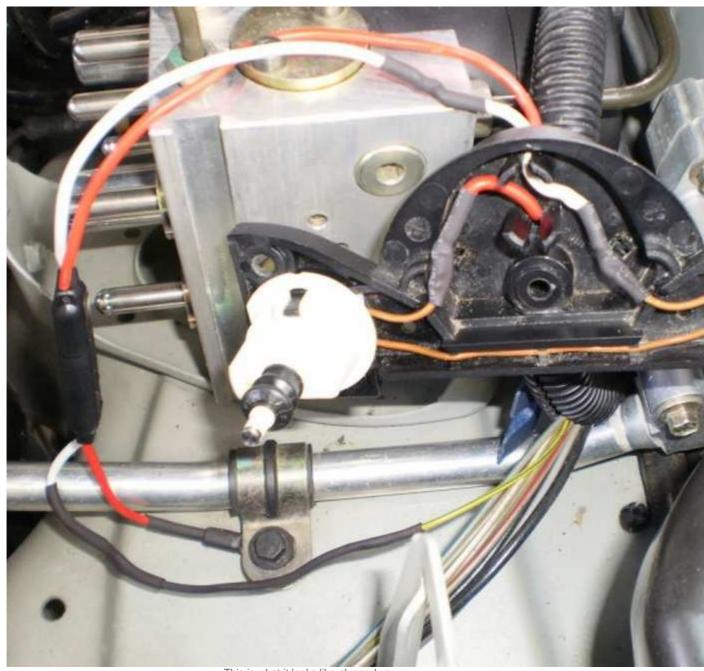
This is what it looks like plugged up.
