# TECHNICAL INFORMATION

No:	76/09/99/NAS
Ref:	WSM 78.10.43.99 TIB 76/03/99/NAS
Issue:	1
Date:	04/23/99

## Front Seat Height Adjustment Binding

**DISCOVERY Series II (LT)** Up to XA218931  
All XA9... series vehicles

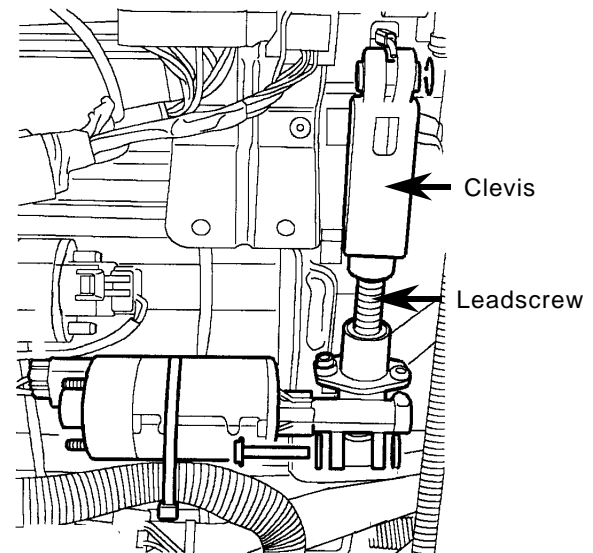
Figure 1

3. Wipe both lead screws and plastic/metal clevis assemblies completely clean of all grease residues using a clean shop cloth.
4. Lubricate each drive assembly with a 2cc (0.07 oz) bead of new blue lubricant (LRNR600D).
