Tektronix 465 Oscilloscope – Power Supply Capacitor Replacement

Ron Childress – October 2008

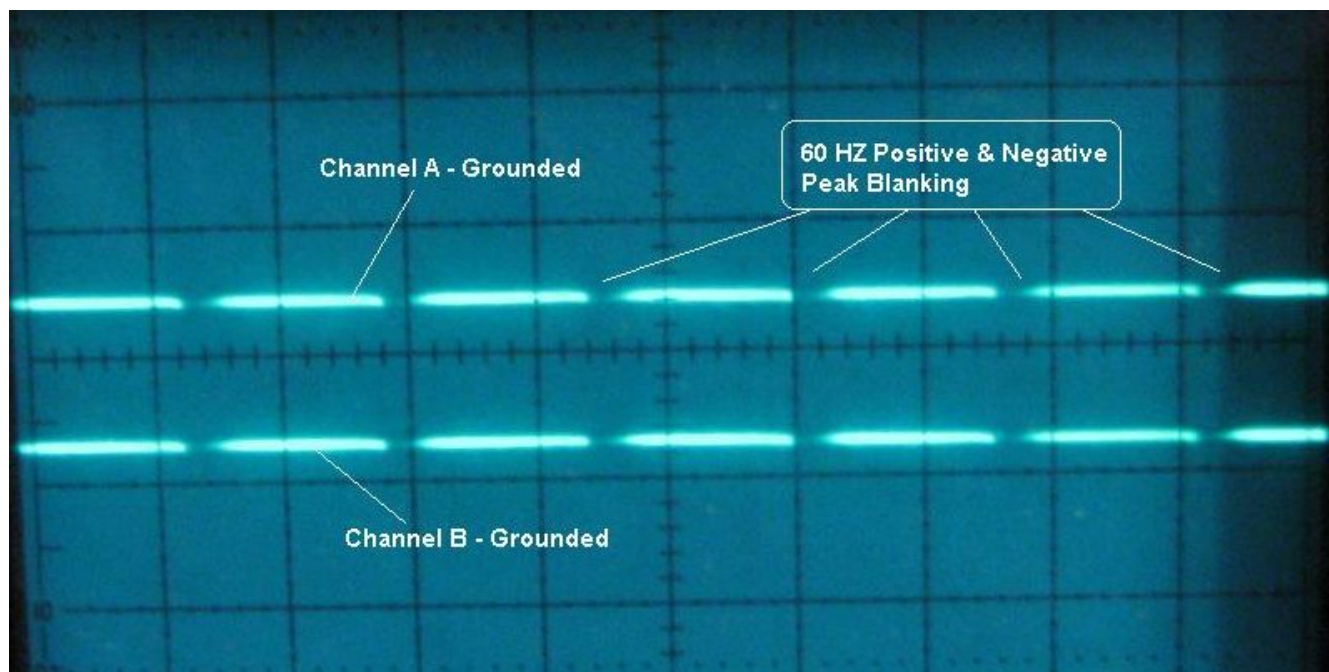
Figure 1: Initial Symptom - 120 HZ Noise appears in Trace A and B

The 465 scope had been in storage for a couple of years. When it was put back in service, a new symptom appeared, as shown below in Figure 1:

The symptom was isolated with the following settings:

- Set Horizontal sweep to 5 milliseconds per division.
- Set Vertical to Channel to Chop to display both Channel A and B
- Set Channel A and B vertical switches to GND.
- Position each trace vertically, as shown above
- Set Trigger Mode to NORM
- Set Trigger Source to Line to synchronize to 60 HZ.
- Reduce the beam intensity (counter-clockwise) to a bare minimum to see the trace.

Where a continuous trace is expected, blanks occur on the positive and negative peaks of a 60 Hertz cycle. This symptom definitely points to a power supply problem. The question is: where?

More importantly, the symptom shown in Figure 1 is gone. The power supply is stable and hopefully good for another thirty years.

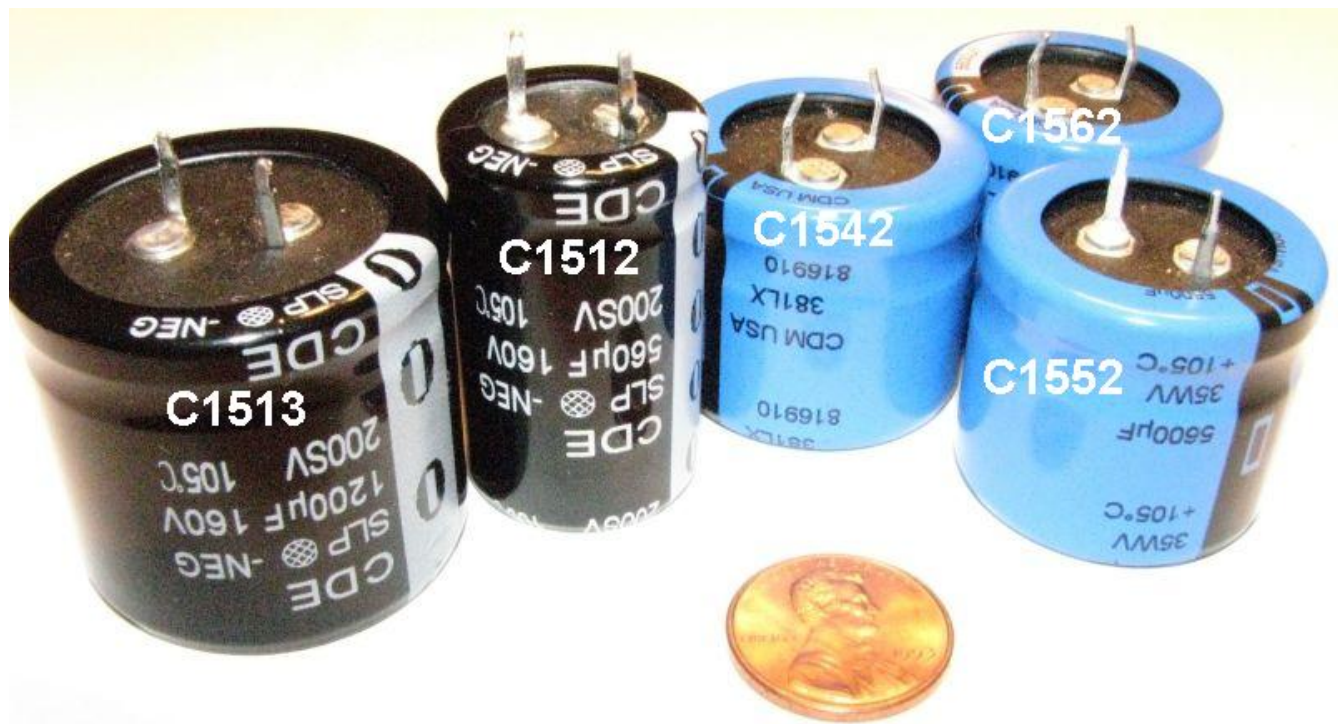
Figure 4: Replacement Capacitors

A few days later, the replacement capacitors arrived, shown in Figure 4. Capacitor numbers are added to this picture for clarity. These capacitors are even smaller than expected. However, the first hint of trouble is the diameter of capacitor C1513 is larger than the original.

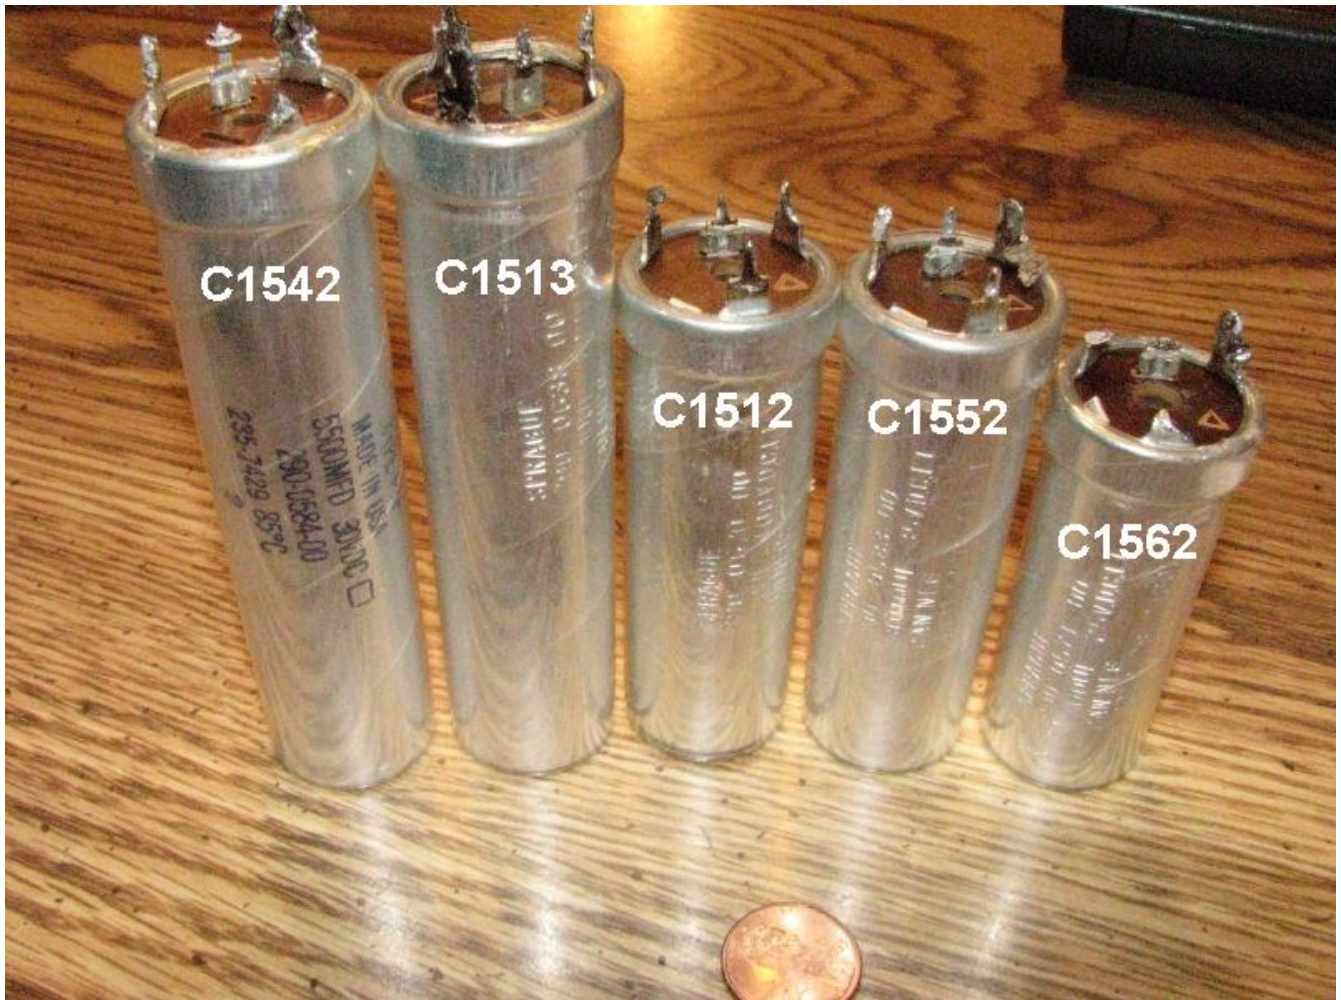
Figure 5: Original Capacitors Removed

For comparison, the original capacitors are shown below in Figure 5. An important feature to note on the old capacitors is four terminals, instead of two. The outside three terminals are all connected to the negative (-) side of the capacitor. The positive (+) terminal is in the center.

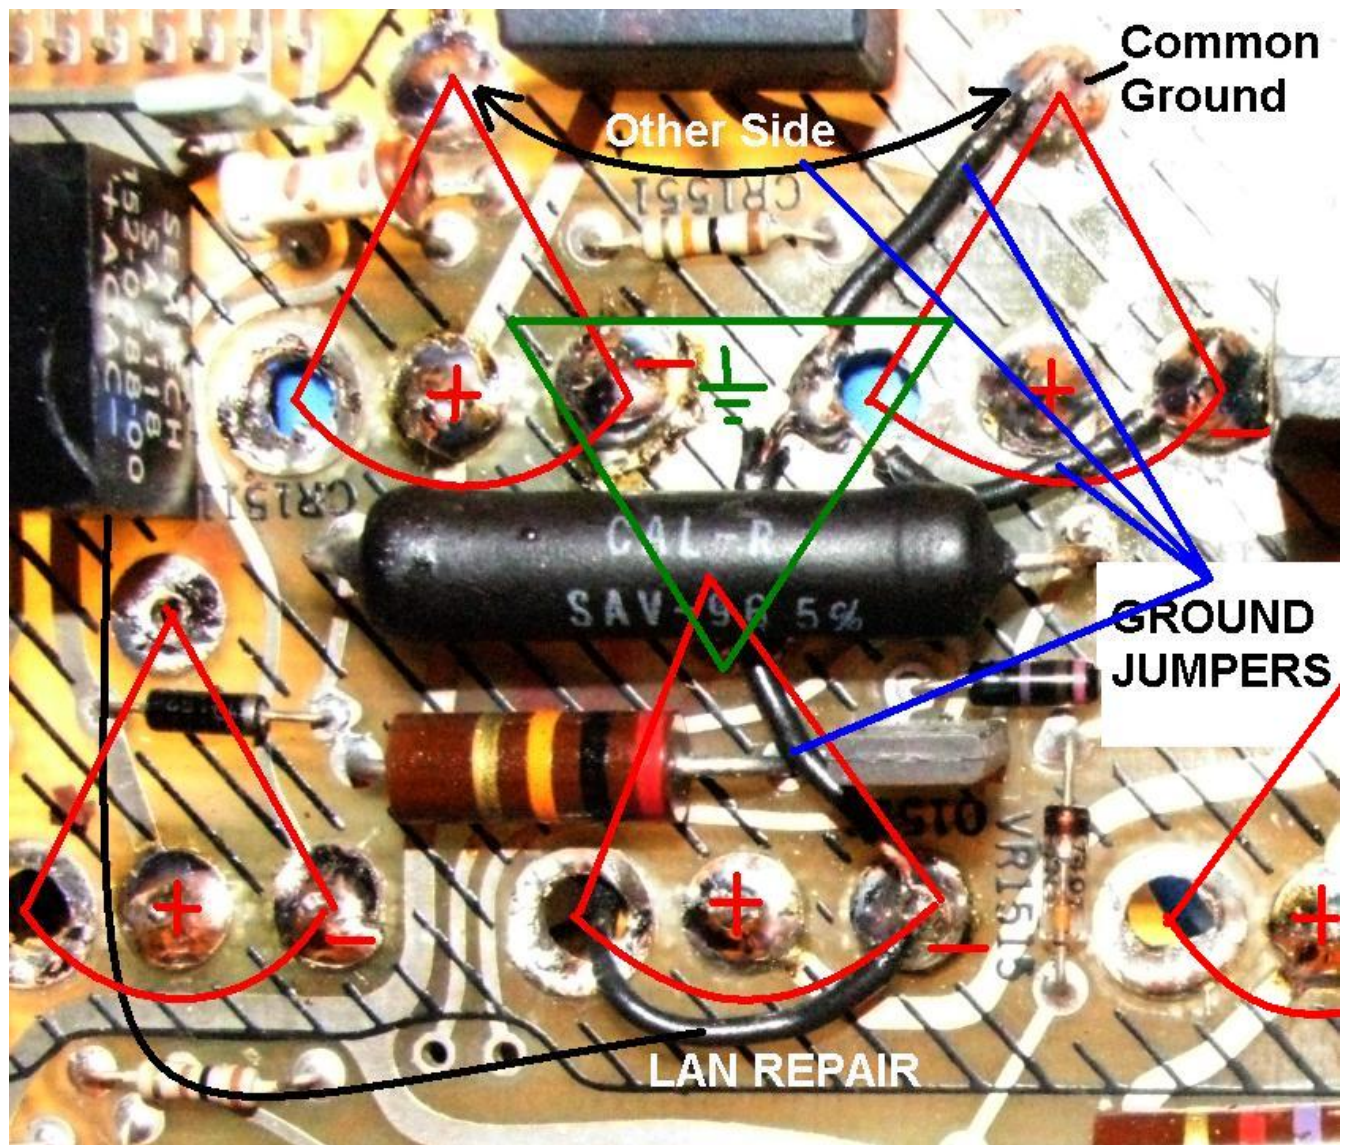
Figure 12: Adding Ground Jumpers

With the old capacitors removed, it is necessary to install ground jumpers, as shown in Figure 12. The original aluminum cans were used to interconnect various grounds to the circuit board. With the aluminum cans removed, these ground connections must be reestablished.

In Figure 12, notice the green triangle drawn in the center. This island pad acts as a central grounding location for original capacitors C1513, C1542 and C1552. Three ground jumpers are required to reconnect these three capacitors to the common chassis ground, shown in the upper right-hand corner. Also, an additional jumper is required to connect the negative (-) terminal of bridge rectifier CR1551 to the common ground. This jumper was added to the topside of the circuit board, as shown in the foreground of Figure 11

To repair circuit board damage incurred while removing C1513, a jumper was added from the negative (-) terminal of bridge rectifier CR1511 to the negative terminal of C1513. This jumper is shown at the bottom of Figure 12 with a black line drawn to show the final destination. This *Lan Repair* wire was routed through the unused ground pad hole and soldered to the underside of the bridge rectifier. This connection is visible and labeled *Lan Repair* in Figure 11. The original circuit trace landed on the larger ground pad of C1513. If undamaged, a jumper would have been required to the negative (-) terminal of C1513 or this capacitor could have been flipped 180 degrees to use the larger ground hole.
