SERVICE MANUAL

nx520p

TYPE:YS1002

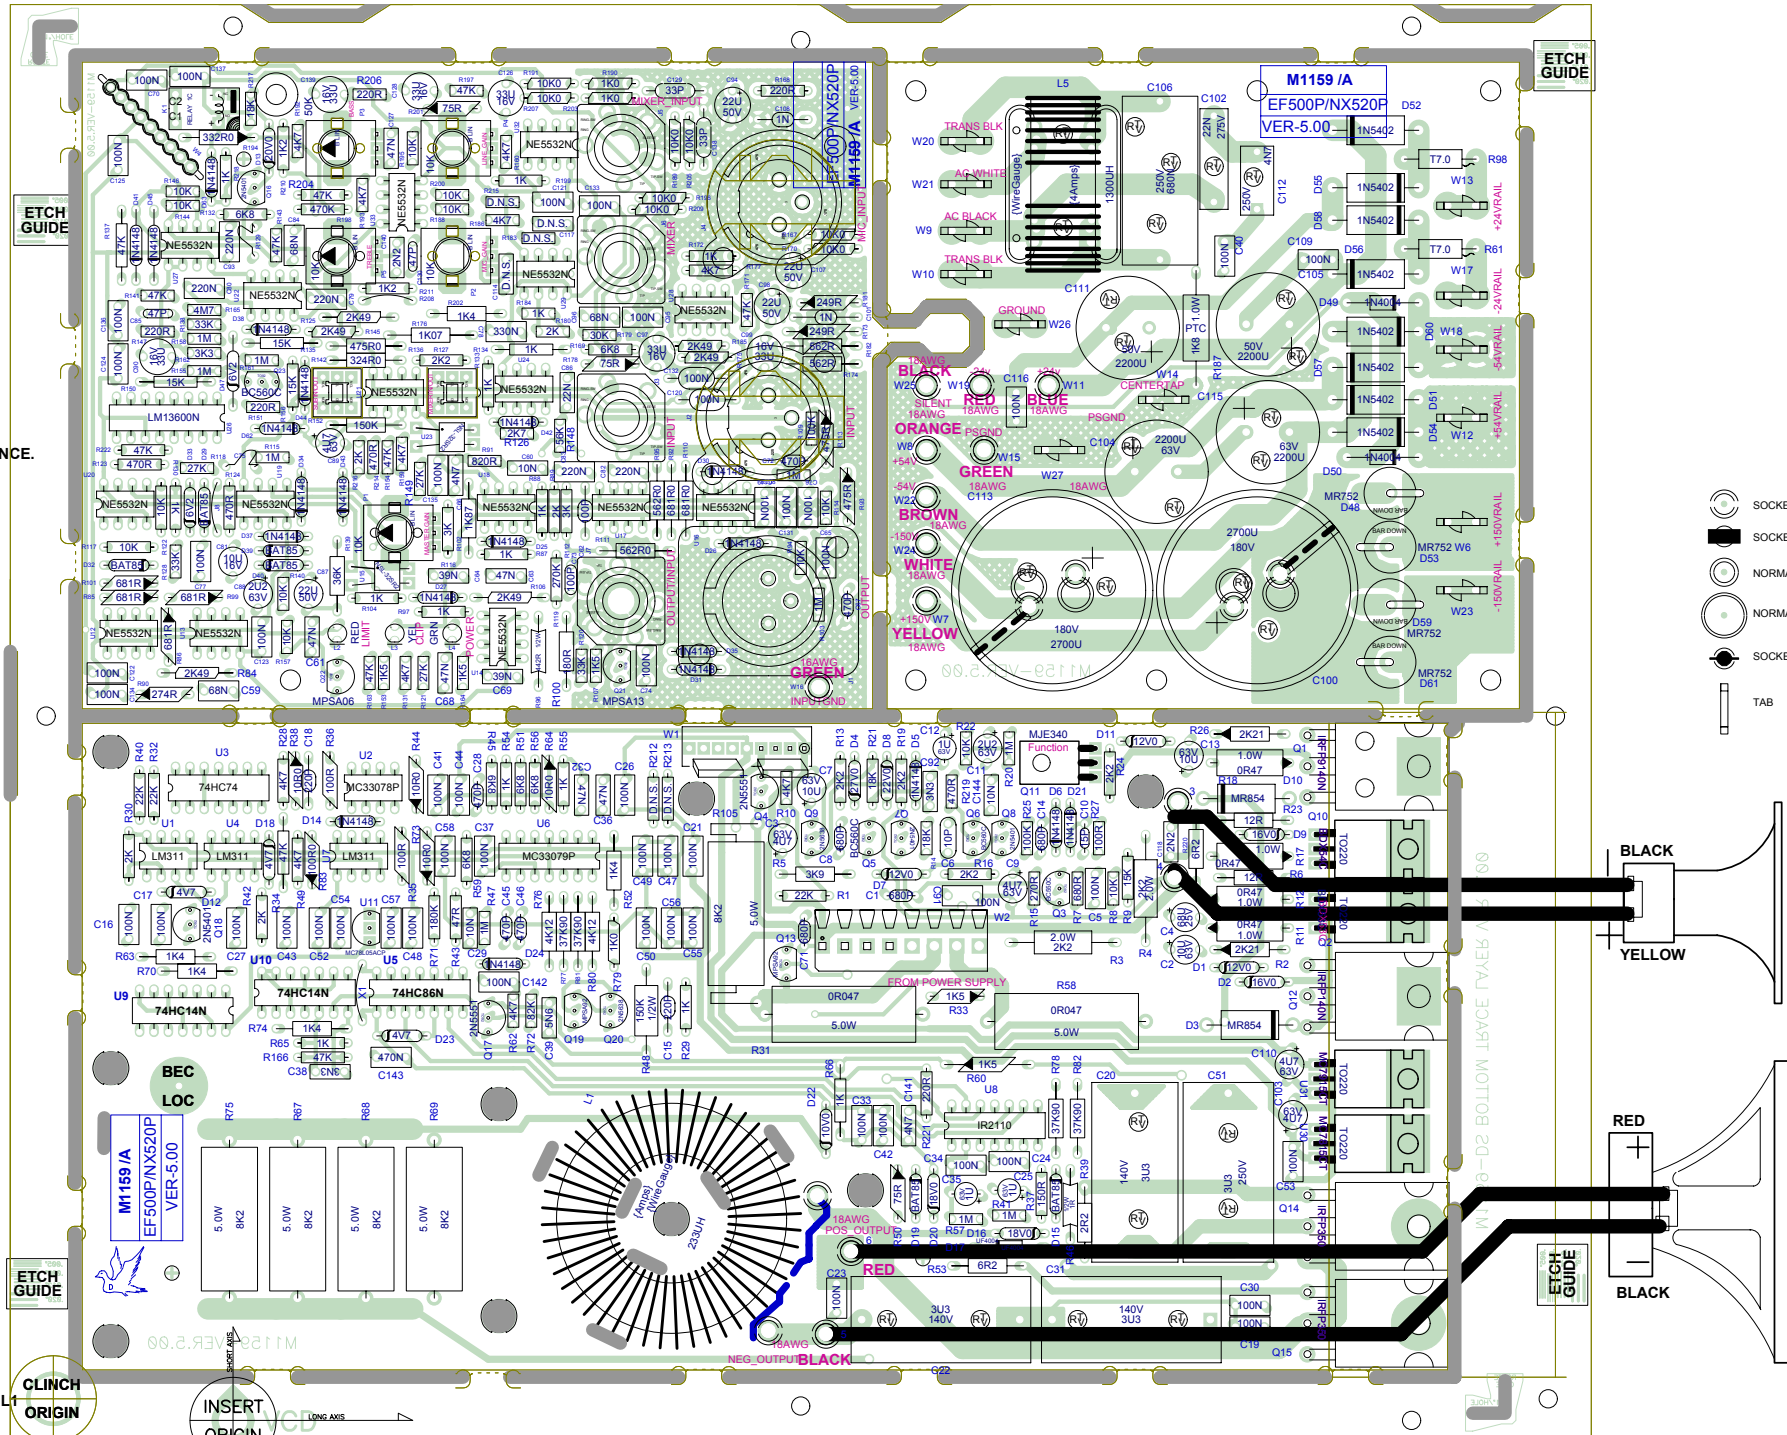
M1159A-NX520P

We have experienced some failures with the short pilot runs of 520P and EF500P due to an incorrectly mounted resistor on the power board. There are only about a dozen of each of these in each of our market territories. These failures at first sight will seem somewhat intimidating due to the blackening soot which is produced when the resistor arcs out to the printed high voltage rails under the resistor designated R60. The damage looks far worse than it really is and is generally repairable by anyone with basic electronics and soldering skills.

Replace parts outlined in red
Check parts outlined in green.

The process for repair of units suffering from an R60 arc over is as follows.

- A) Remove the remains of R60 and clean the soot from the board. Please remember this is a double-sided circuit board with thru plated component holes. Do not use excess force to remove the component leads from their solder holes. They will come out easy enough when you have enough heat on the joint.
- B) Replace the following components : 1) Q15 , IRFP350 2) Q17 , 2N5551 3) U10 , 74HC14N 4) U8 , IR2110 And finally, R60 , 1K5 , which should be installed about ¼" above the board so as not to arc out to the high voltage traces again.
- C) Measure the following parts; just to be sure we don't have any stragglers. 1) R58, .47ohms 2) R50 , 75R 3) R65 , 1K and 4) D20 , 18 volt zener.
- D) Yorkville Part #'s (Q15 = 6914) (Q17 = 5107) (U10 = 6603) (U8 = 6887) (R60 = 2034)
