# TECHNICAL BULLETIN

Freelander

Bulletin N<sup>o</sup>: 0076  
CDS. ref: L8664bu  
Issue: 1  
Date: 17.10.01

**WATER INGRESS INTO VEHICLE**

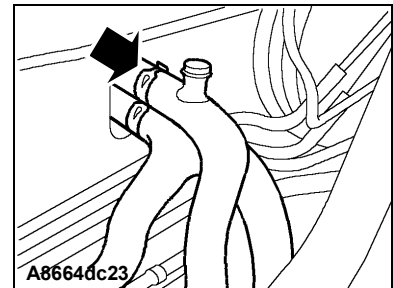
**23**

1. Lift bonnet and apply water to heater pipes in the engine bay whilst checking for water in the footwell. The water will soak through the NVH cover on the bulkhead and run into the footwell.
2. If water is present in footwell, refer to Workshop Manual, Cooling, for appropriate coolant drain procedure.
3. Release 2 clips securing heater hoses to heater and disconnect hoses, (arrowed in illustration 23).
4. Push grommet into position so it locates correctly onto heater pipes and bulkhead, (arrowed in illustration 24).
5. Connect heater hoses to heater and secure with clips.
6. Refill coolant system, refer to Workshop Manual, Cooling, for appropriate coolant refill procedure.
