THE ROVER COMPANY LIMITED
S E R V I C E D E P A R T M E N T

Rover Service News Letter No. 40

January 29th, 1954

TO ALL DISTRIBUTORS AND DEALERS

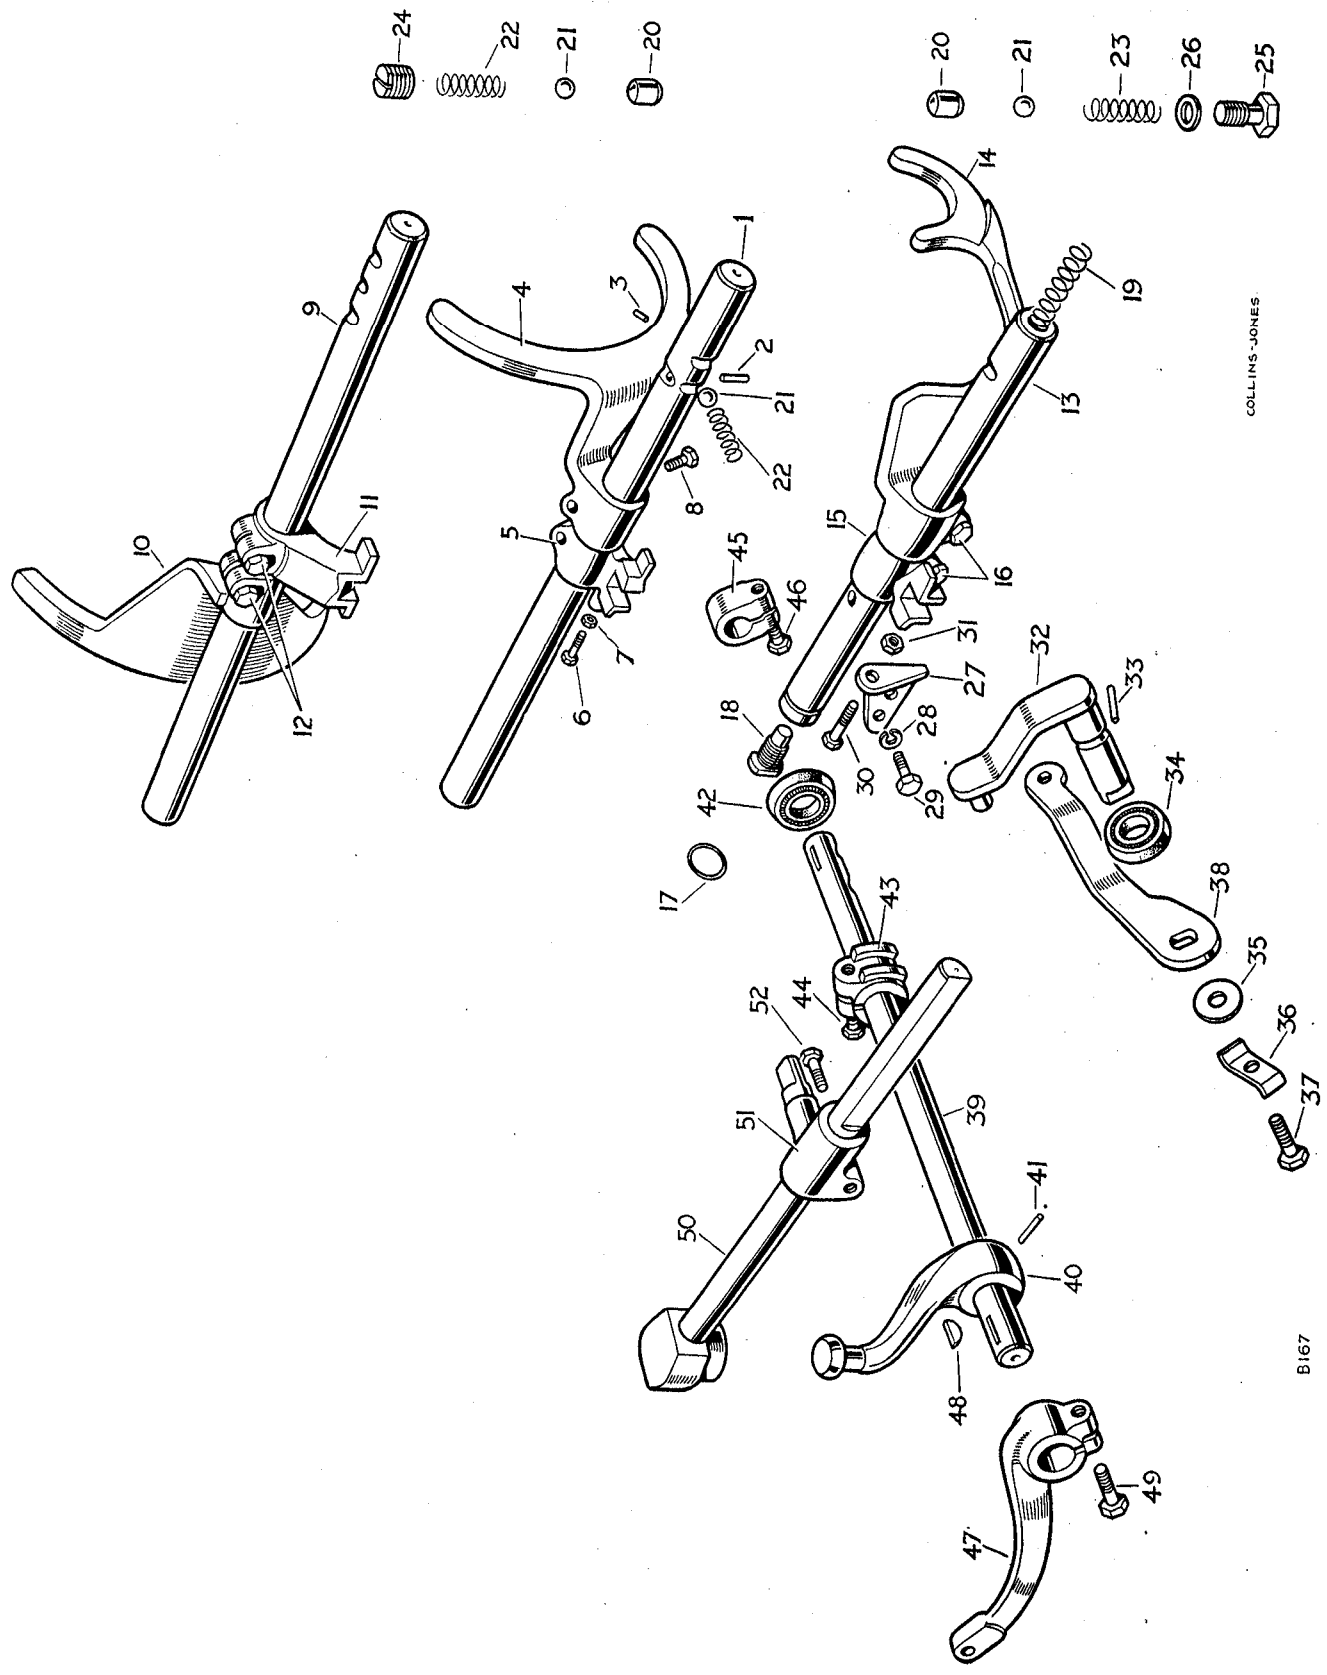
Fig. 2. Gearbox selector mechanism.

8. With the detent springs Fig. 2 (21 and 22) and side cover removed, check that full travel of all selector shafts and gears is obtainable without undue friction. The selector shafts Fig. 2 (1, 9 and 13) should have .003 in. (0,075 mm.) clearance in their bores.

9. Ensure that the main selector shaft Fig. 2 (50) slides freely in the side cover and is not caused to bind by the reverse light switch.
10. Ensure that the slots in the selectors line up with one another, so that there is no corner for the selector toggle Fig. 2 (51) to foul when passing from one selector to the next. The engaging end of the selector toggle should be highly polished to assist smooth action.

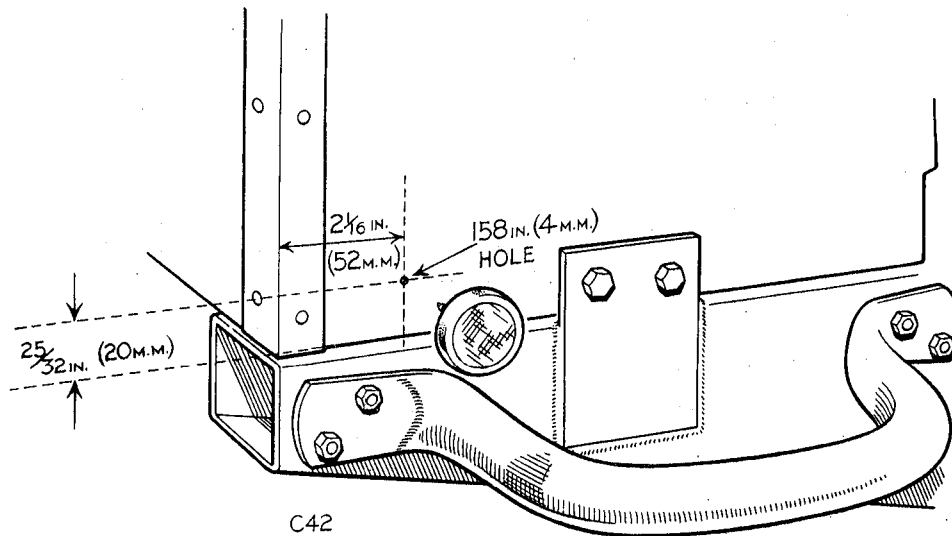
C42

From October 1st, 1954, two Red Reflectors must be fitted to the rear of all vehicles as detailed under the 1953 Road Transport Lighting Act. Suitable reflectors, complete with drive screws, for the Land-Rover can be obtained from our Spares Department under Part No. 240542. These are required at two per vehicle and should be fitted as detailed in the sketch below.

Fitting red reflector.

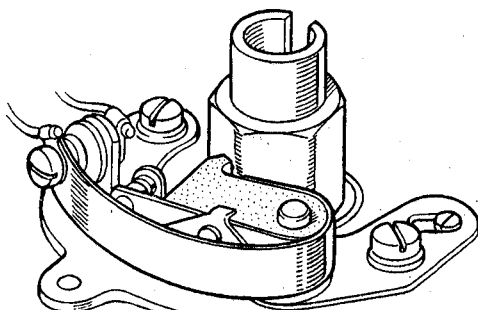
C43.

During the 1952 Season there was a change on the Contact points for Distributor, Part No. 237705, which is used on late 1951 models and all 1952-54 "75" models.

Part No. 262705
used on early models

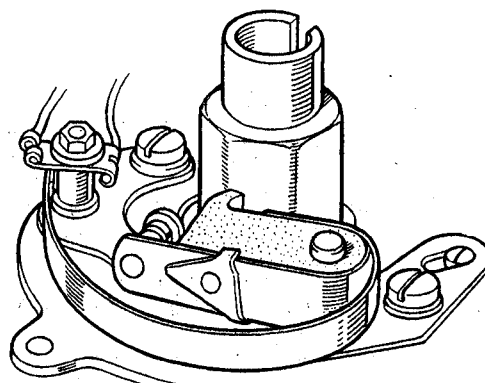
C44.

Part No. 245858
used on late models

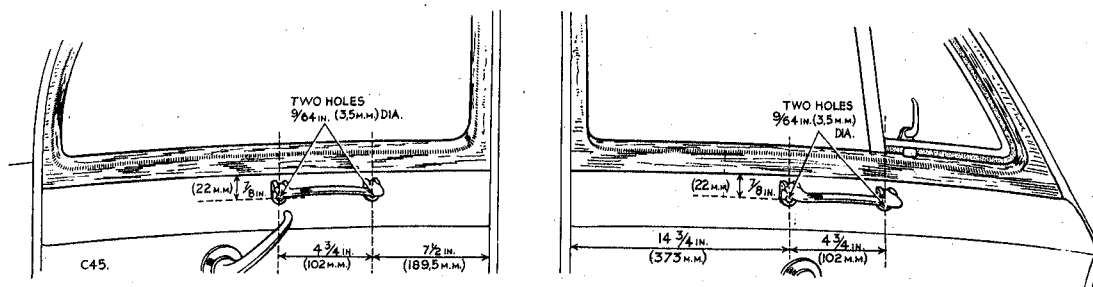
A complete kit of parts to enable earlier 1954 Cars and 1950-53 models to be modified is also available under Part No. 314184. The pull handles can be easily fitted as detailed in the sketch below. Use pull handle as a template.

Fitting pull handles to front and rear doors.

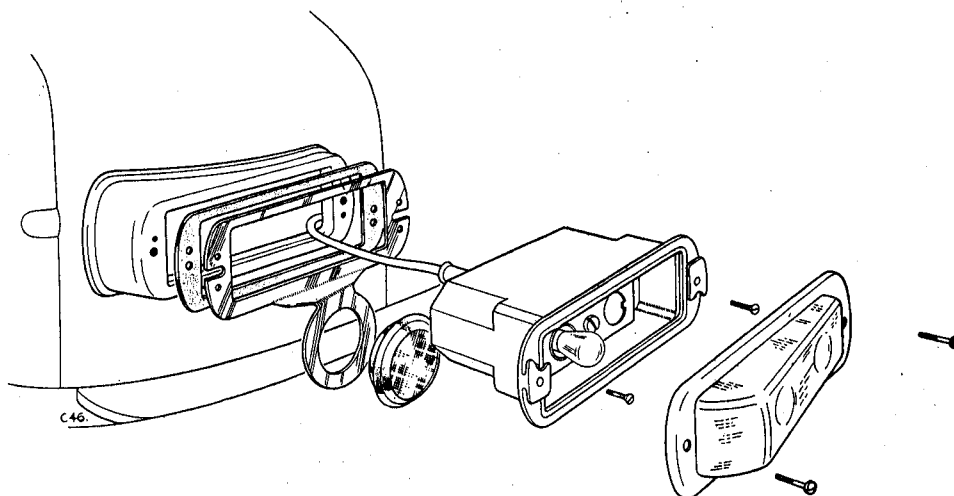
The reflectors and brackets can be easily fitted to any 1950-54 Car as shown in the sketch below. It will be noted that no drilling or cutting of body panels is necessary with the parts supplied.

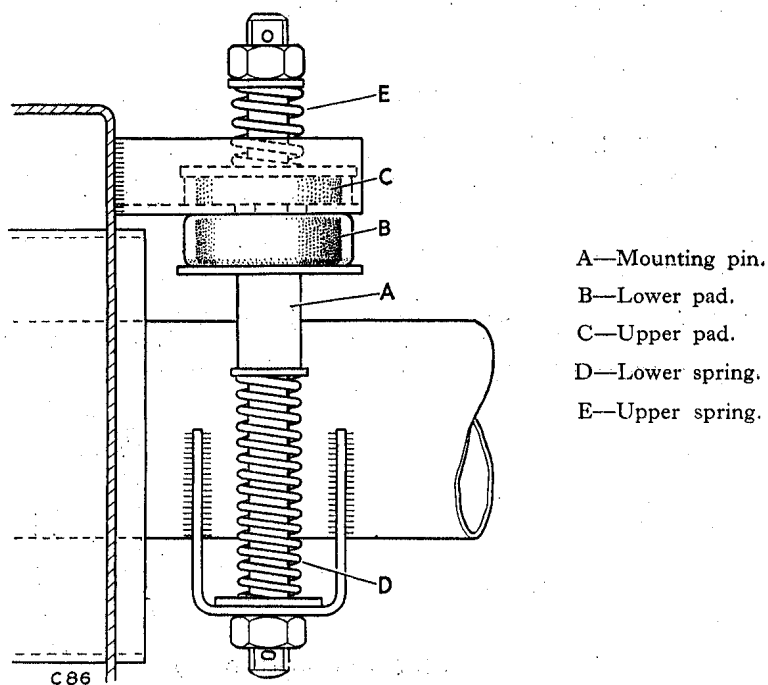
Fig. 2. Front mounting for exhaust pipe.

Any earlier 1954 Car can be modified if the parts above are supplied and in addition one plain washer, Part No. 2550, and one split pin, Part No. 2389, are also used. The sketch below shows the method of assembly.
