Tektronix 49x/275x/279x-Series Spectrum Analyzer Service Notes

John Miles, KE5FX
jmiles@pop.net

April 29, 2011

Errata and helpful notes on calibration/service procedures

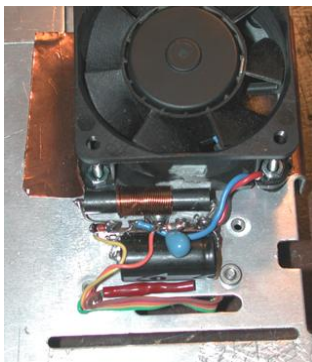
Similarly, careful electrical isolation is needed to maintain the instrument's original performance. Twist the fan leads together and keep them as short as possible. Bypass the fan with a parallel combination of a large (470 to 1000 uF) electrolytic capacitor and smaller tantalum capacitor (~10 uF), and use a series choke with a value of 100 uH or more that's rated for the fan's supply current.

A more subtle consequence of using a replacement fan is extended warm-up time for the entire analyzer, assuming the fan is no longer temperature-controlled.
