on
30FXB TRANSMITTER

SERVICE NOTES ON THE 30FXB TRANSMITTER

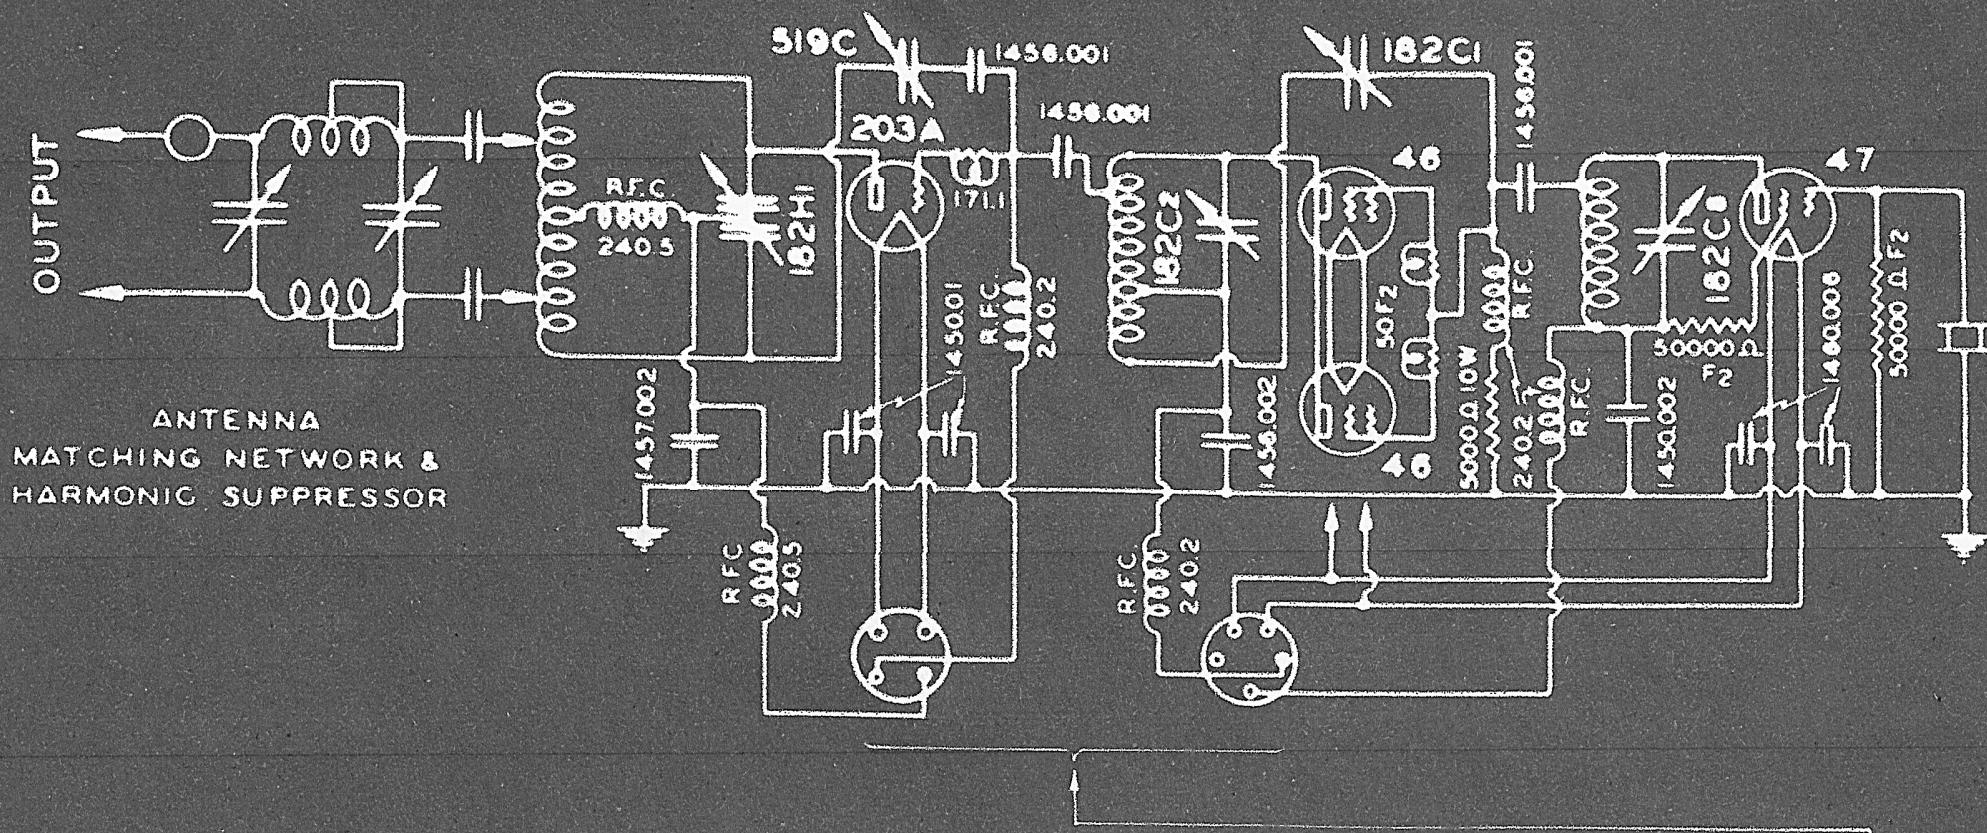
10 J. R.F. UNIT

TYPE 14C CONTROL BOX
APPLY FILAMENT POWER 15
SECONDS BEFORE PLATE POWER
