COMPANY: **CRESTAUDIO**

TITLE: **HP810 LEFT PCB**

ORG DRAWN: TAZ	DATED: 5/27/04	CODE: D	SIZE: D	DRAWING NO: 76D5473	REV: 01
CUR REV DRAWN:	DATED:	DRAWING NO: HPOPLMN1.SCH		FILE NAME:	
RELEASED:	DATED:	SCALE:		SHEET: 1 OF 2

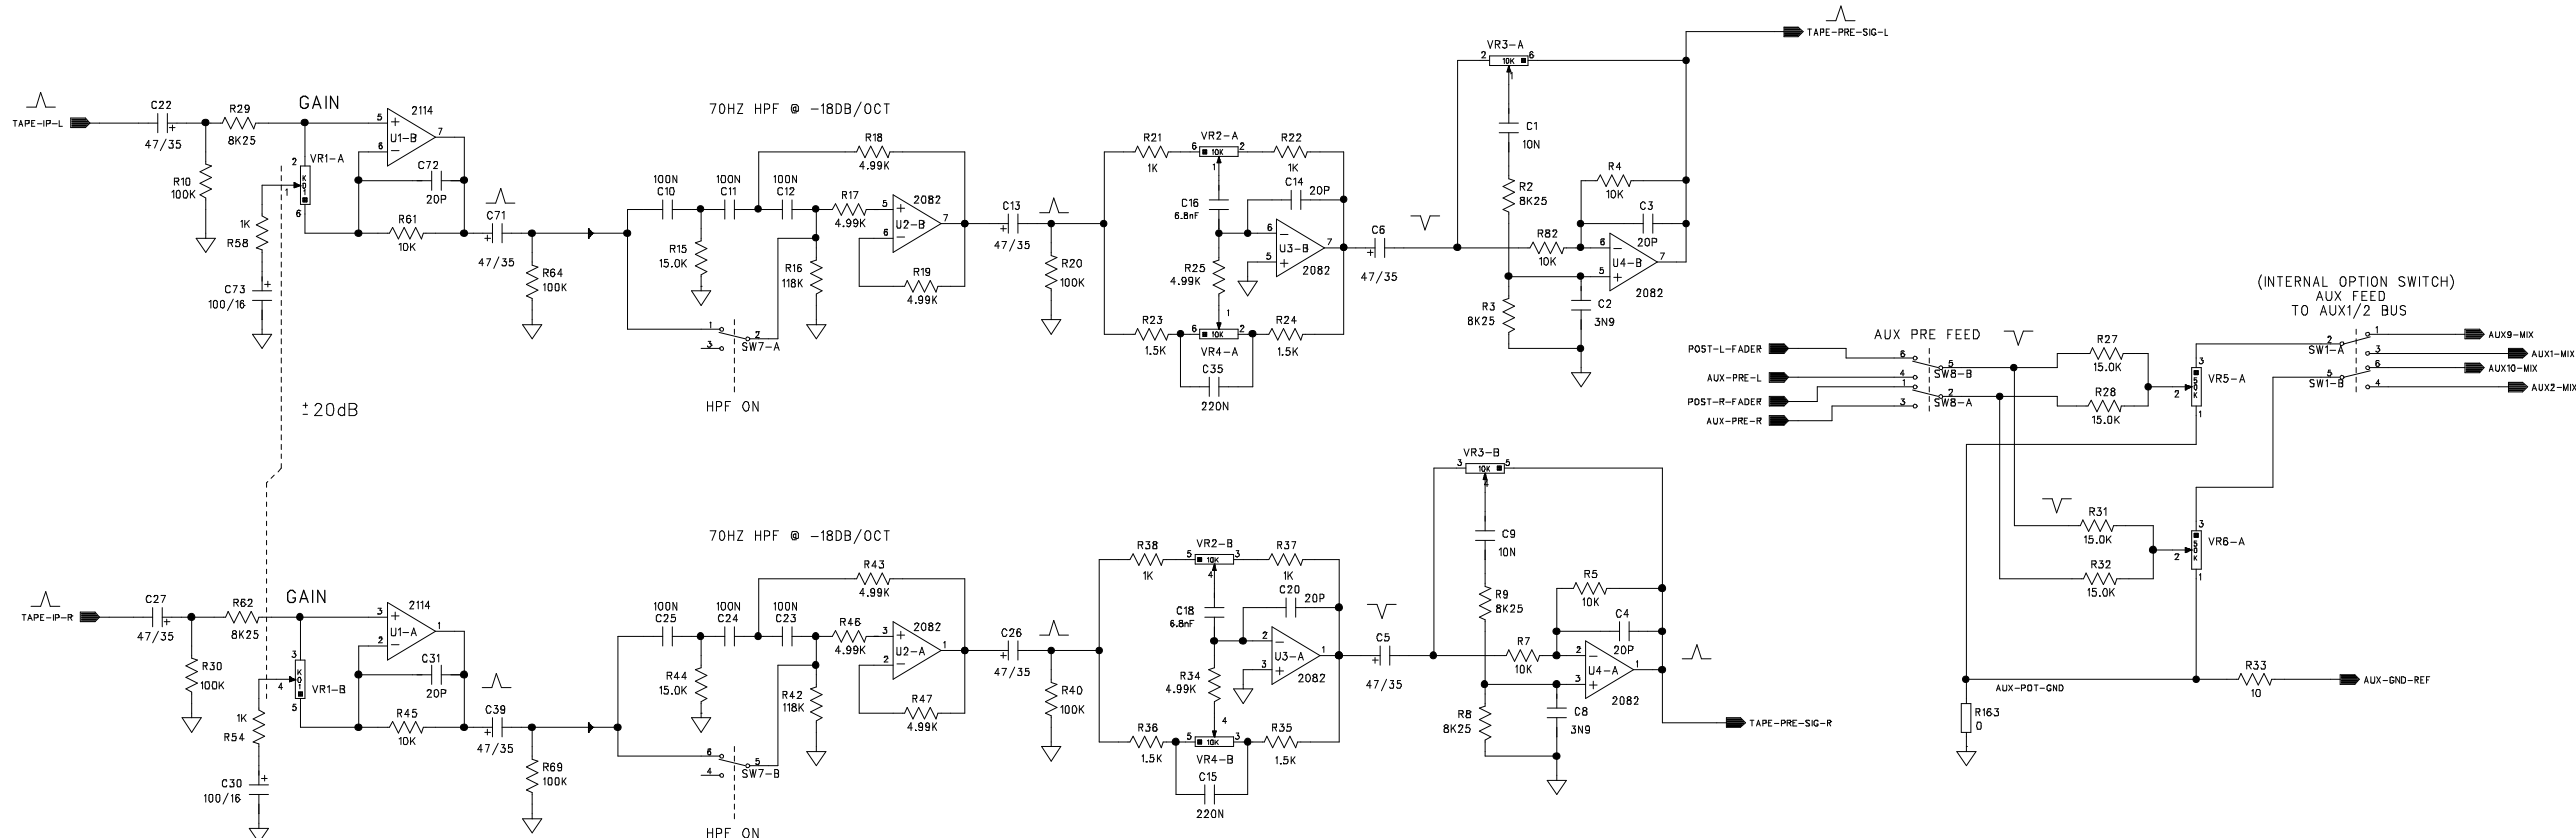
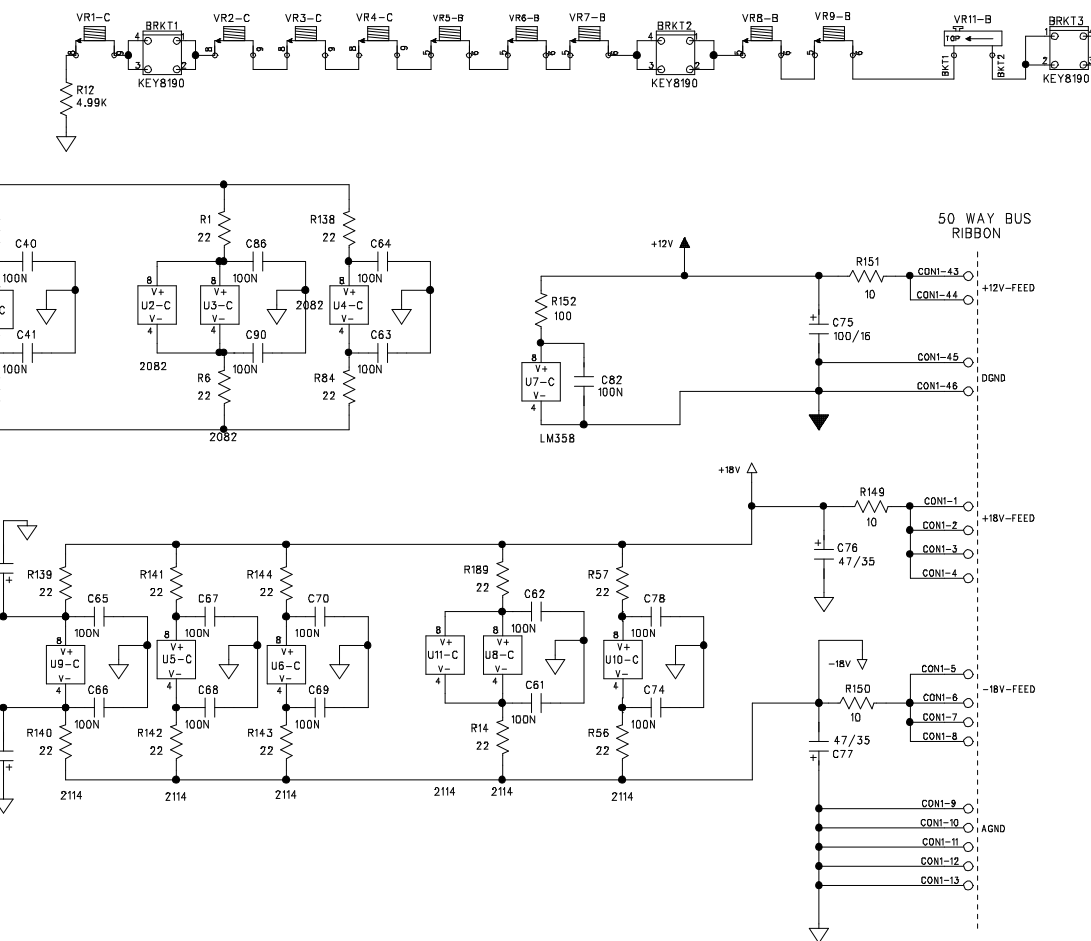
TITLE: **HP810 LEFT PCB**

REVISION RECORD					
REV LEVEL	ASMBLY LEVEL	DATE	ECO	ENG.	DESCRIPTION
A	A	9/03		TAZ	PROTOTYPE PCB
B	A	10/29/03		TAZ	PCB REVISION FROM A TO B MOVED ALL SWITCHES UP BY 0.060" TO USE NEW SWITCH CAPS SO AS SAME HEIGHT AS SWITCHES ON INPUT MODULES - INTERNAL WORKING LEVEL CHANGE FROM +4dBu TO -2dBu CHANGE R74 FROM 30.1K TO 16K2 CHANGE R109 FROM 33K2 TO 18K25 CHANGE R87, R105 FROM 10K7 TO 20K CHANGE R49, R201 FROM 10K TO 20K CHANGE C7 FROM 100pF TO 39 pF CHANGE R125, R126, R136, R135 FROM 30.1K TO 15K CHANGE R127 FROM 15K TO 7K5 CHANGE R112, R114 FROM 4K99 TO 10K CHANGE R123, R124 FROM 5K62 TO 10.7K - MUTE TRIM CHANGE R118 FROM 499R TO 187R - REMOVE CLITCH THAT OCCURRS WHEN SOLO SWITCH RELEASED - ADD C91 AND C93 (100nF) - CHANGE STEREO RETURN MID EQ TO PEAKING AT 2KHz CHANGE C1, C9 FROM 5N6 TO 10N CHANGE C2, C8 FROM 2N2 TO 3N9 - CORRECT ERROR CHANGE R45 FROM 15K TO 10K
00	A	1/16/04		TAZ	PCB REVISION FROM B TO 00 - PRODUCTION RELEASE. MOVED LED UP 0.050" - SITTING LOW ON THE PCB. REMOVED C91 AND C93 (100nF), CAUSING GLOBAL SOLO GLITCHING ON CONSOLE. MUTE TRIM - CHANGE R118 FROM 187R TO 249R.

01	A	5/27/04		TAZ	PCB REVISION FROM 00 TO 01 - AUX9/10 SPEC IMPROVE CHANGED TRACKING OF STEREO FEED TO AUX 9/10 (IMPROVE NOISE/XTALK SPEC) CHANGE VR5 AND VR6 FROM DUAL TO SINGLE POT ADDED SW1 (INTERNAL SWITCH FOR OPTION SELECT)
