# TestBook Information

MODEL <b>New Range Rover</b>	SUBJECT <b>BeCM Re-Programme</b>	05/10/95 <b>TB 002/95/EN</b>
AFFECTED VEHICLES LP All LH LJ LD

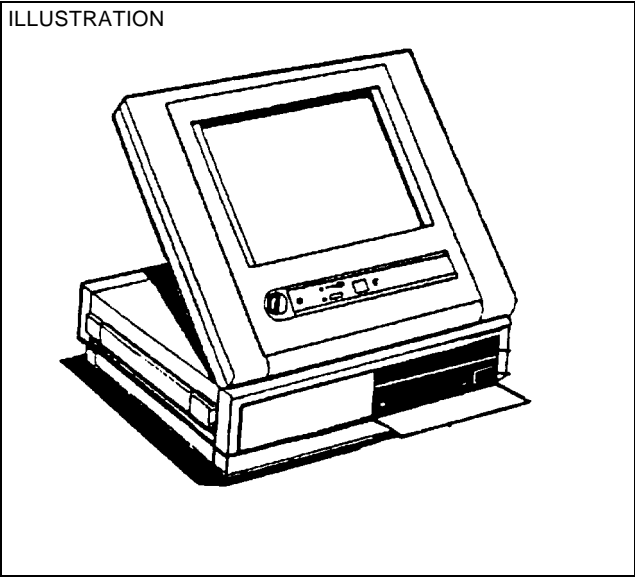
- PROCEDURE**
1. Connect TestBook to the vehicle.
  2. From the welcome screen select diagnostic system.
  3. Select model Derivative.
  4. Select BeCM Re-programming.
  5. Select Vehicle options.
  6. Select options.
  7. Tick off relevant addition specification.
  8. Select OK
  9. Exit programme
