Collector's Quarterly Magazine

Volume 1 Issue 4

Spring 1992

The care and feeding of your KWS-1 and other pertinent trivia

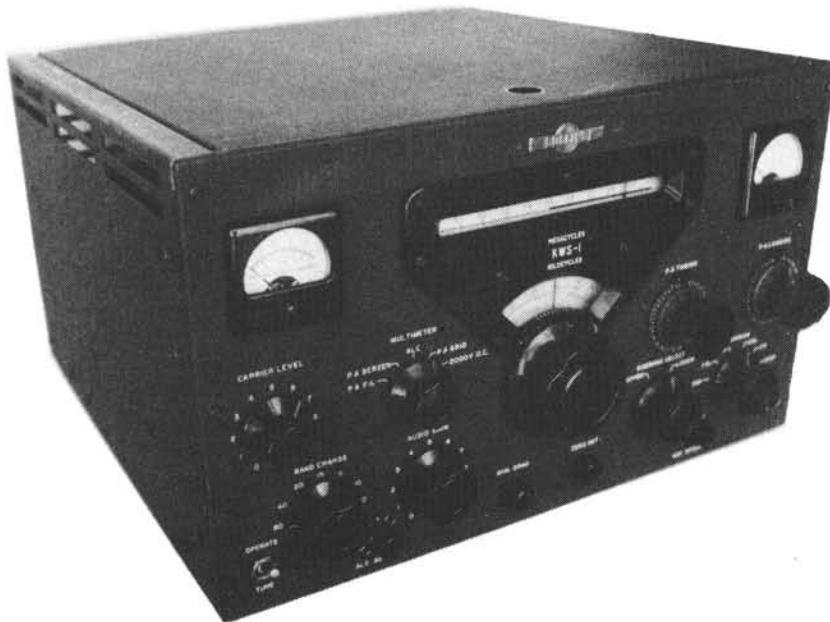
On the Cover

General Partridges at the controls of an air-mobile KWS-1, 75A-4. Installed in a DC-6—note the shock mounts and shields.

For this demonstration, standard KWS-1 and 75A-4 amateur equipment was installed in the passenger compartment of both General LeMay's C97 and General Partridges DC-6 aircraft. See this quarterly's cover. These aircraft and subsequently, others were then flown throughout the North Polar region, the Far East, Europe, and Africa communicating reliably with North American test sites.

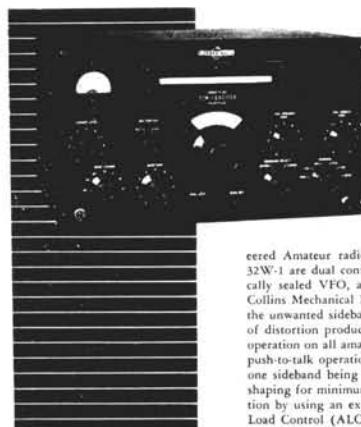
Figure 3A

Early "30L-1" advertisement that appeared in the 1955 ARRL Handbook.

Early in the introduction strategy of the KWS-1, the marketing group was calling it the "30L-1" (Ref. 2.), the next logical product model after the AM 30K-1 thru 5 transmitters. There followed an embarrassing product announcement of the "30L-1" (sic) 1 KW SSB transmitter in the 1955 ARRL Handbook, actually laid out in late 1954. See Figure 3A.

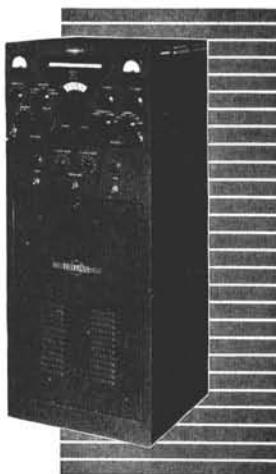
Figure 3B.

Introduction advertisement for the KWS-1 appearing in the March 1955 QST.

The KWS-1 was born and introduced to the world in the March 1955 issue of QST (Figure 3B). Actually, afraid that the rather large price would reduce the market acceptance, the introduction included a series of building block products starting with the low end 32W-1 exciter only. This was a KWS-1 exciter without HV power supply and with the low voltage supply in the PA cage area. Figure 4 shows another 32W-1 configuration. The 32W-1, introduced also in March, apparently never went into production.

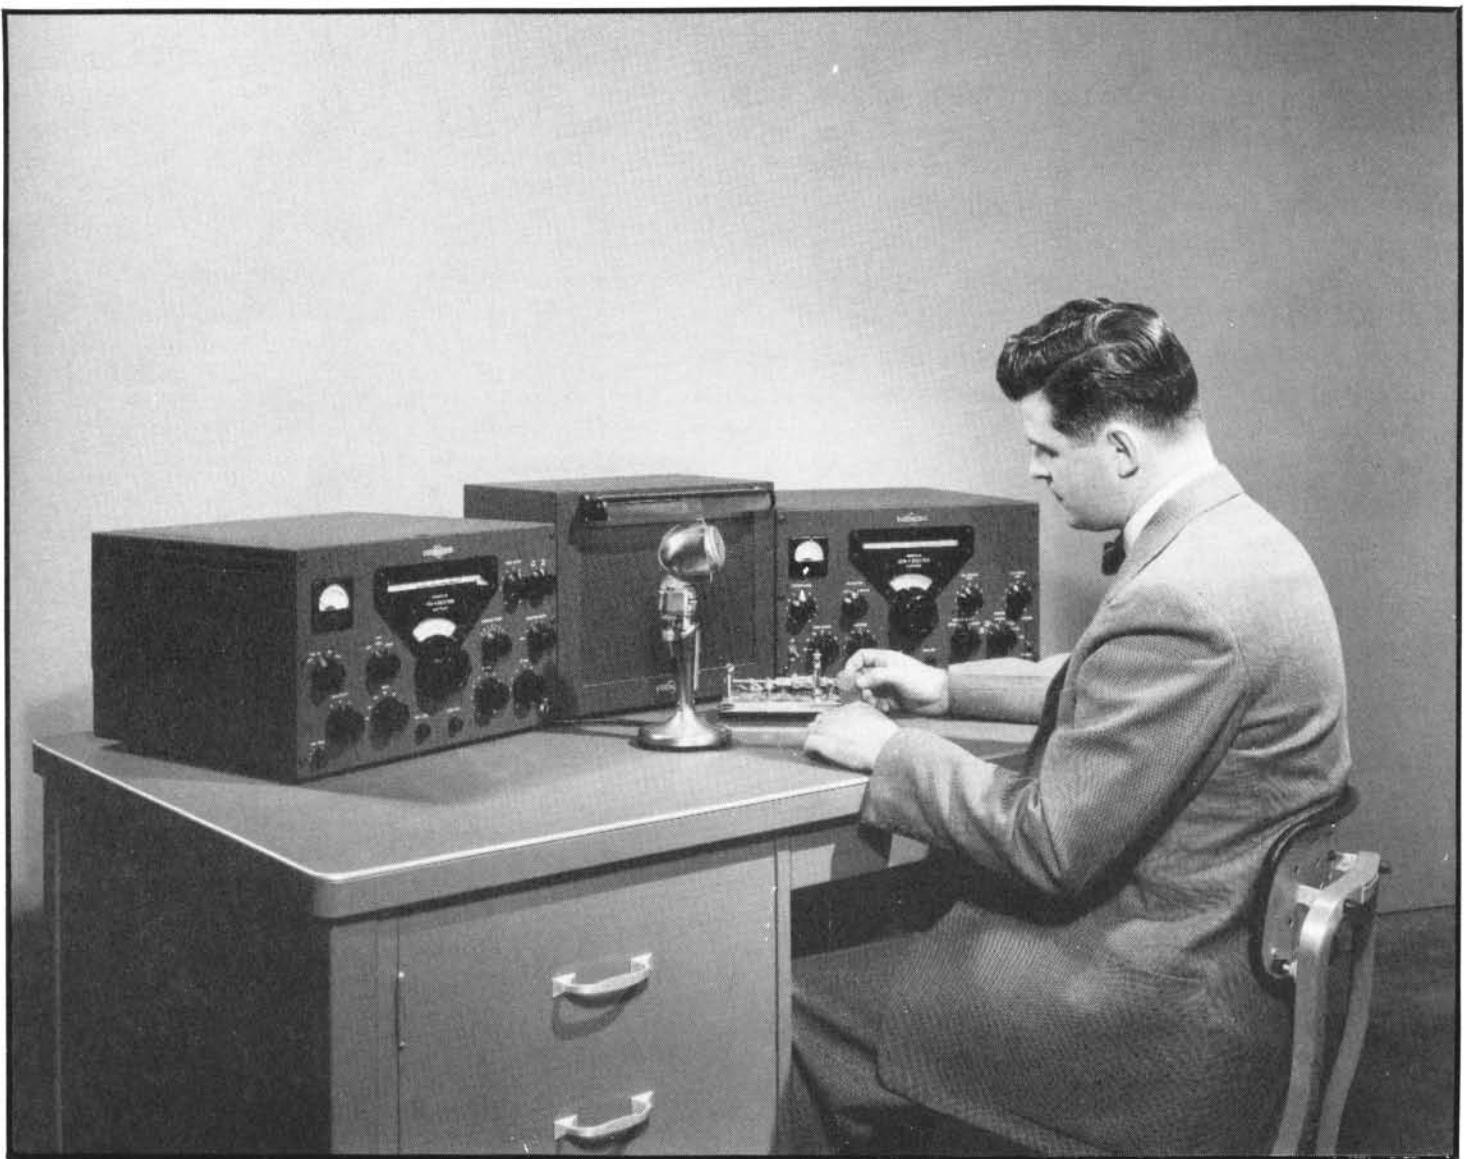
Figure 4.

Collins public relations photo of 32W-1 mock-up or prototype - none were produced. Robert C. Miedke, Engineering Group Head, shown seated.

Note the difference in front panel control configuration between the 32W-1 prototype in Figure 4 and the intro model pictured in the QST advertisement. There was also a power supply location difference. It is evident that the marketing strategy for this version was never clear.

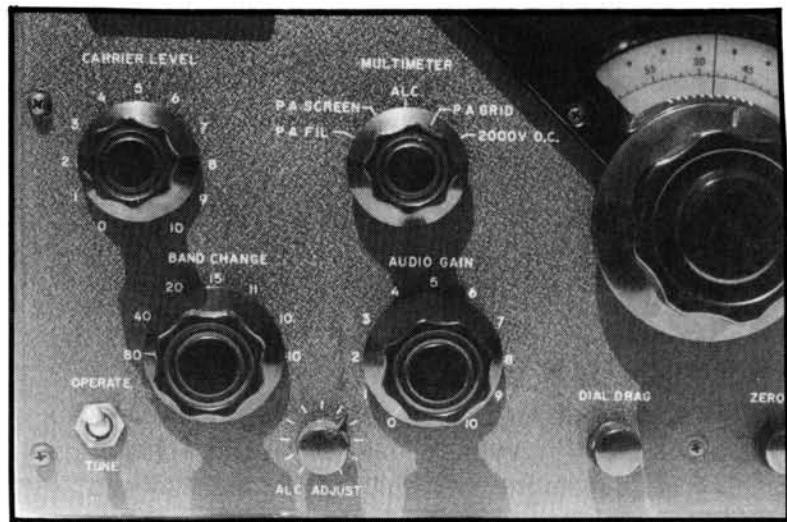
Figure 6A.
Early series exciter with variable ALC control.

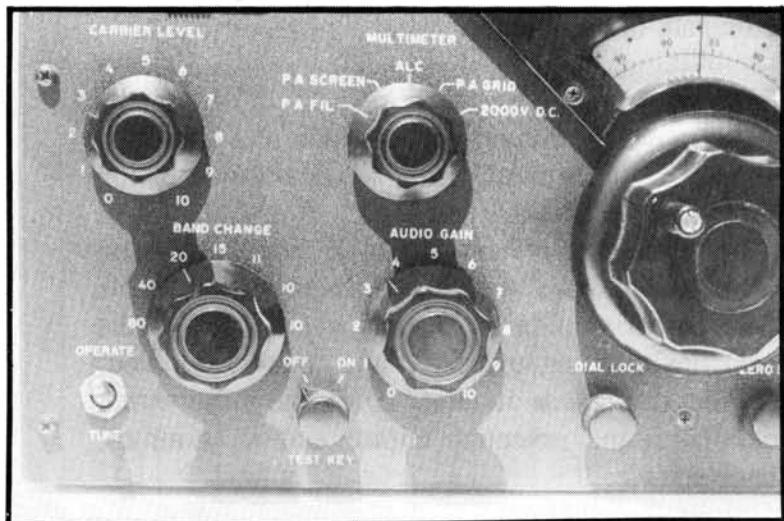
Figure 6B.
Late series exciter with fixed ALC and Test-Key (key lock) switch.

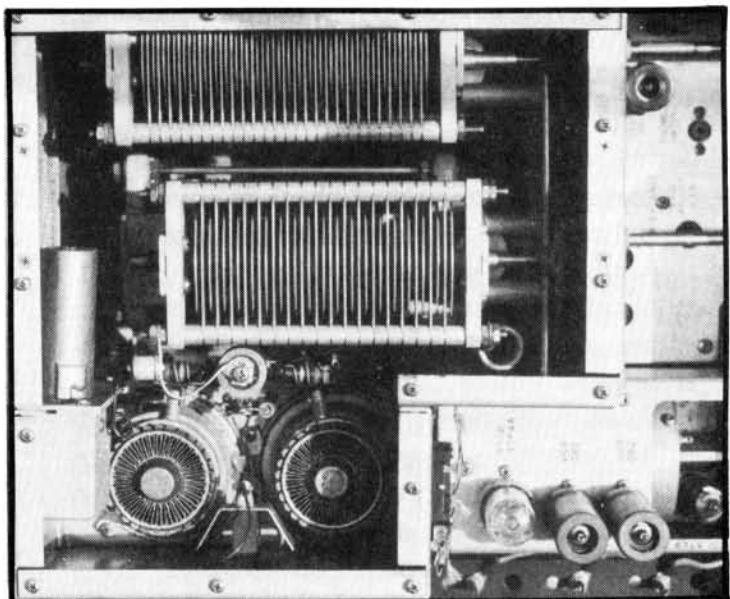
Figure 7A.
Final amplifier shown with cover off.

Also, always check the P.A. tuning and loading alignment of the roller inductors and capacitors to each other and the dial settings. Particularly the loading inductor roller can be bounced off of the coil during rough handling or going against the end stops too hard. The alignment check is covered in service bulletin #6G. With an antenna close to 50 ohms, your P.A. Tune and load settings should closely match the preset chart that is under the lid. A post script on loading: never reduce loading to run at reduced power output. This results in the plate voltage swinging below the screen level and causes the screen to source current. The screen current handling capability of the 4CX250B is easily exceeded. Reduce power out with the carrier control on cw or the audio gain control on sideband. Use minimal to no lubrication inside the RF cage. Most tuning roughness is usually in the turns counters.

Caution: The gears on the turns counters are soft brass and easily damaged. If your tuning is rough, carefully remove the counter components, remove all old grease and dirt and lubricate sparingly with a good grade lithium automotive grease and reassemble. Note that the brass gears have probably established a wear pattern and you will have to try several different gear mesh relationships and knob depths on the shaft to find smooth. Do this carefully and it is worth it. Also, be very careful not to lose the little tiny pointer screws. I have never been able to find a source for them.

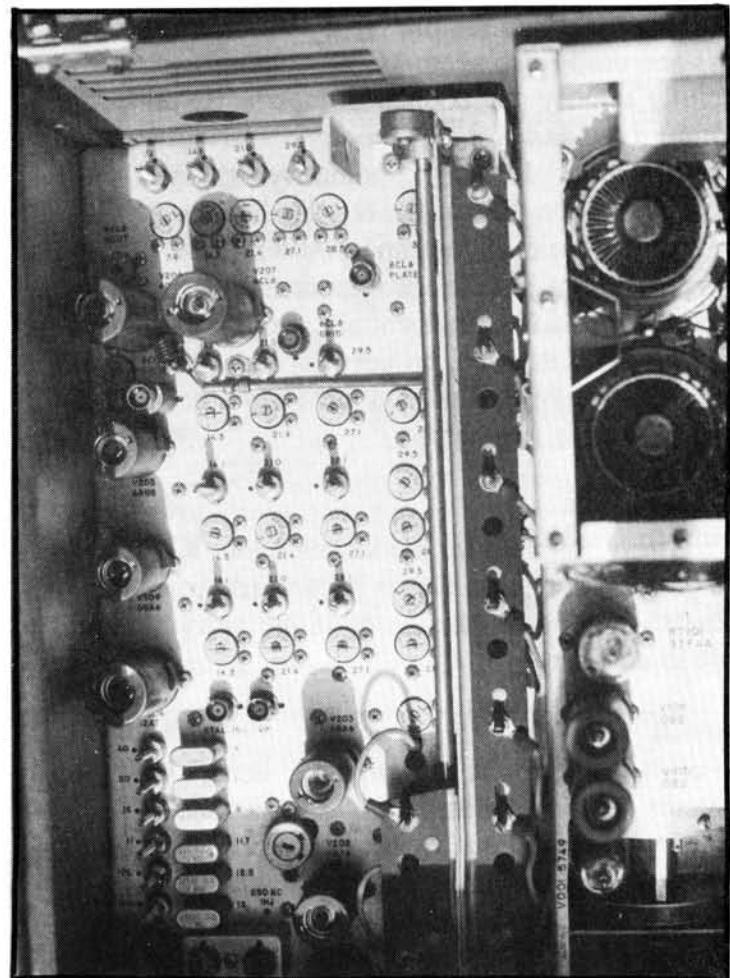
Figure 7B.
Exciter/IF stages.

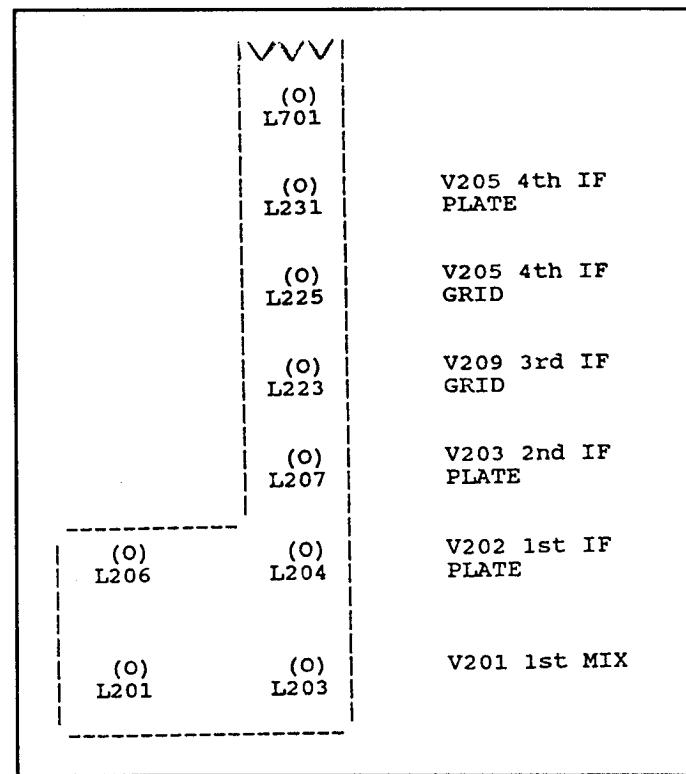
Figure 8.
Top view of slug rack tuning inductors labeled by function.

I have included a top view location diagram, see Figure 8, for the tuning inductors called out in the alignment procedure. This will save a lot of hunting around. I suggest making a copy and putting it with your manual. Also, included is a table of typical AC (both audio and RF) signal levels encountered throughout a good unit.

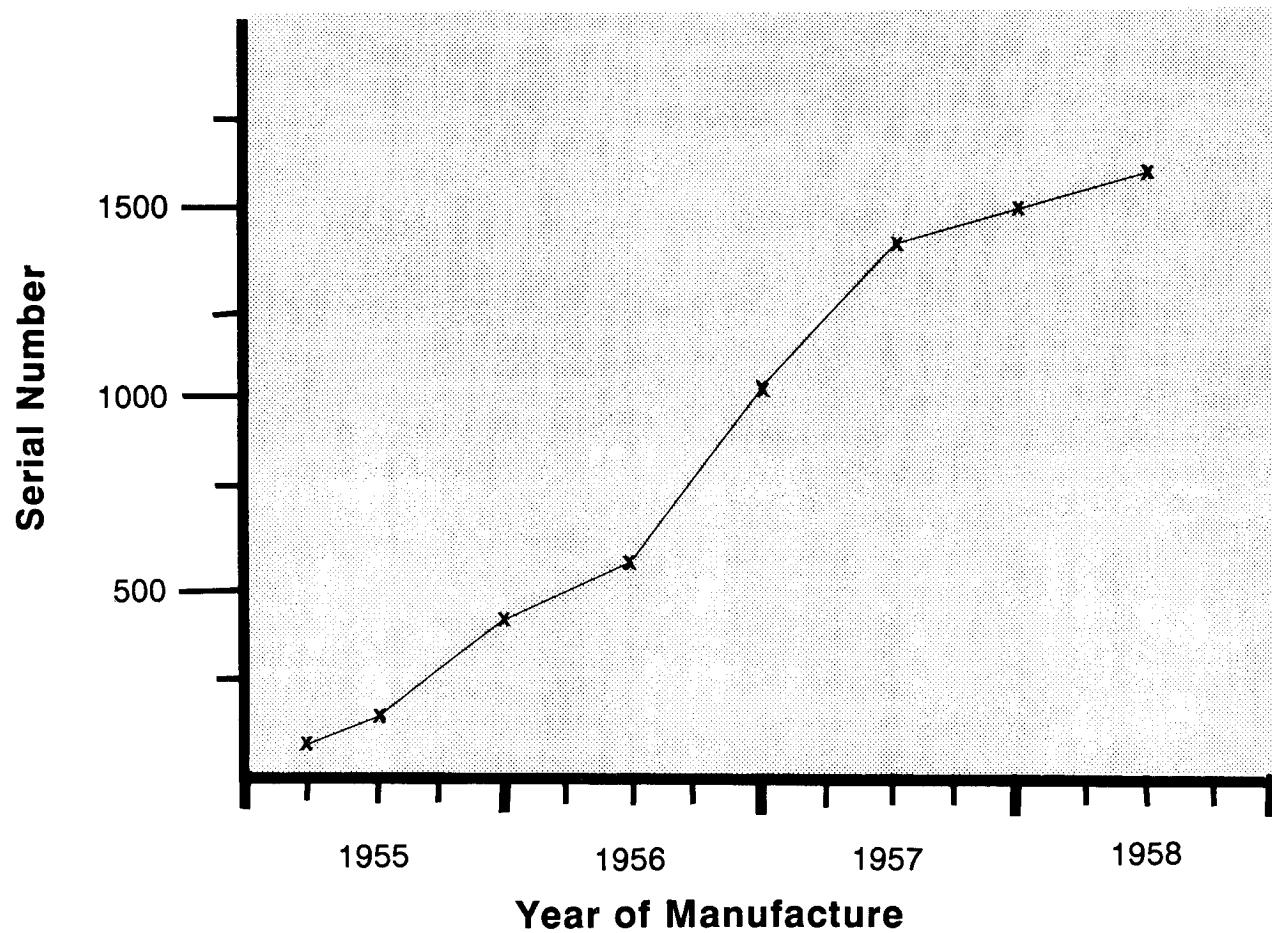
Figure 9.

Estimated KWS-1 serial number vs. manufactured date.

It is believed that ultimately about 1600 KWS-1s (and KWS-1K's) were built with production ending in about mid 1958.

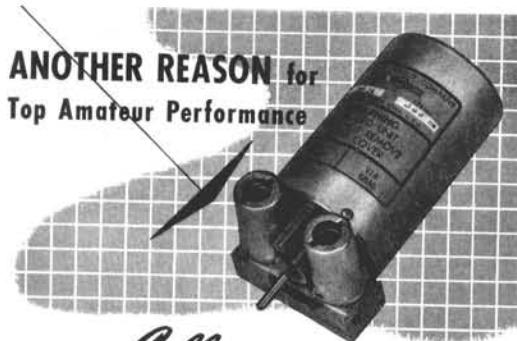
Collins PRECISION VFO

Another reason for the superior performance of Collins KWS-1 Transmitter and 75A-4 Receiver is the use of Collins Variable Frequency Oscillator — famous for its linear calibration and stable output. The units in the KWS-1 and 75A-4 are designed specifically for Amateur operations and are 100% tested under lab conditions to rigid specifications.

- An average of 24-hour stability of .003% or better is achieved under normal operating conditions.
- Precision ball-bearing construction allows single-knob, permeability tuning with rock-steady vibration stability.
- Each unit is hermetically sealed against atmospheric changes for life-long, drift-free operation.
- Each unit is individually temperature-compensated for minimum drift. Each is lubricated for life.
