# Technical Service Bulletin No. 27

**Created by: Lab.gruppen AB Service Department**

**Reference no: C12**

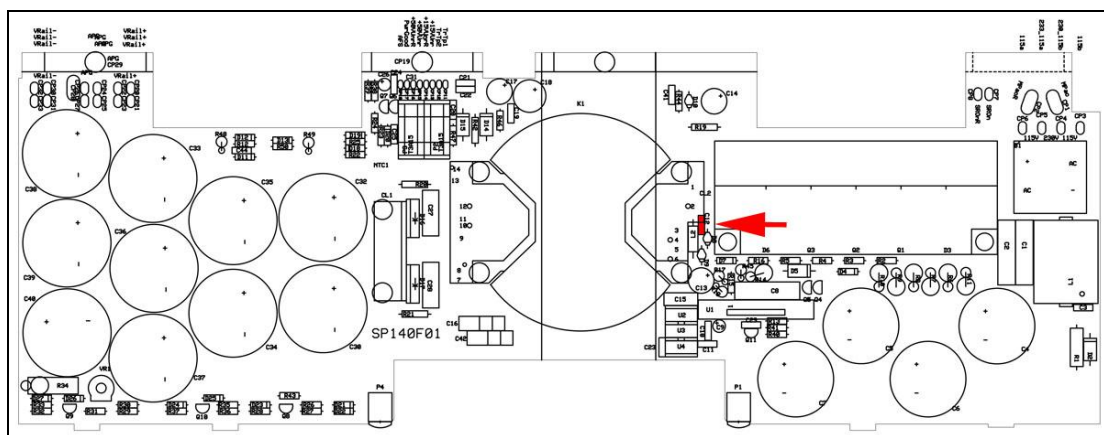
Screaming sound from power supply if amplifier powers up.

Amplifier does not power up.

Replace capacitor C12 with either of below listed components.
