Title: **ISA Turn-on Hangup**
Bulletin #: ISA0001 Issue Date: April 4, 2002
Models Affected: ISA 750, 800T, 450, & 500T
Bulletin Revision: A
Production Range: 01/2000–04/2002 (serial # 0100xxxxx–0402xxxxx)

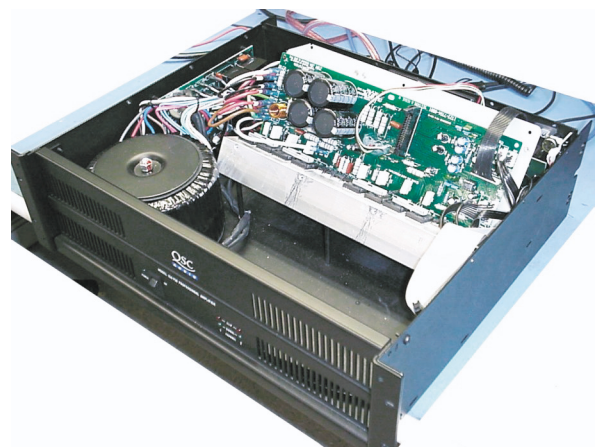
Figure 2. Prop the channel module assembly up on the chassis standoffs.

5. Lift up the front of the channel module assembly. Rotate it so that channel 1's module (the lower one) is on top; set the assembly down in the chassis with the heat sink resting on the standoffs (Figure 2).

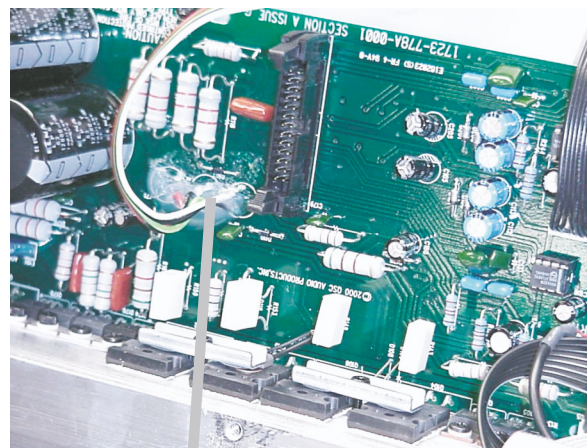
Figure 3. You might need to clear hot glue away from diode D107. Use your hot soldering iron tip.

6. Disconnect the ribbon cable from the channel 1 module.
7. Locate zener diode D107. It is near where three wires are soldered to the circuit board and secured with hot glue. If the hot glue covers the diode, use the tip of your hot soldering iron and a small screwdriver to melt and clear the glue away (Figure 3).
