TECHNICAL INFORMATION

No: 76/24/99/NAS
Ref:
Issue: 1
Date: 11/02/99

Optional Auxiliary Cupholder

DISCOVERY Series II (LT) All

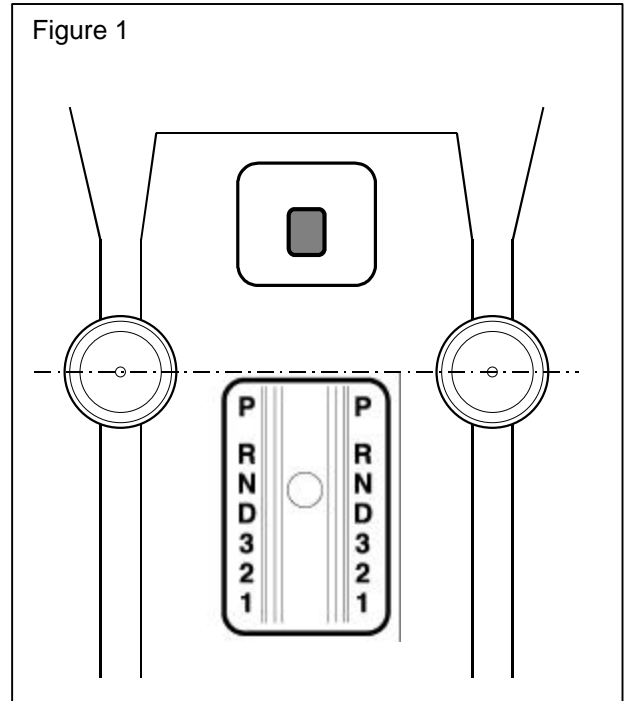
1. Refer to Figure 1 and determine retaining screw location as follows:
 - Place a ruler across the center console area just touching the shift lever trim.
 - Align the ruler using the dot pattern in the console mat.
 - Mark each side of the console with a pencil.
2. Align the centerline reference mark on the cupholder with the pencil mark on the console. (Figure 2)
3. Mark the drill location through the cupholder mounting hole with a pen.
