TECHNICAL INFORMATION

Upgraded Rear Seat Latch Strap

No: 76/04/00/NAS
Ref:
Issue: 1
Date: 09/22/00

Discovery Series II (LT)

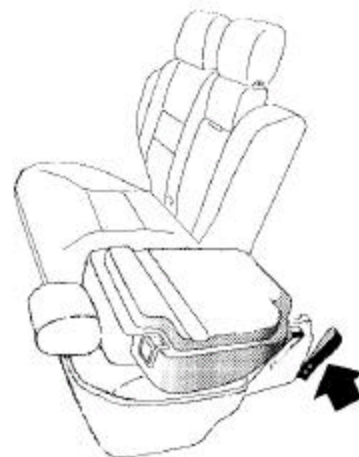
Figure 1

1. Carefully center mark and drill out both rivets used to secure the damaged or broken strap.
2. Position the ends of the new strap on either side of the lever.
3. Insert the new rivets supplied in the kit through the strap webbing and the seat release lever. (Figure 1)
4. Press the two halves of the rivets together with your fingers until they seat together.
5. Protect the outer surfaces of the rivets to avoid marring.

NOTE: Initially the rivet will resist compression and then it will compress approximately 3mm (1/8 inch).

6. Using large parallel jaw pliers, compress the two halves of each rivet together to secure the strap to the lever.
